**MARSH GRASS PROTECTION WITH LOW-COST BREAKWATERS
SHORELINE EROSION CONTROL DEMONSTRATION**

Marsh Grass Protection with Low-Cost Breakwaters
Shoreline Erosion Control Demonstration

Final Project Report
for
Albemarle-Pamlico Estuarine Study

UNC Sea Grant College Program
&
Dept. of Civil Engineering
North Carolina State University
Raleigh, North Carolina

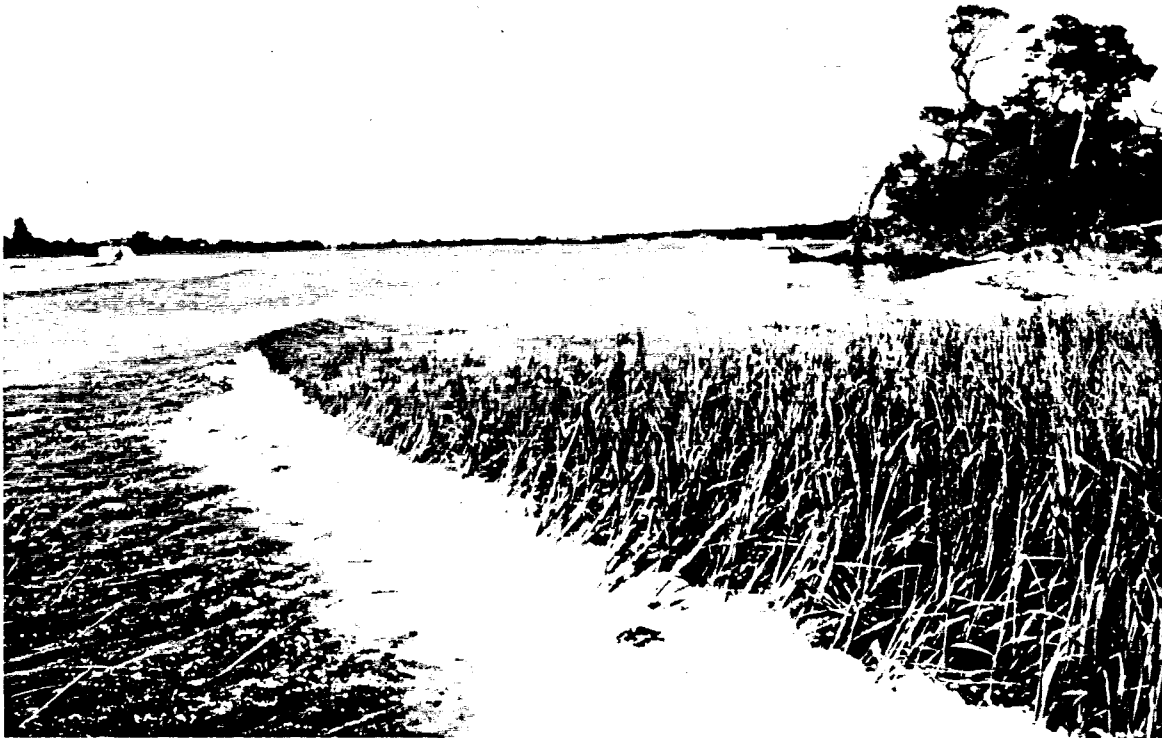
Figure 1. Waves dissipated by the marsh.

Marsh grasses are most effective for erosion prevention during higher water levels when waves are dissipated as they move through the many stems (Knutson et al., 1982; Gleason et al., 1979). The turbulence created by a single stem has little effect on the wave, but when thousands of stems in a fringing marsh are combined, the wave damping effect is substantial (figure 1). In addition, the grasses develop a

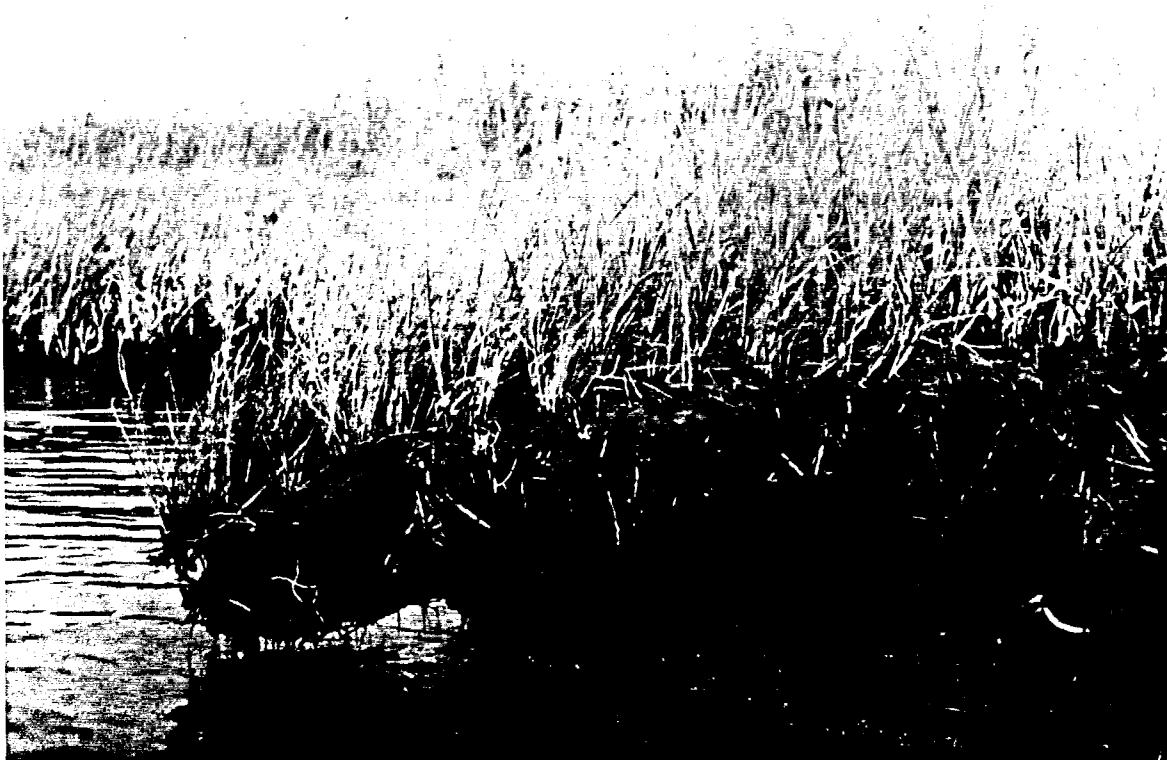
Figure 3. Root mat undermined by erosion.

erosion undermines the outer edge of the mat, removing the unconsolidated soils below (figure 3). Undermining occurs during normal, non-storm conditions when waves break directly on sediments seaward of the marsh or on the vertical scarp of the root mat, causing localized scour. Once undermined, clumps of the mat are torn away during storms by breaking waves. The marsh width is narrowed until its erosion-resistant properties are lost. New grasses cannot re-establish seaward of the root mat because the water is too deep. The marsh is eventually destroyed by natural processes, leaving a sand beach.

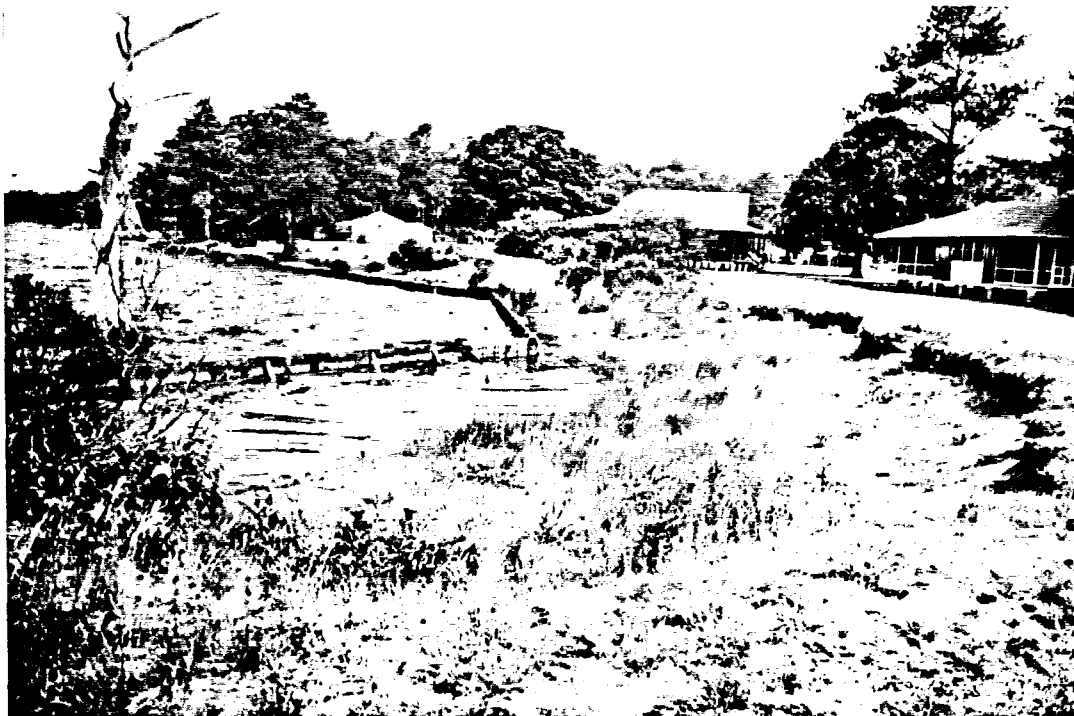
Figure 4a. Two years after "accidental" breakwater construction at Camp Leach.

fixed open-plank breakwaters. Hardaway et al. (1985) reported on rubble-mound sills in the Chesapeake Bay. In North Carolina the successes of a variety of both accidental and planned wooden breakwaters are described by Rogers (1989) that provided the basis for site selection and design of this demonstration (figure 4a-c).

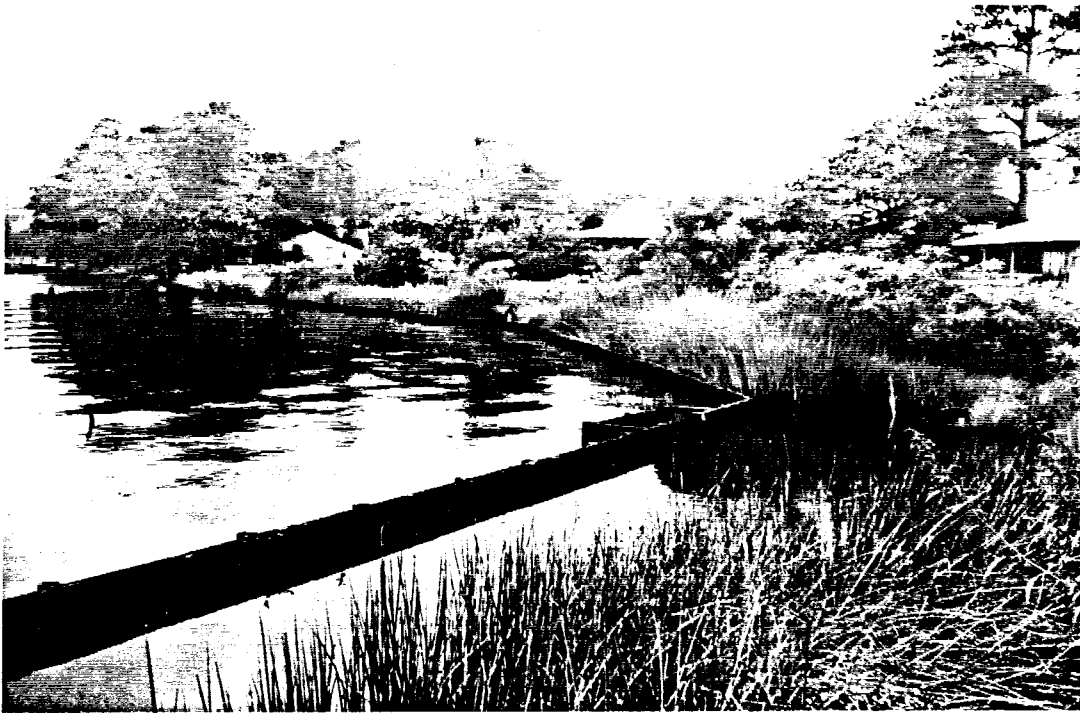
Figure 4b. Camp Leach after 5 years.

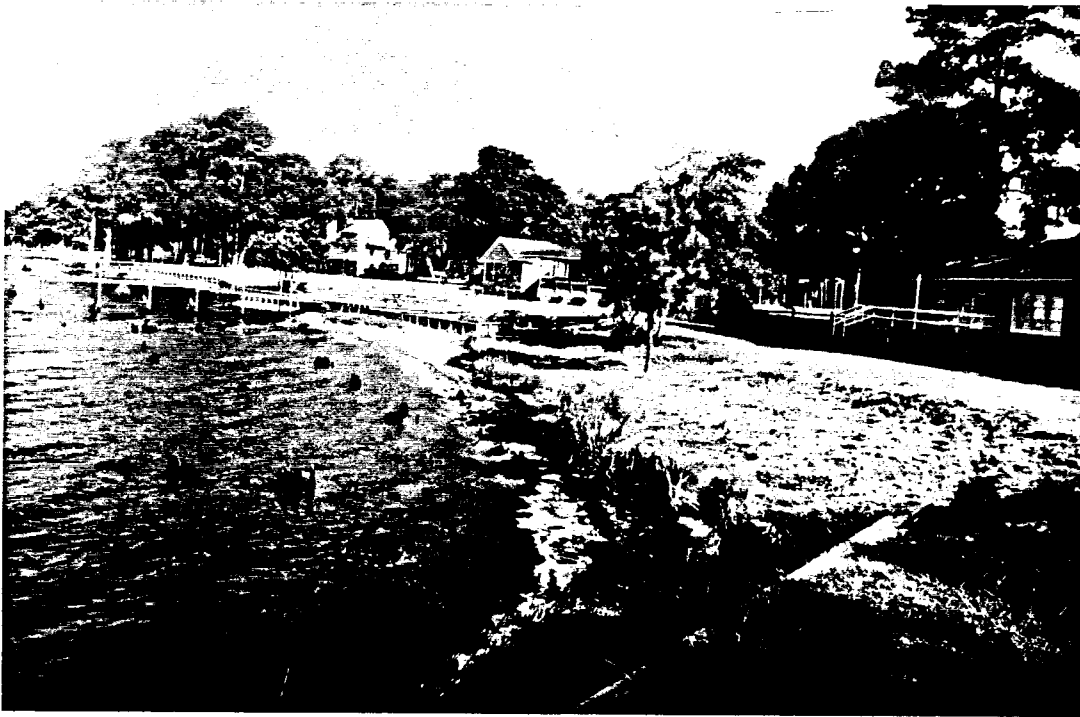
Figure 4c. Six months after removal of breakwater.

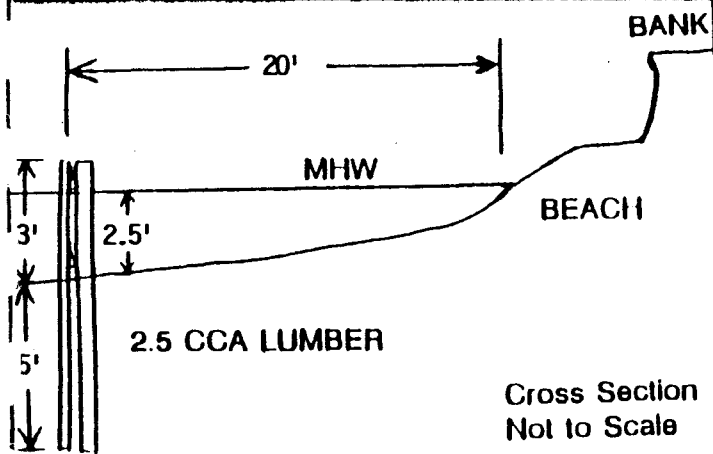
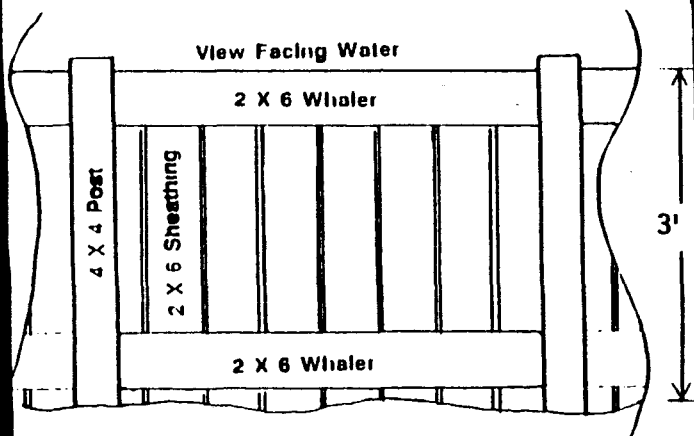
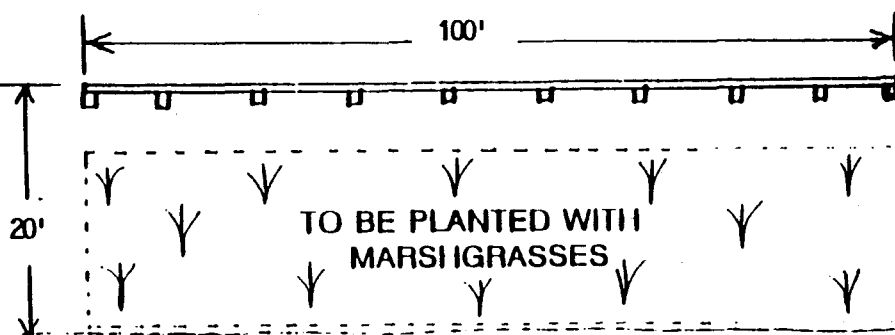
Figure 6.

Plan View Not to Scale

Breakwater designs for all sites were based on materials previously tested in Croatan Sound on Roanoke Island (Rogers, 1989). A typical design is shown in figure 6. The breakwaters resemble a low, free-standing bulkhead but have several important differences. All breakwaters were constructed with treated lumber (marine grade, 2.5 CCA). The posts were 4x4's spaced 4 feet apart. The sheathing and walers were 2x6's. Posts and sheathing were both 8 feet long unless otherwise noted. In some cases 4x6 posts were used when treated 4x4's were difficult to find.

Located in deeper water, a breakwater will experience higher waves than a bulkhead. The materials in the free-standing structure must withstand all of the wave forces, unlike a bulkhead, which transfers most of the force to its backfill. To keep the breakwater cost to a minimum, they were designed to avoid impact by the worst waves. As discussed previously, at normal water levels the shallow water depths cause the largest waves to break farther offshore before reaching the structure. The breakwater must be tall enough to prevent the marsh root mat from undermining. By building the top of the breakwater low, 6 inches above the normal high water elevation, larger waves during elevated storm tides are allowed to pass over the structure, avoiding the worst of the wave forces. The low elevation allows the largest waves to be transmitted to the shoreline but only at higher water levels when the marsh has been found to be best able to handle them. Without a developed marsh,

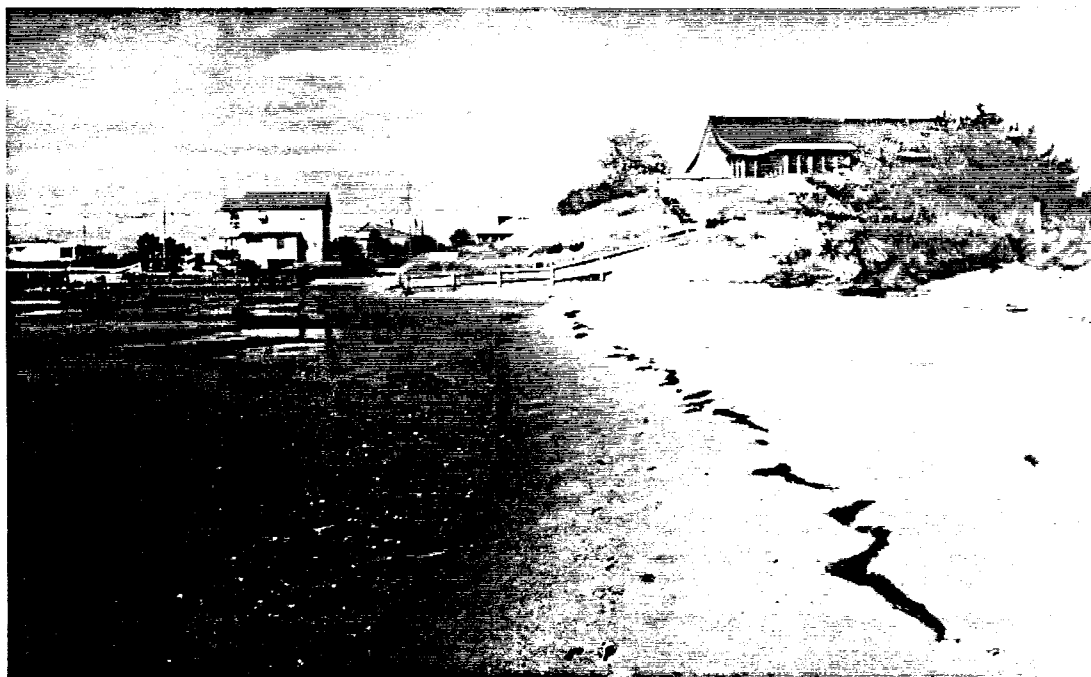
Figure 8a. Site 6 prior to construction.

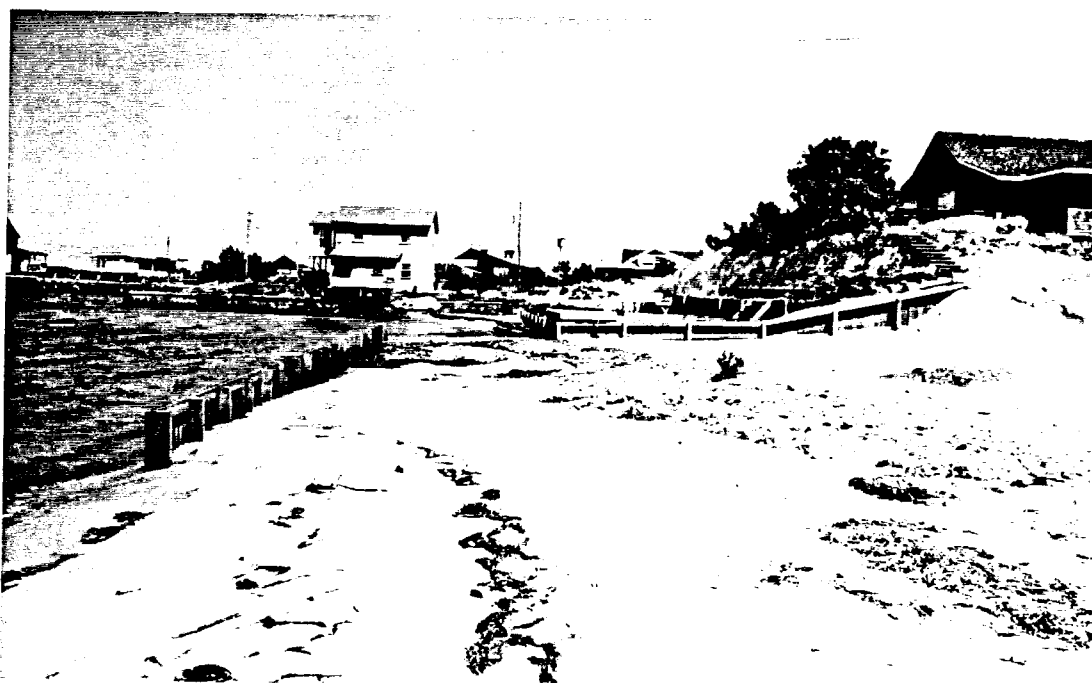
Figure 8b. After breakwater construction. Beach width increased due to March storm.

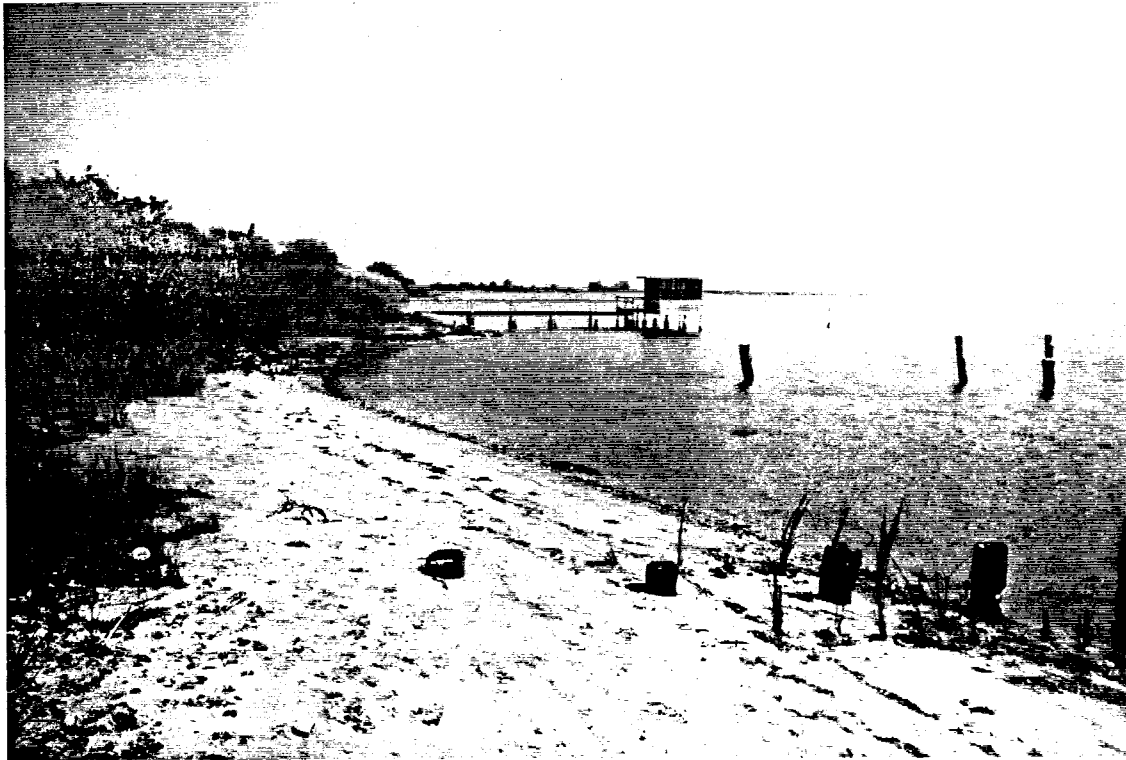
Figure 9a. Site 7 before construction.

7. Stumpy Point Civic Club/Golden: The Civic Club building and adjoining private lot face south on Stumpy Point Bay (figure 9). The fetch is 2 miles. The shoreline is a narrow sand beach with a short section of eroding smooth cordgrass. The land elevation is low, below +5.0 feet NGVD.

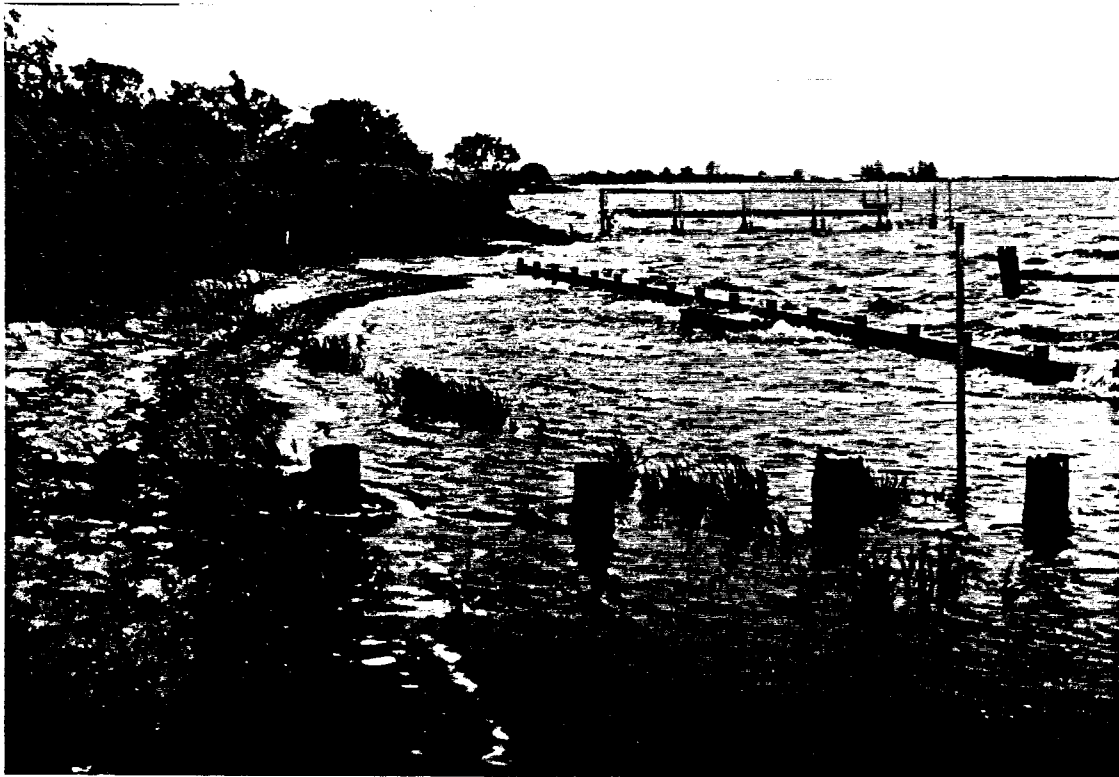
Figure 9b. Two years after construction and planting.

Two hundred feet of breakwater was constructed 20 feet offshore in water 1 foot deep. One-inch sheathing in lengths of 6 feet was used. Construction and initial planting were completed in June 1992. Smooth cordgrass transplanted from local marshes. Sand accreted at each end of the breakwater with little change in the center. The site was replanted with nursery-grown grasses in April 1993.

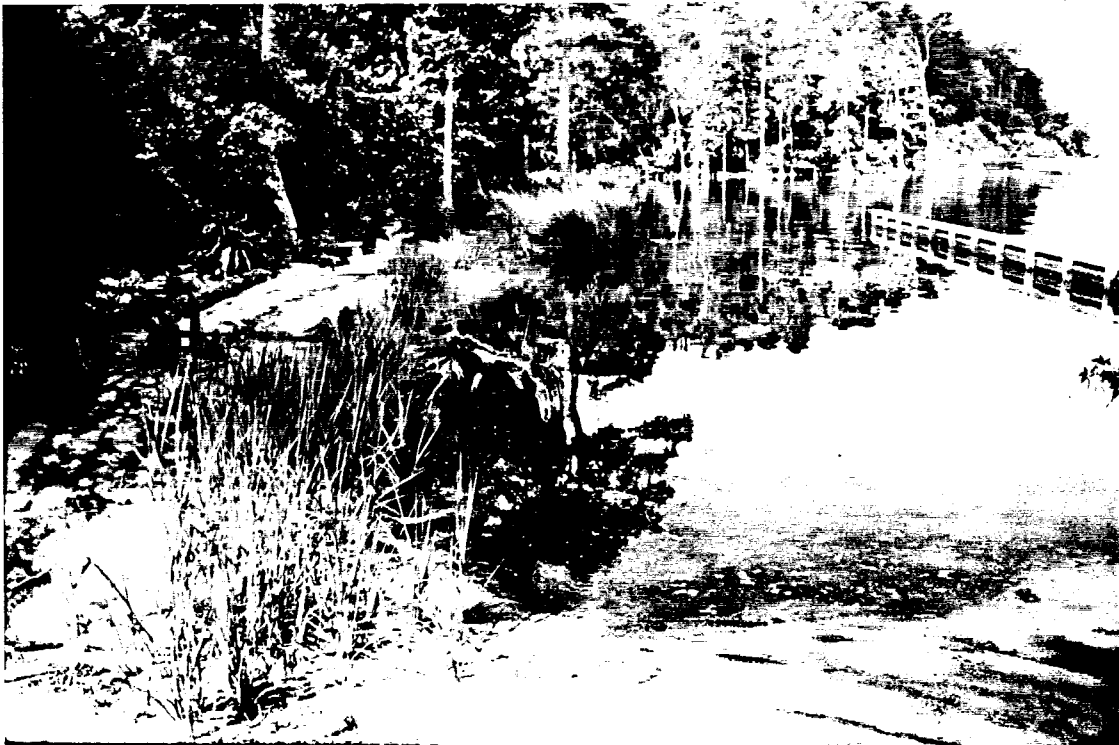
Figure 10. Site 9, one year after construction and planting.

One hundred feet of breakwater was constructed 30 feet offshore in 2 1/2 feet of water in April 1992. Smooth cordgrass was planted in June 1992. The existing black needlerush is expected to spread as well. The shoreline has remained unchanged since construction. The planted grasses are surviving but have shown slow growth in the first season.

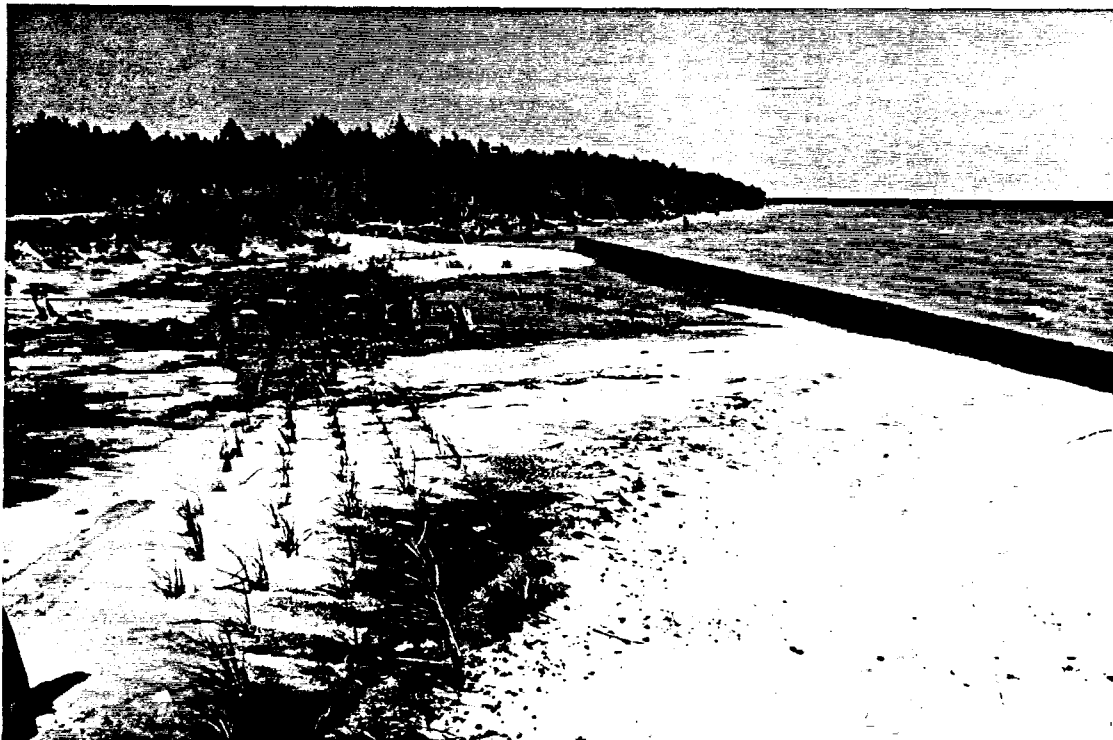
Figure 11. Site 11, one year after breakwater construction.
