Objectives:

- To Evaluate Material Performance as Oyster Habitat
- To Evaluate Material Long-term Durability and Stability
- To Evaluate Overall Material Performance for Reproductive Potential and Larval Recruitment

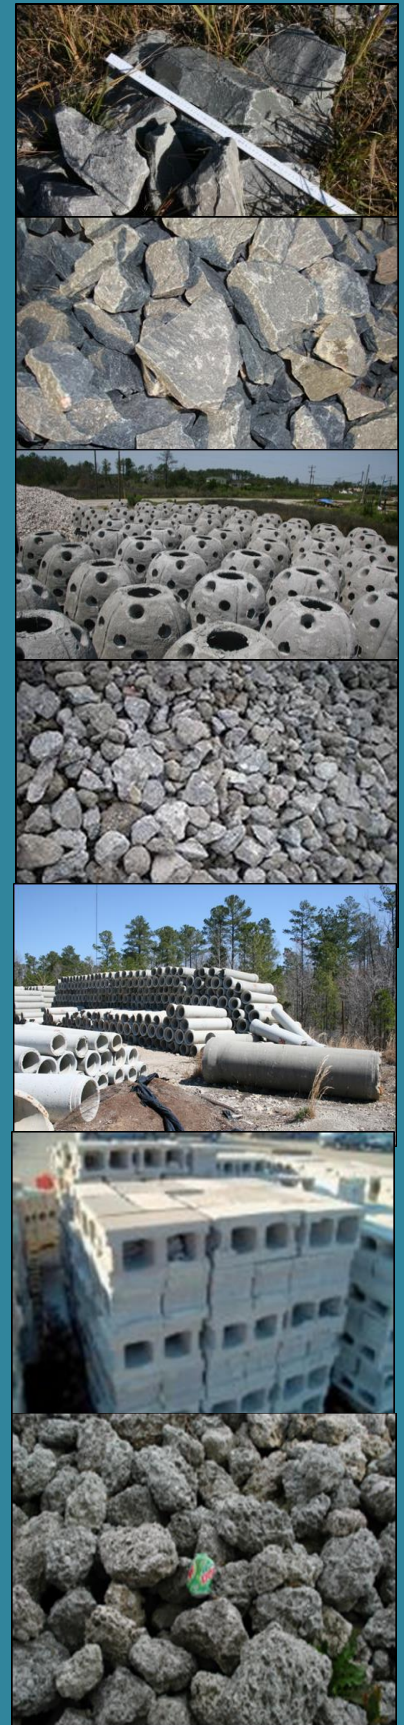
Marl Rip Rap (class B)	Limestone Marl	Granite	Crushed Concrete	Reef Balls	Concrete Pipe	Concrete Box Units
OS-01	Croatan Sound							
OS-02	Deep Bay							
OS-03	West Bay							
OS-04	Clam Shoal							
OS-05	Crab Hole							
OS-06	Ocracoke							
OS-07	Middle Bay							
OS-08	Neuse River							
OS-09	West Bluff							
OS-10	Gibbs Shoal							
OS-11	Long Shoal							
OS-12	Raccoon Island							
OS-13	Pea Island							
OS-14	Little Creek							
OS-15	Swan Island
