Mapping Low-Salinity SAV

In the Western Pamlico Sound

NC Division of Water Quality

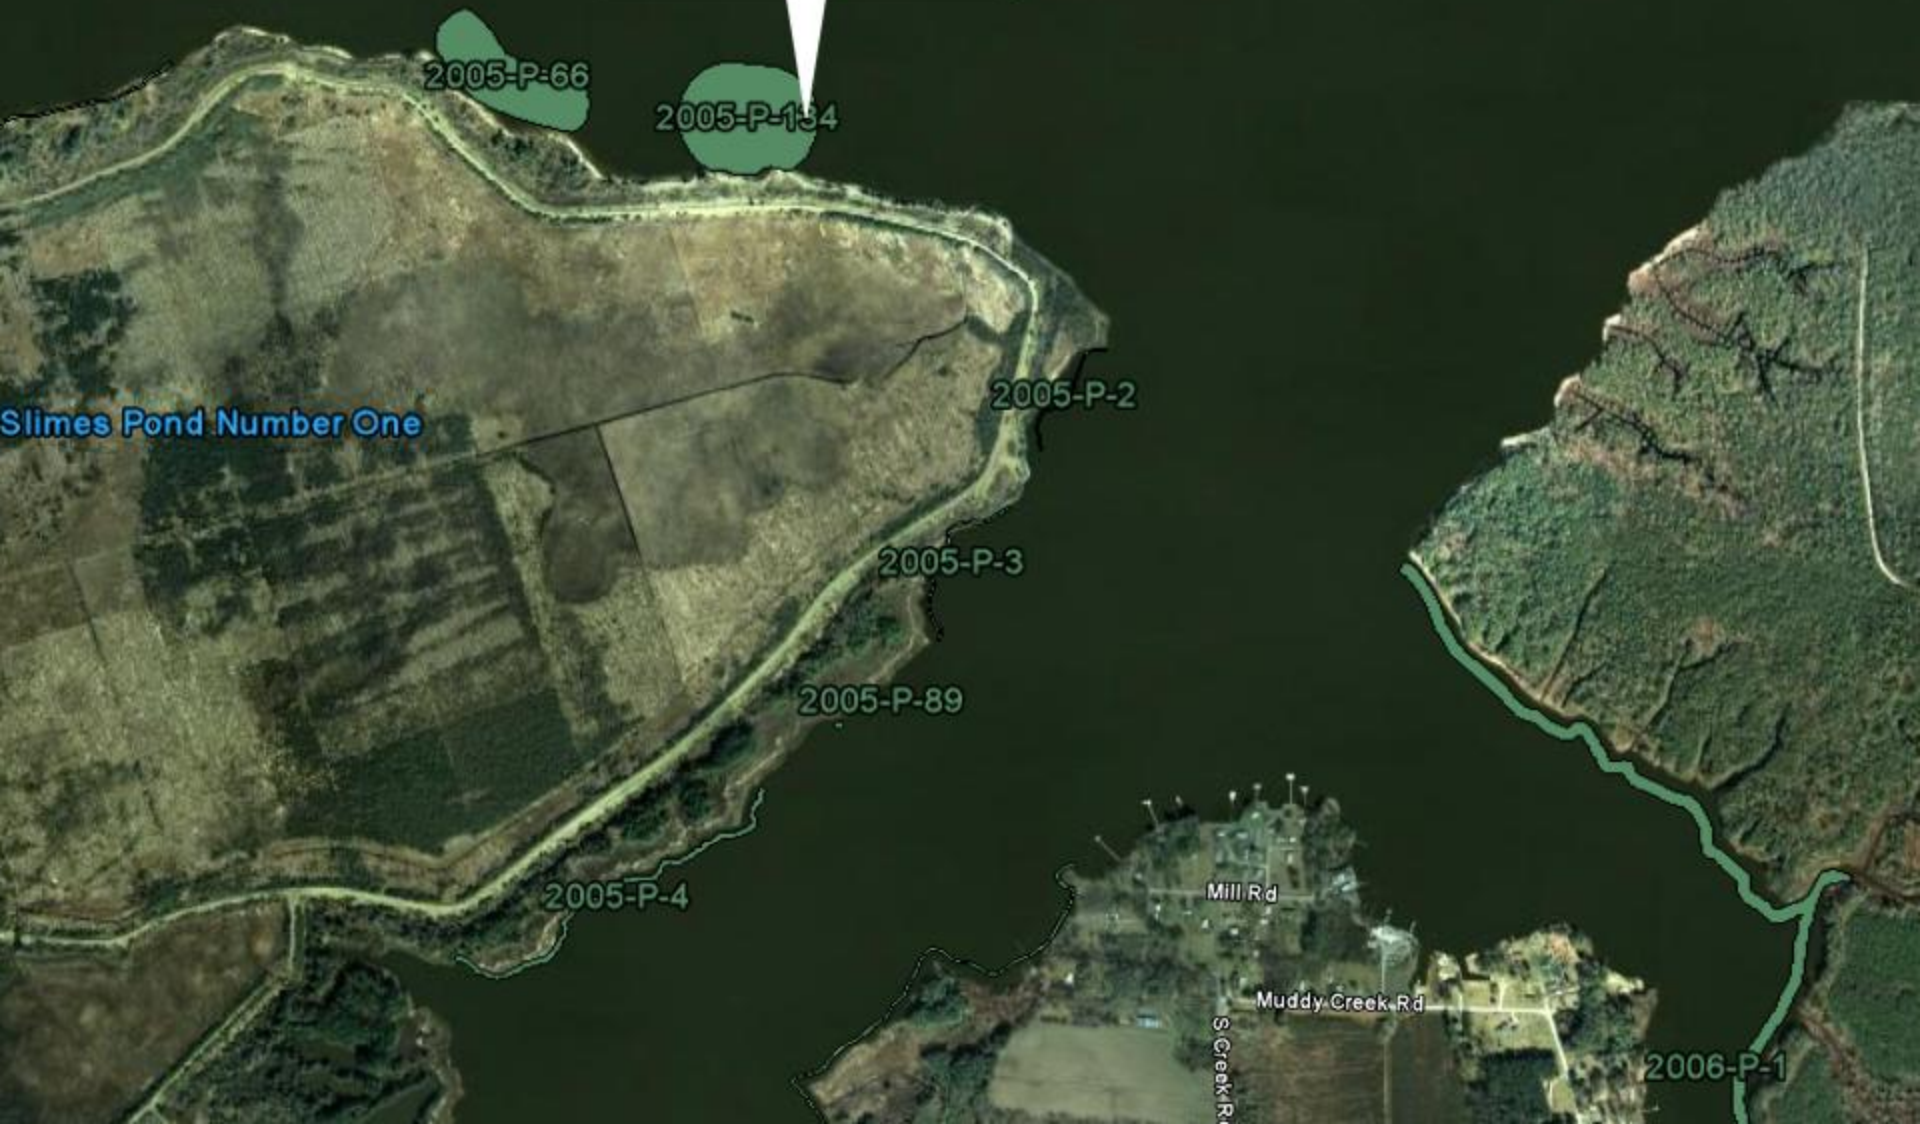
KML Example

LOC_NAME = South Creek
Patch 1
SAV_AREA= 35327.86
COL_NUM = 2005-P-134

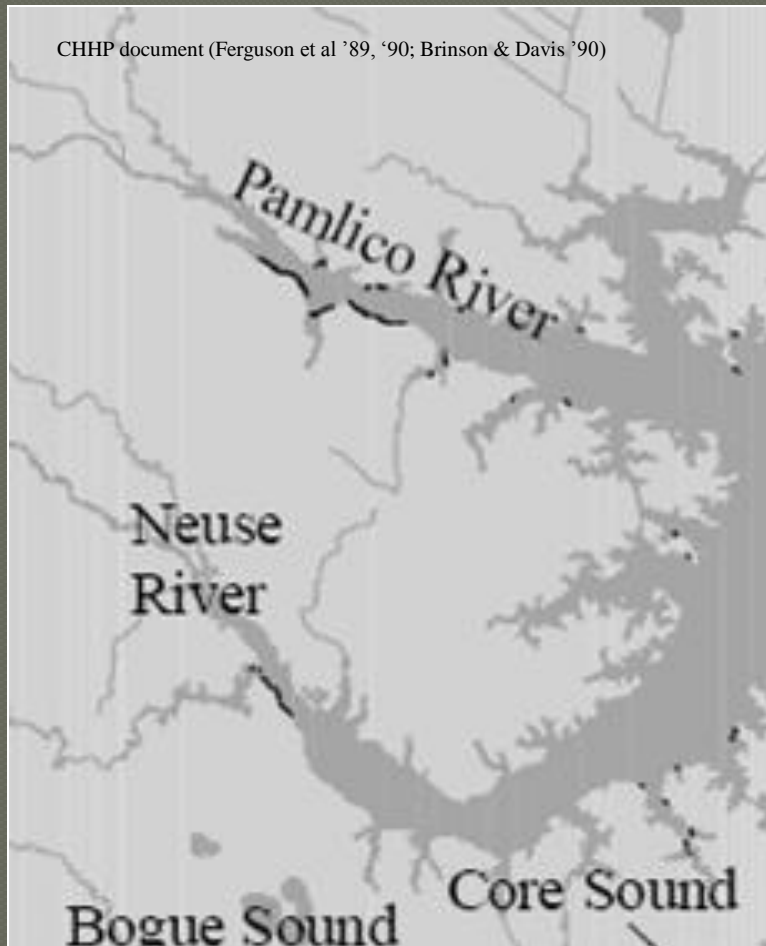
Aerial Imagery-late '80's and mid 90's

General Historical Comparison

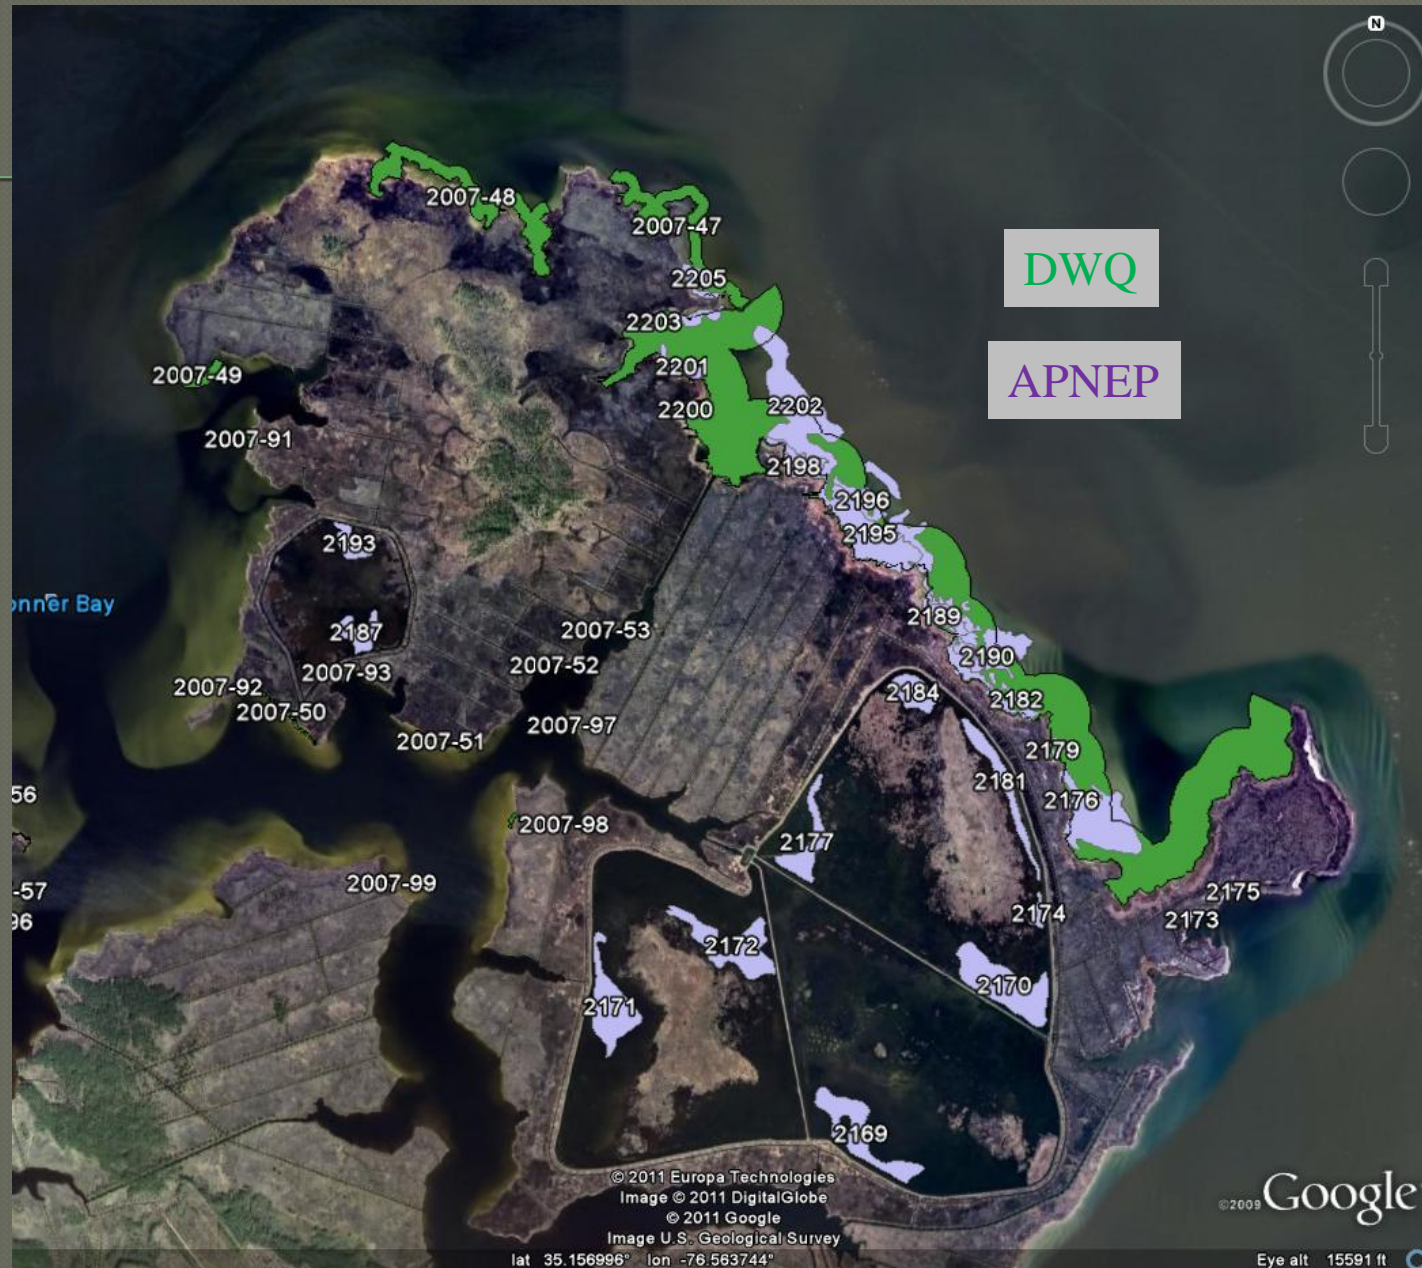
Bonner Bay (Bay River and Pamlico Sound confluence)
