# Salmon River Estuary Projects

Albemarle-Pamlico National  
Estuary Program

July 22, 2009

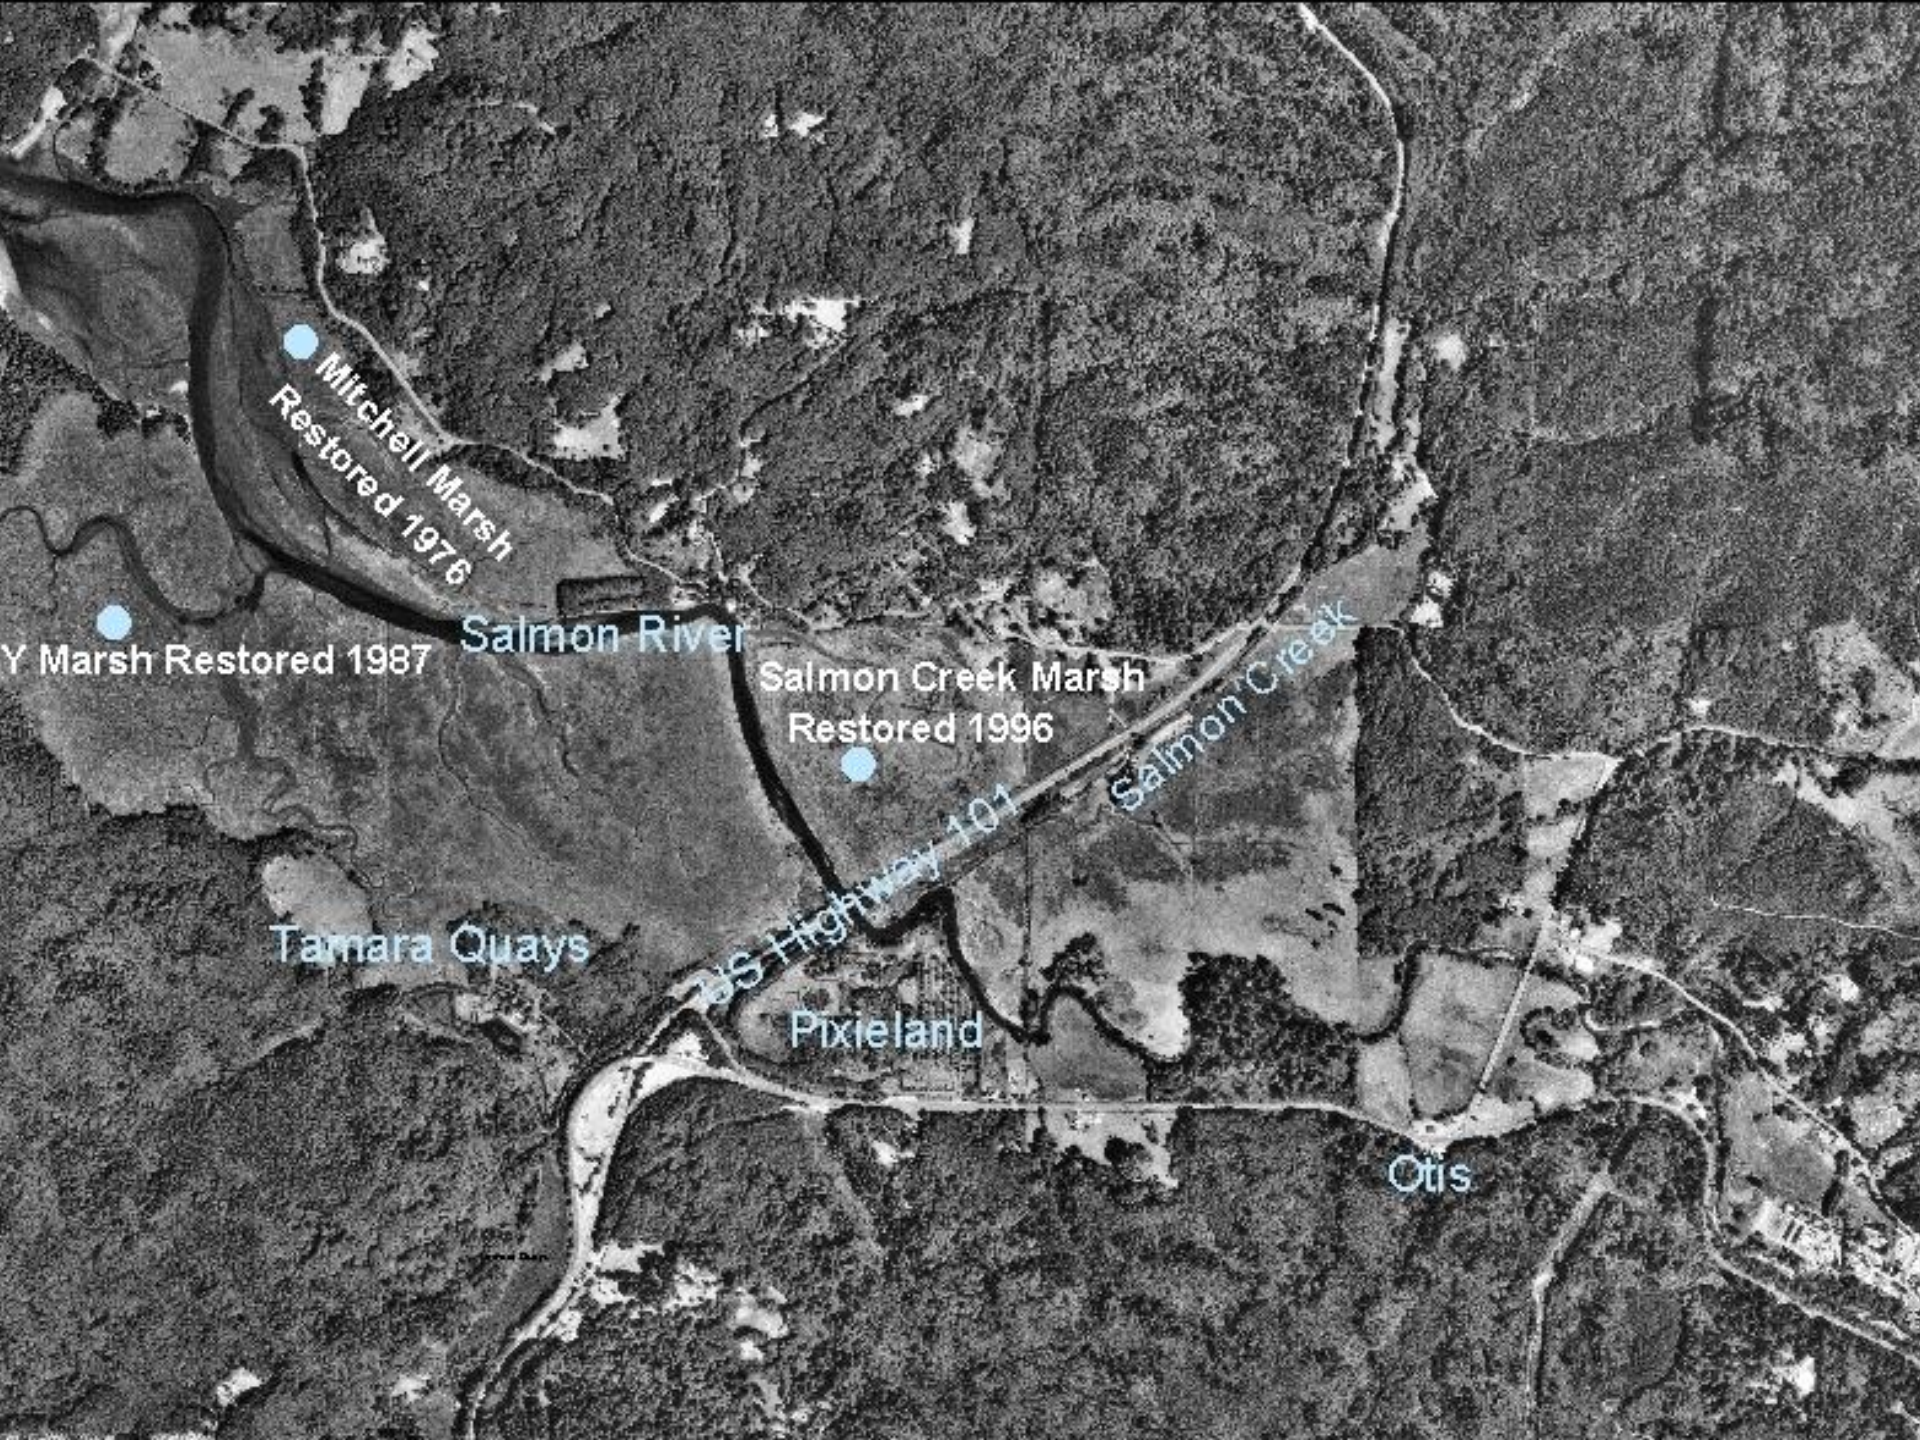
Mitchell Marsh  
Restored 1976

Y Marsh Restored 1987

Salmon Creek Marsh  
Restored 1996

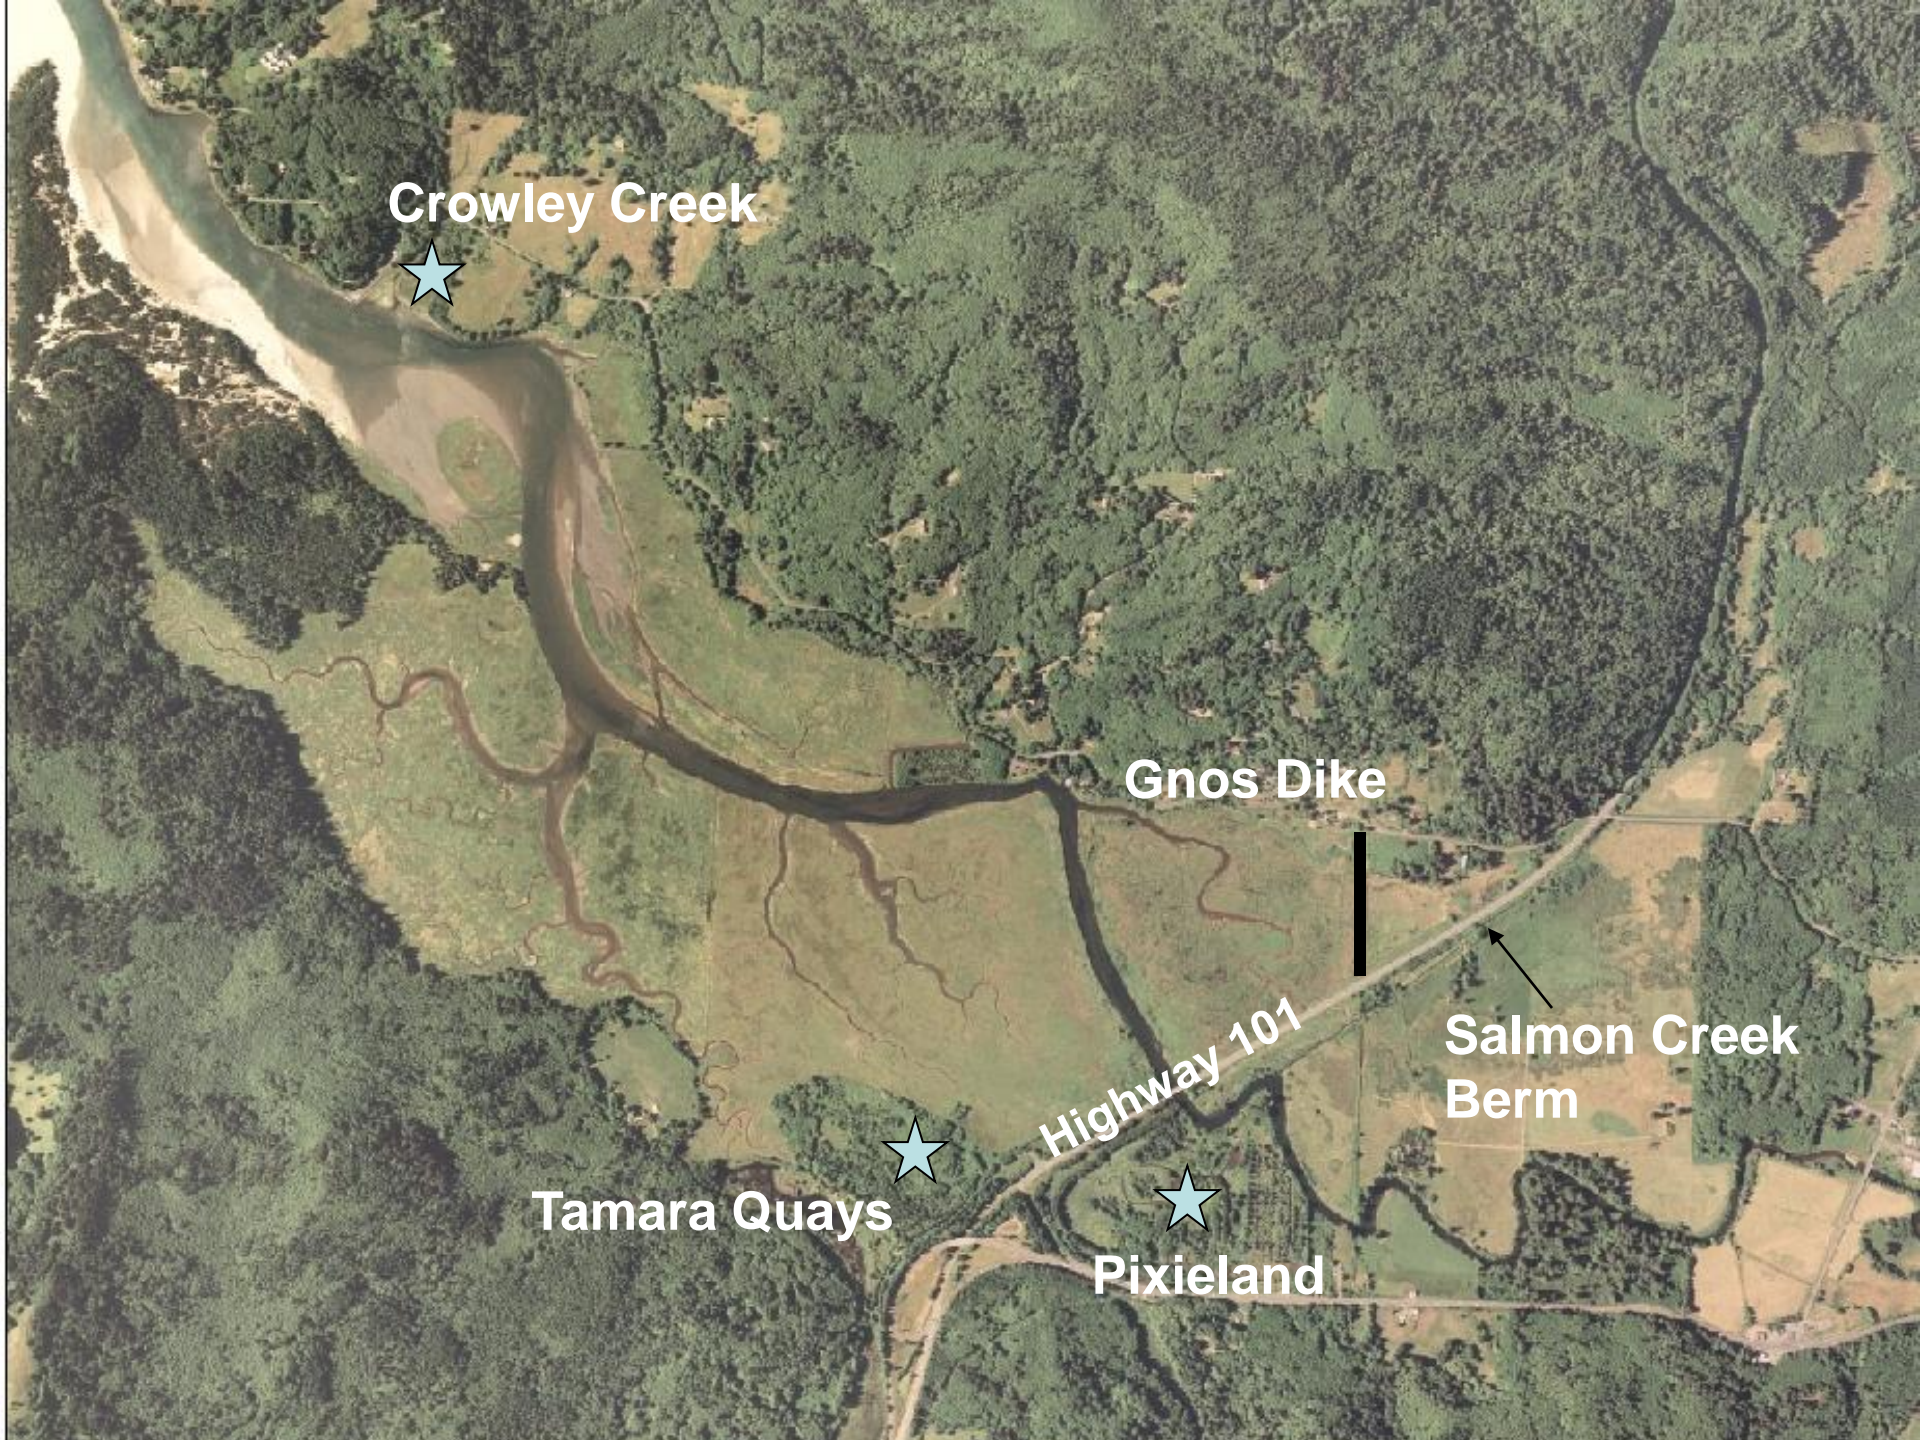
- o Gnos Dike
  - Repair dike (2008)
- o Crowley Creek
  - Riparian planting (2007)
  - Remove dike across from Knight Park (2008)
- o Tamara Quays
  - Restore hydrology and native vegetation (2008)
- o Pixieland
  - Asphalt and noxious weed removal (2007)
  - Restore hydrology and native vegetation (2008)
- o Highway 101 – Salmon & Fraser Creeks
  - Restore stream and tidal flows

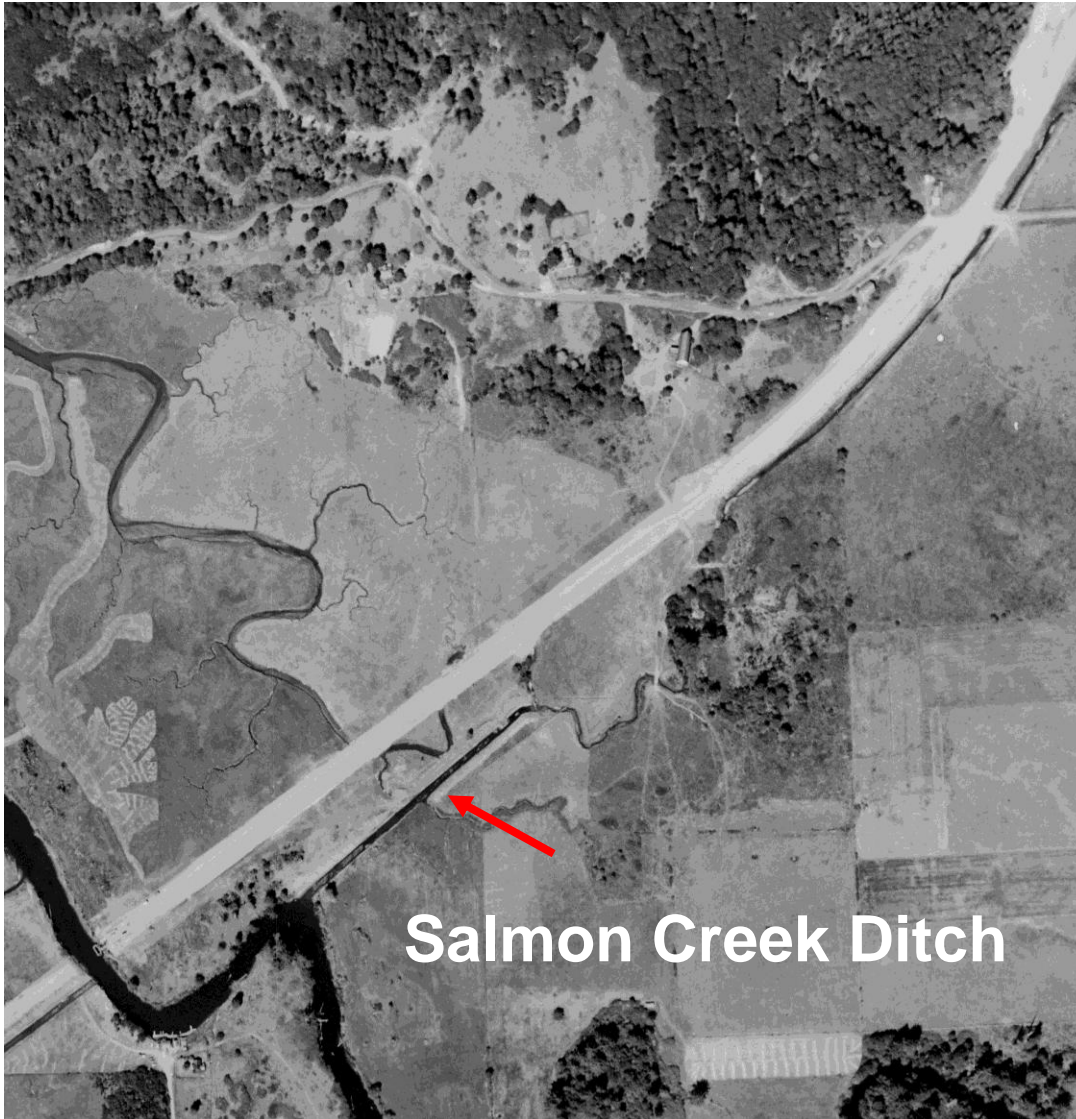
Salmon Creek Ditch

Short-term repair to prevent juvenile Coho fatalities in pastures.

Long-term goal to work with landowner on stream restoration.

1961 photo

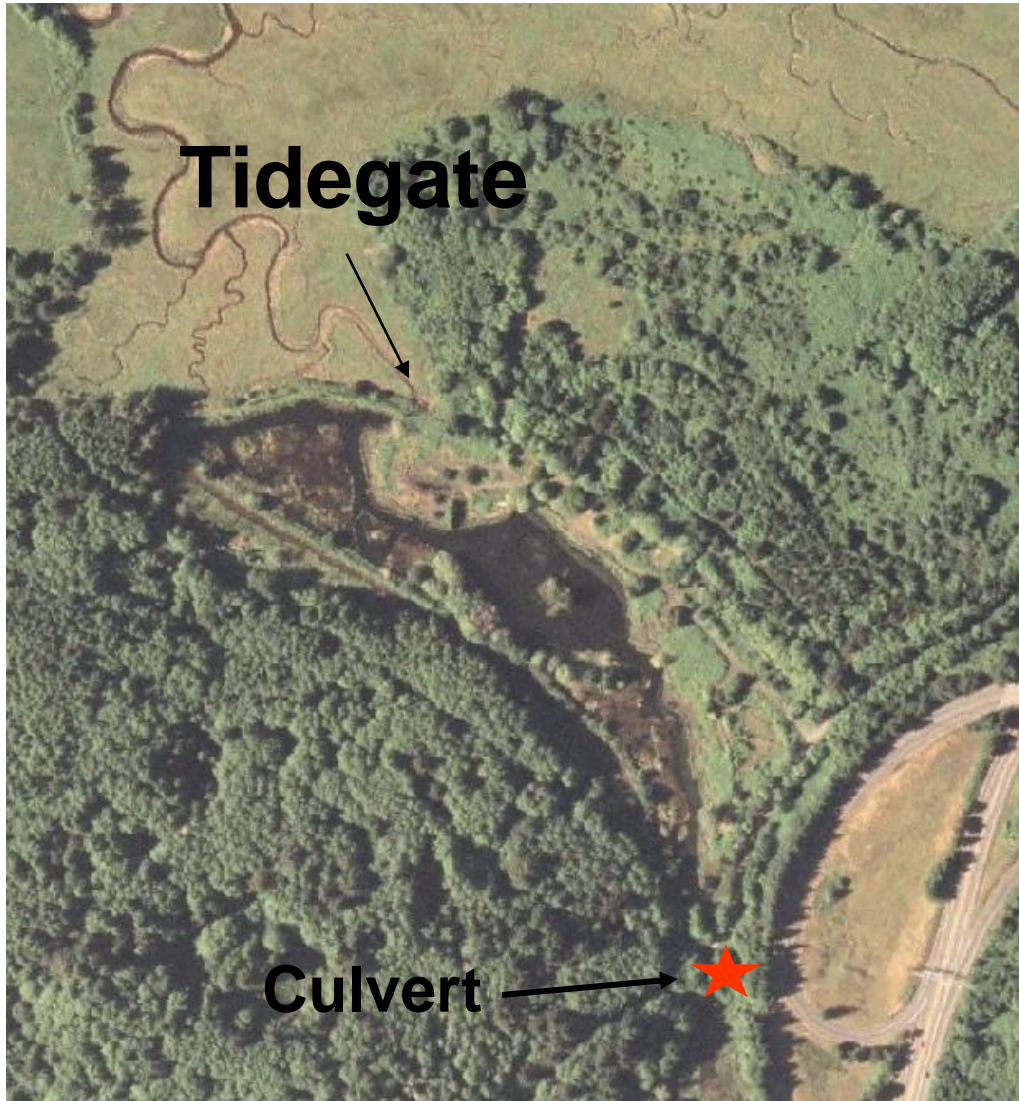
2005 photo-Tamara Quays, Kingfisher Lake and dikes

Remove dikes, tidegates,  
and Kingfisher Lake.

Fill ditches and replace  
culvert with fish-passage  
culvert.

Restore native vegetation.

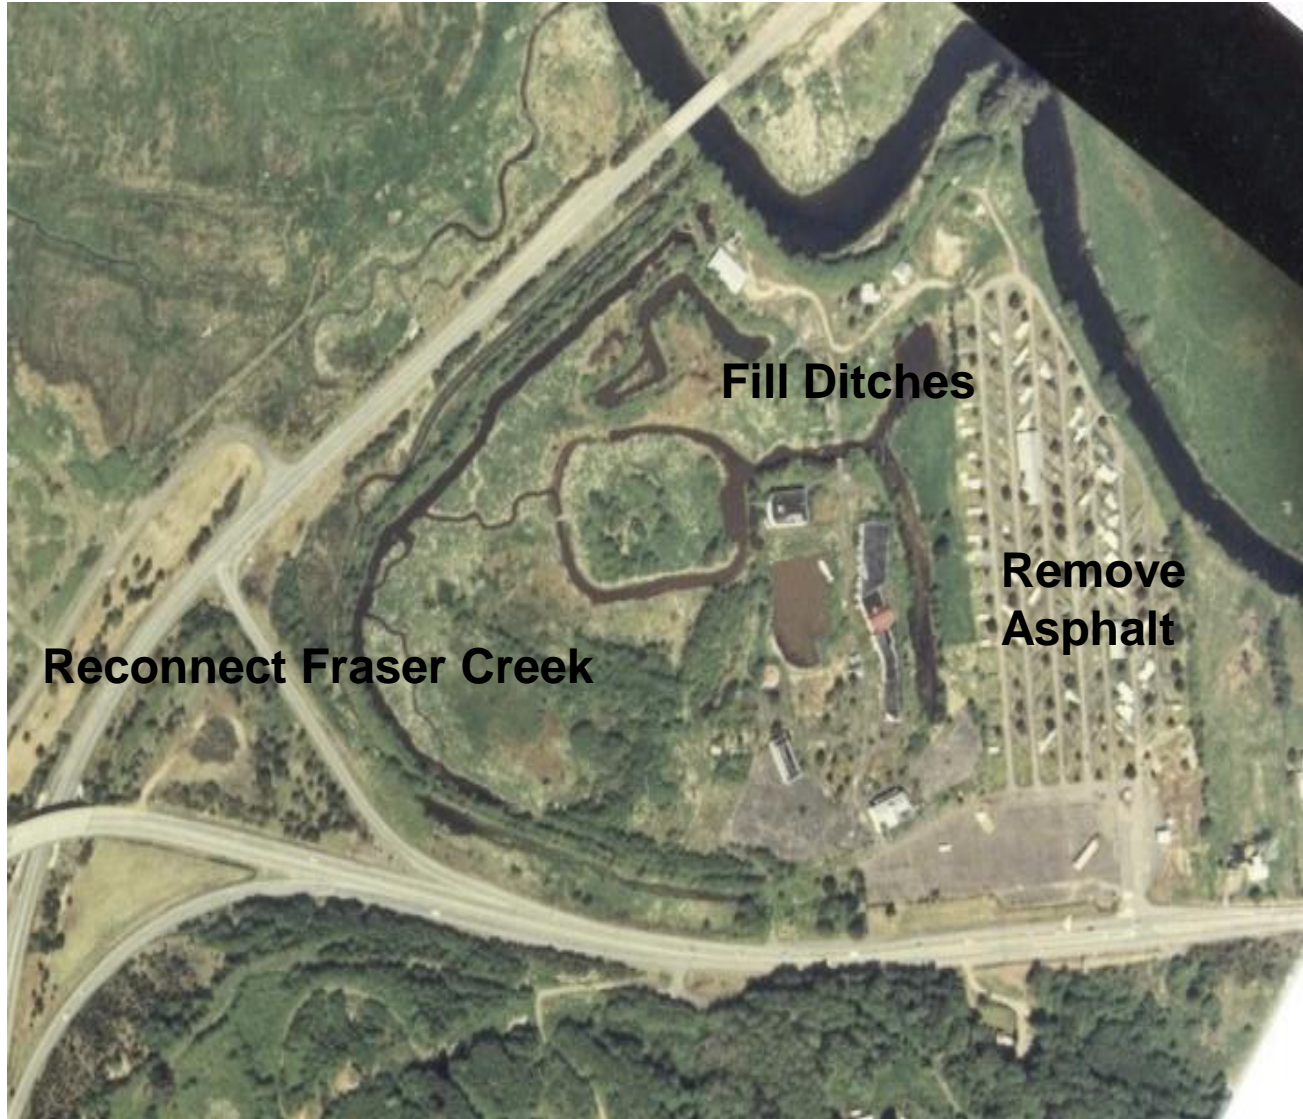
Restore Fraser Creek.

Remove dike, concrete and asphalt.

Fill ditches and pond.

Restore native vegetation.

Possible fishing access site.

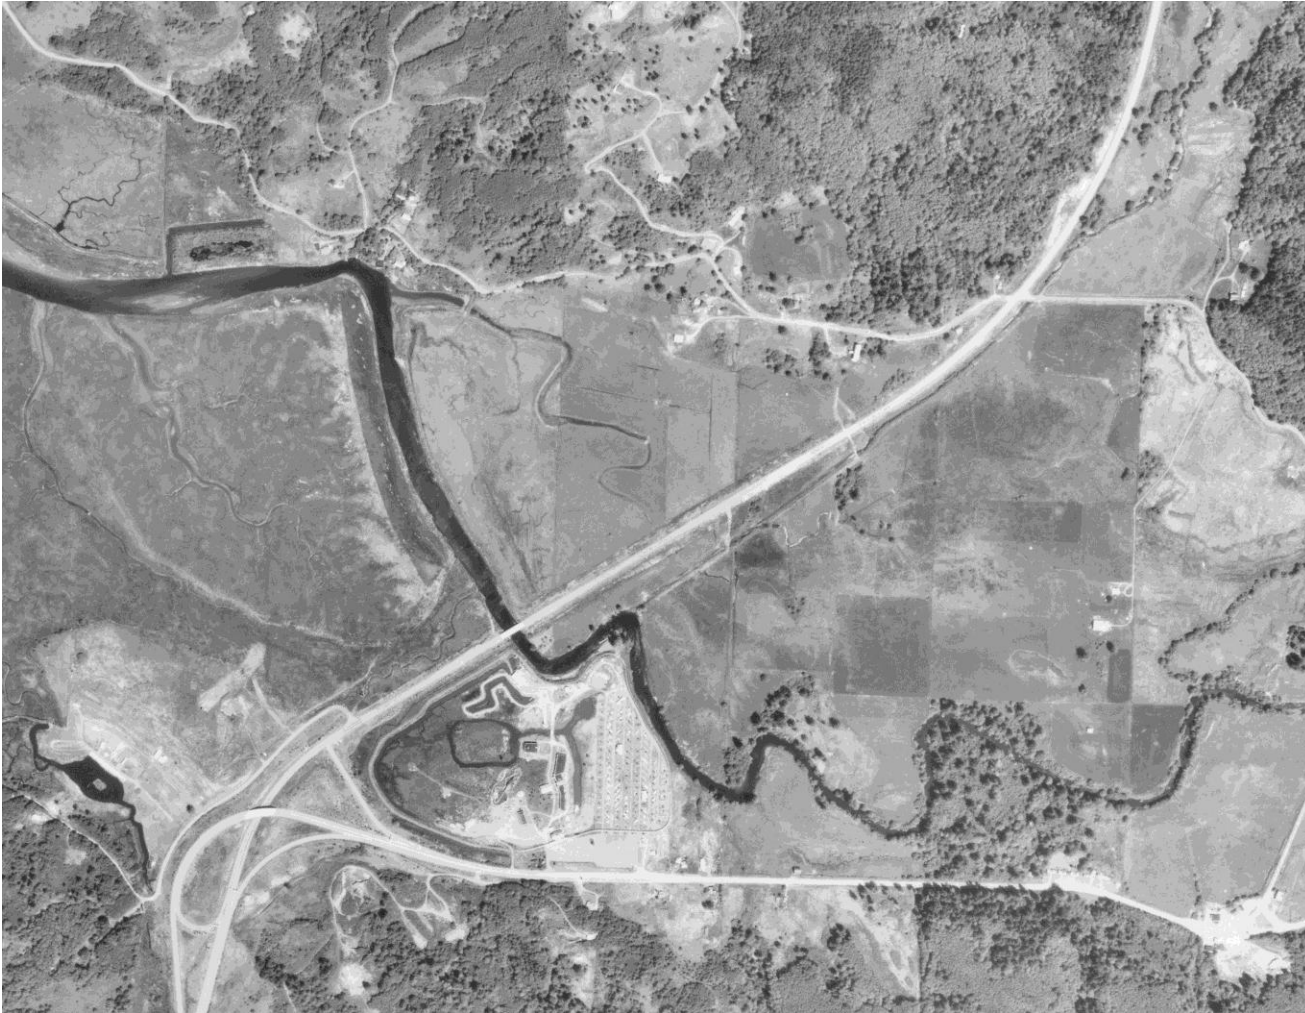
Hwy 101 is the last major dike on estuary.

Reconstruct Hwy 101 from Three Rocks Rd to Hwy 18.

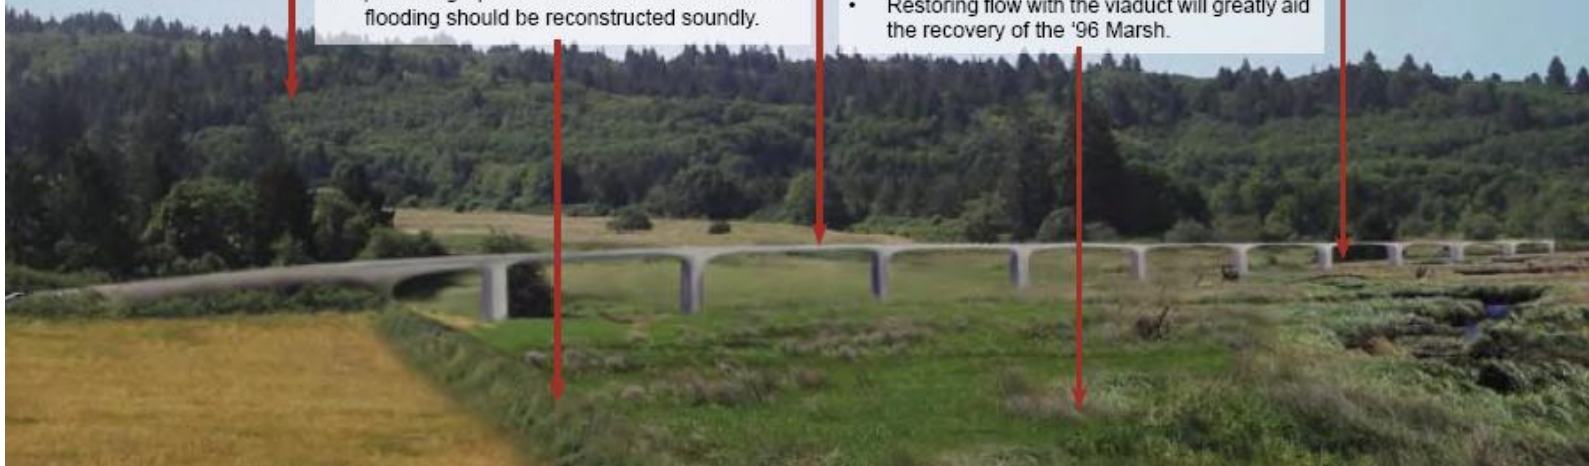
(Artistic rendition)

- Continue to work with the Gnos family towards restoration of the marsh upstream of the highway.
- Wetland mitigation banking and other funds are available to compensate for the change.

- Optimally, the viaduct will stretch from the reconstructed Gnos dike to Tamara Quays.
- The Viaduct should be elegant, blend with the landscape, and allow for maximum sheet flow beneath.
- Construction should be sturdy and tall enough to withstand seismic activity, a tsunami, or predicted sea-level rise.
- The road should include a wide bike and pedestrian pathway.
- Some form of access to the Salmon River should be allowed, either in the form of stairs or a path from the side.
- In the interim, blackberries should be mowed to allow viewing of the estuary

- Salmon Creek will be reconnected to its historical channel downstream of the highway.
- Sinuosity and depth should be restored in the channel upstream of the highway.
- The ditch currently routing salmon creek should be disconnected from Salmon Creek or filled entirely.
- Fraser Creek will also be allowed to return to its historic sinuous channel

- To protecting a portion of the Gnos land from tidal flooding should be reconstructed soundly.

- Restoring flow with the viaduct will greatly aid the recovery of the '96 Marsh.
