**CORE BANKS:
THE CROWN JEWELS
OF NORTH
CAROLINA'S BARRIER
ISLANDS**

**STANLEY R. RIGGS
DOROTHEA V. AMES
GEOLOGY DEPT.
EAST CAROLINA UNIV.
GREENVILLE, NC 27858**

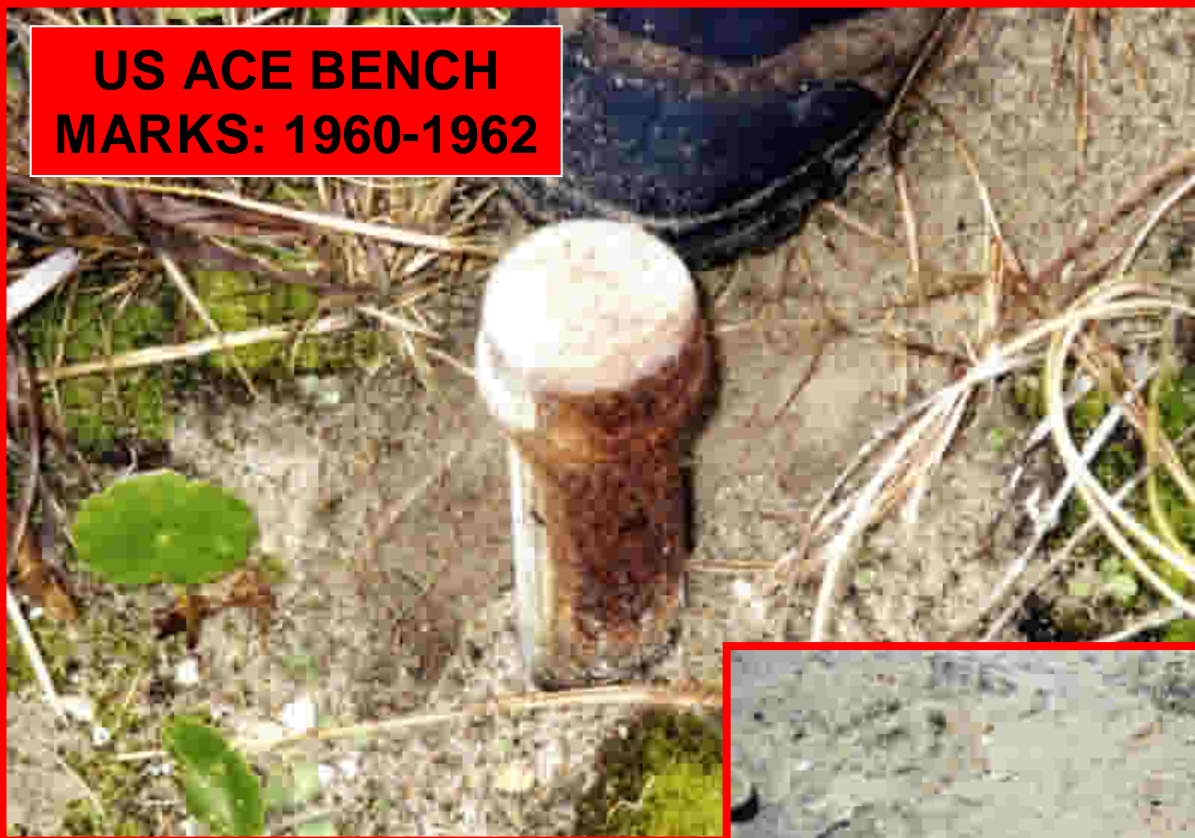
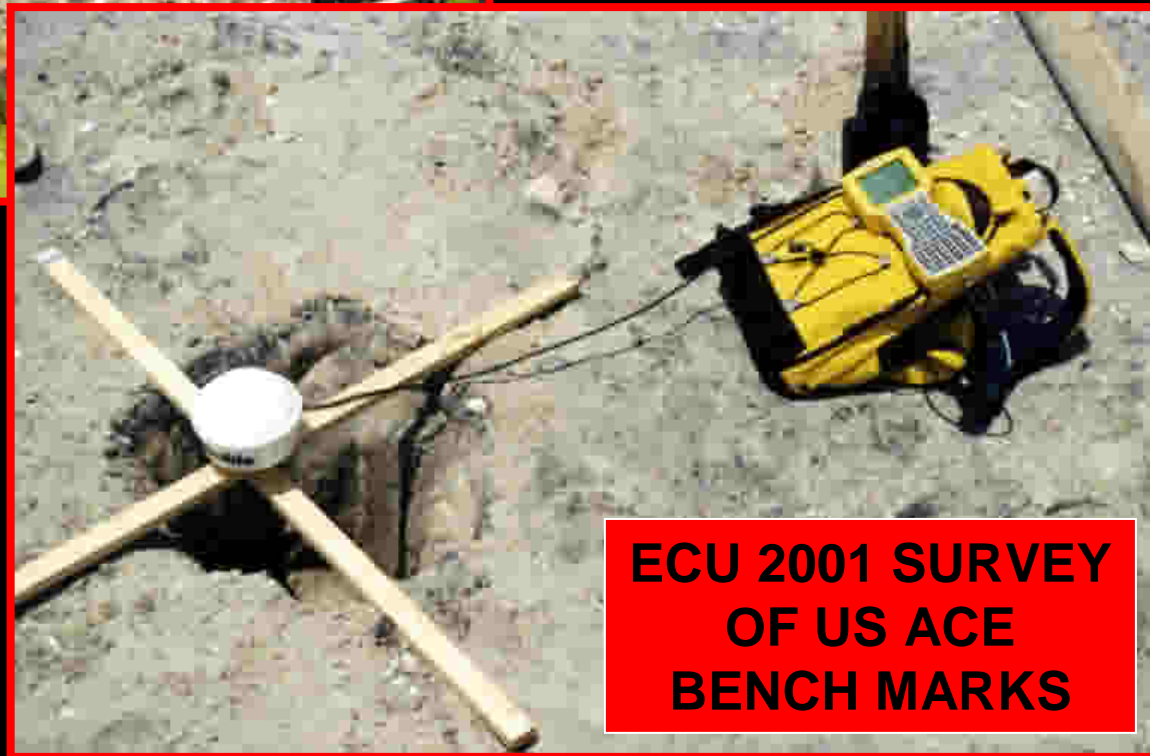
**US ACE BENCH
MARKS: 1960-1962**

1960 SURVEYED 77 PROFILES
3,000 FT APART

1961 SURVEYED 231 RM 100 FT
APART PERPENDIC TO
SHORE + CROSS ISLAND
TOPO SURVEYS

1962 REPLACED RMs &
RESURVEYED 77
PROFILES

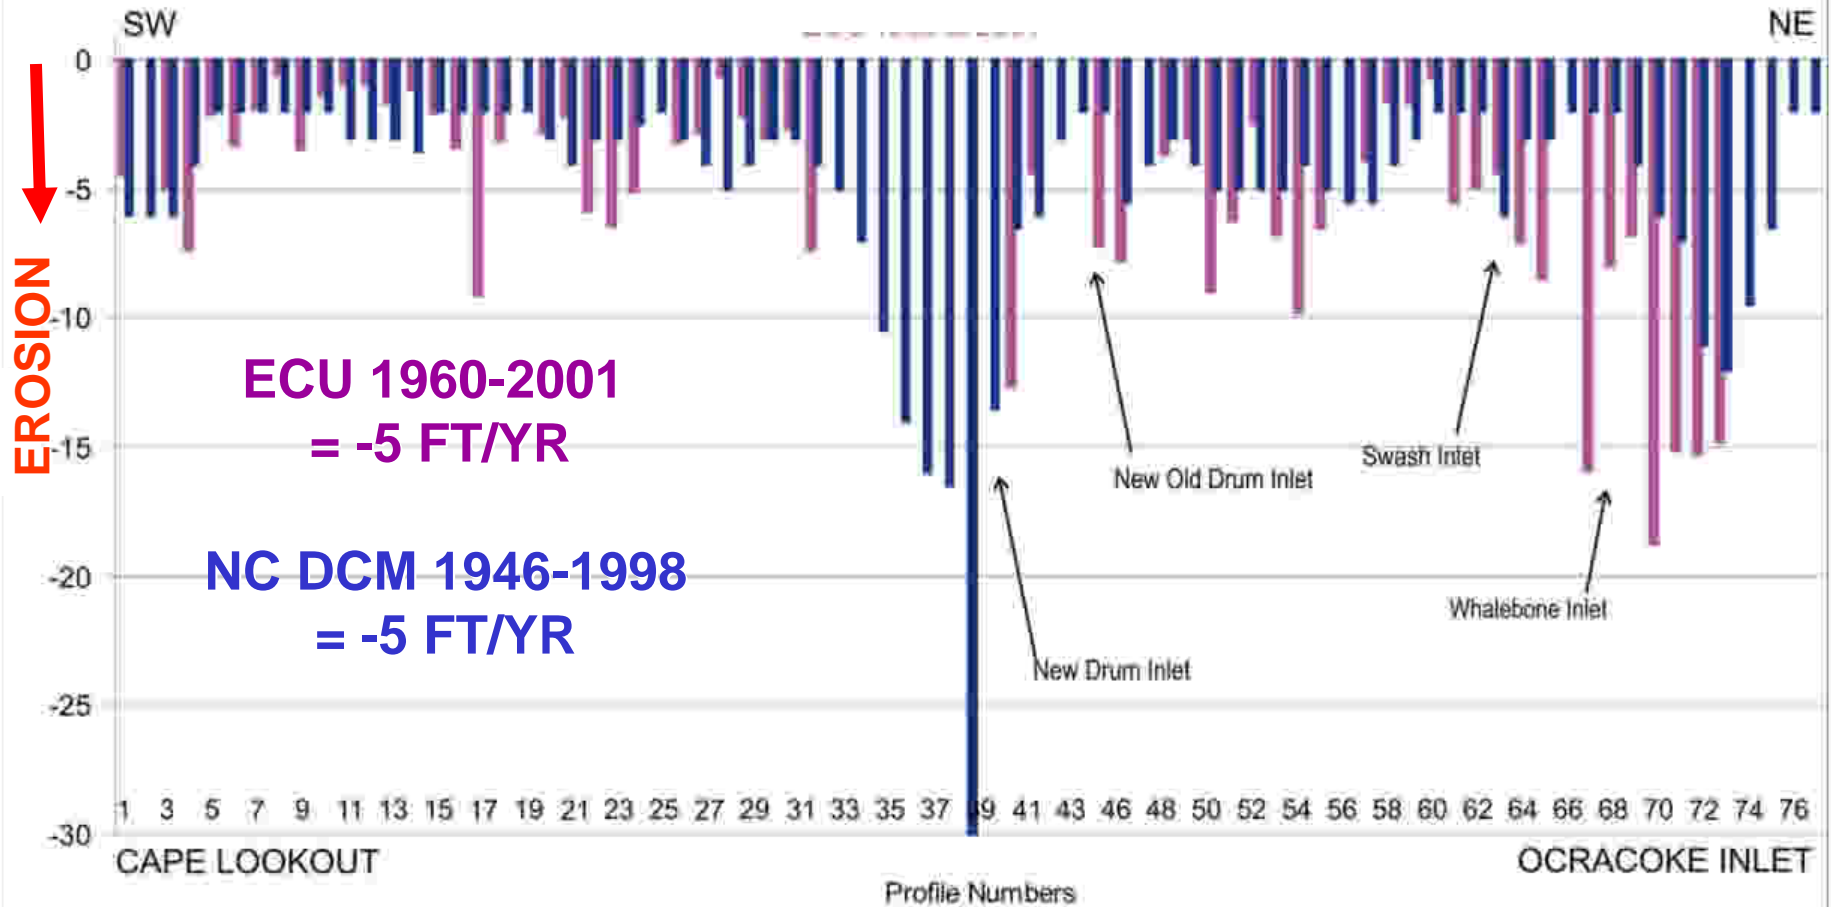
SUMMARY OF AVERAGE ANNUAL EROSION RATES FT/YR

North Core	South Core	All of Core	
USACE 1960 - 1962		-52	-21	-36	Stormy, short term
G&G 1962 - 1971		+20	+ 4	+12	Non-Stormy, intermediate term
ECU 1960 - 2001		-8	-3	-5	Mixed, long term
NCDCM 1946 - 1998		-5	-5	-5	Mixed, long term

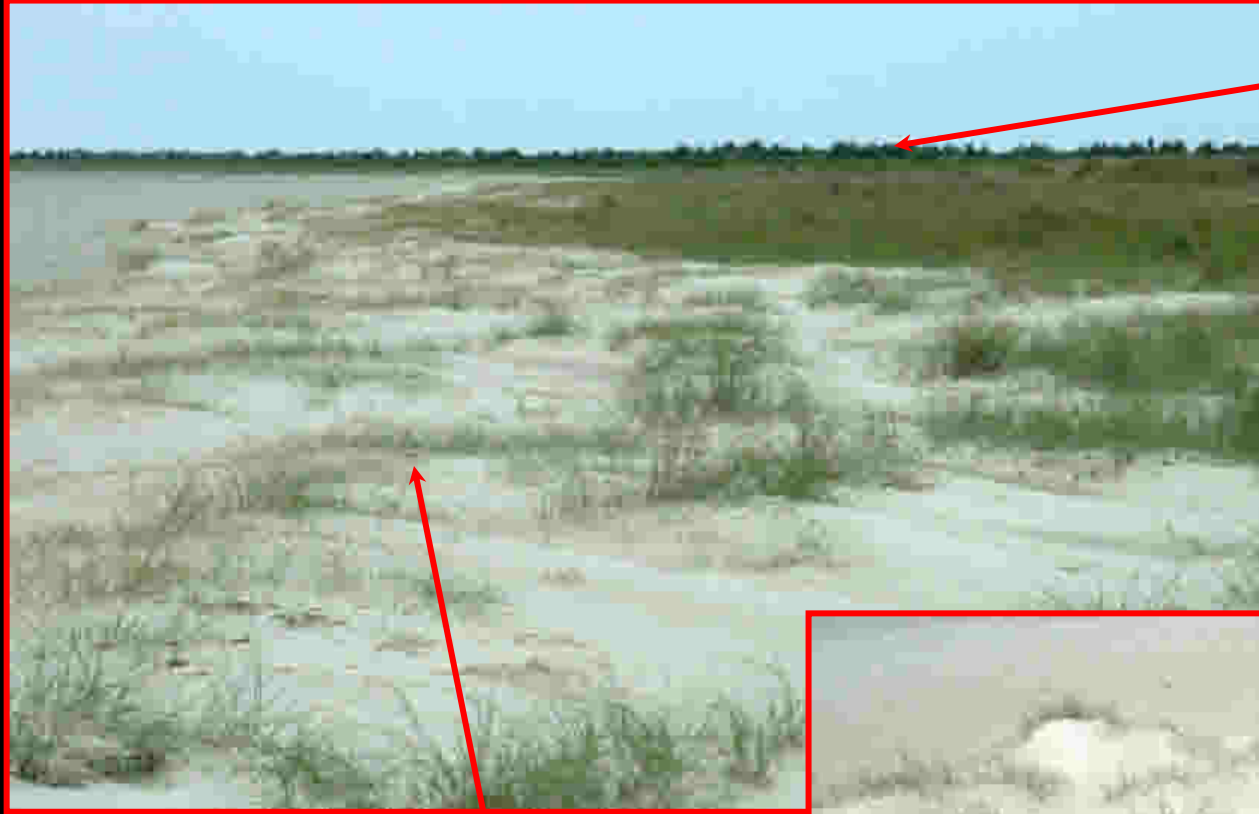
**BACK—BARRIER
BERM**

**SAND TRAPPED
BY *SPARTINA
PATENS***

**SEASONAL AEOLIAN
DUNE RINGS IN
FRONT OF BACK—
BARRIER BERM**

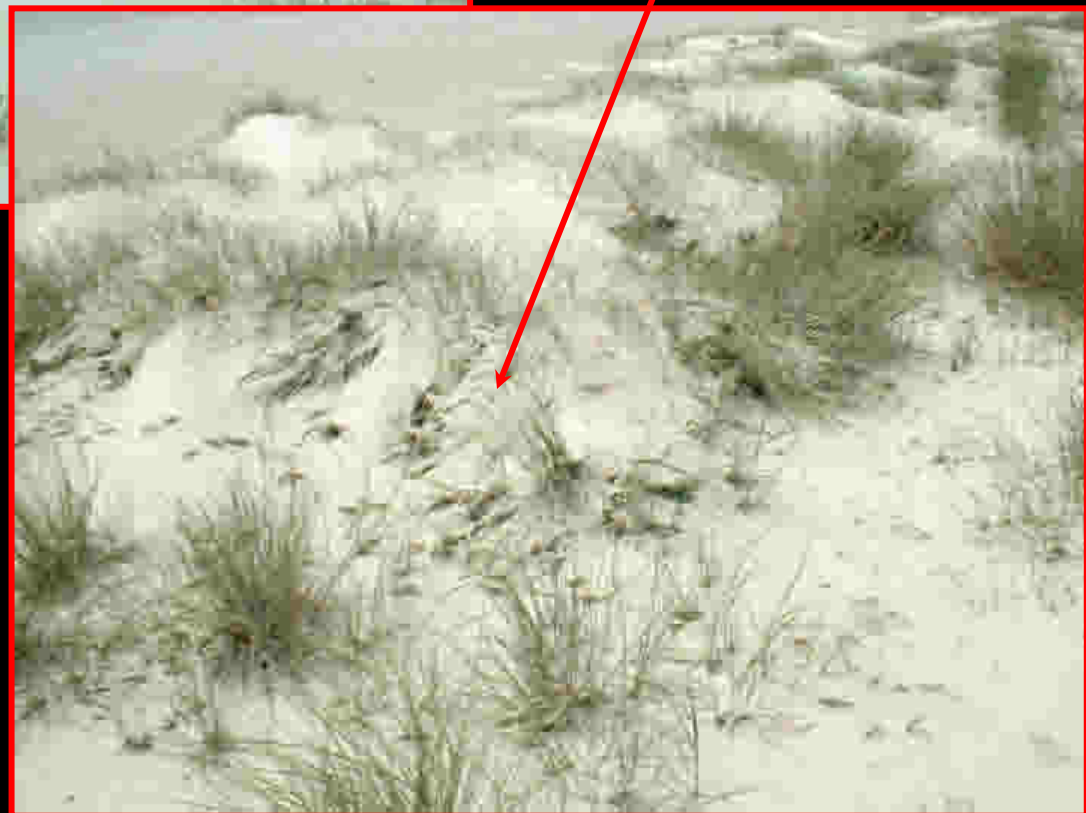
PORTSMOUTH SITE: POST--HURRICANE BONNIE 1998

BACK-BARRIER BERM

OVERWASH TIDAL CHANNEL

MARSH PLATFORM

FLOODED ALGAL FLAT

FOREDUNE

OVERWASH PLAIN

**WIND
WAVES**

**FLOOD THE
ALGAL FLATS
AND REWORK
AEOLIAN DUNE
RINGS INTO
BEACH RIDGES**

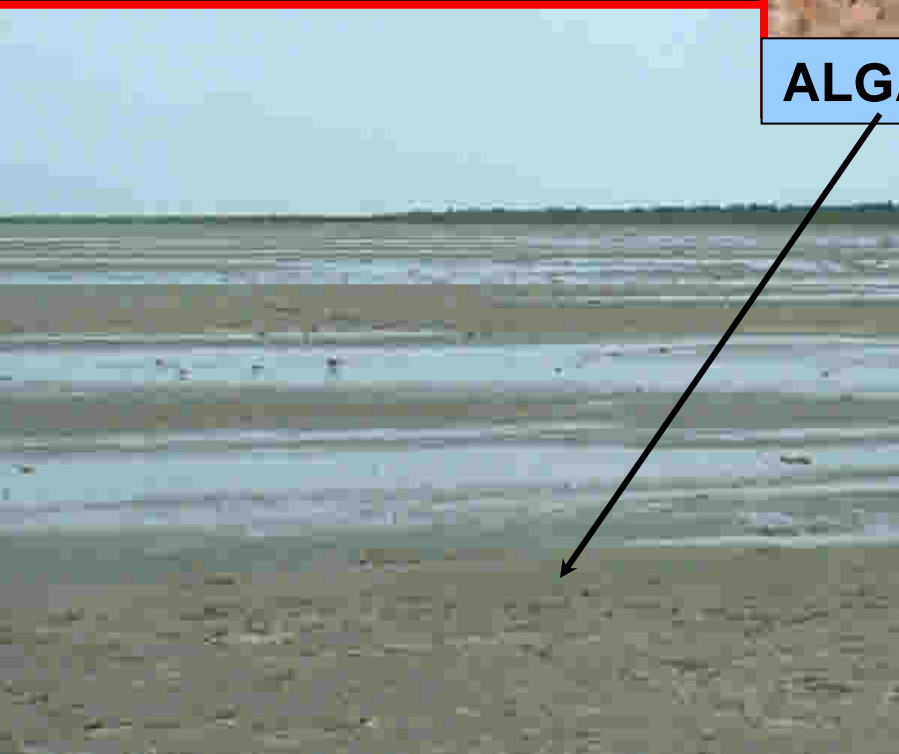
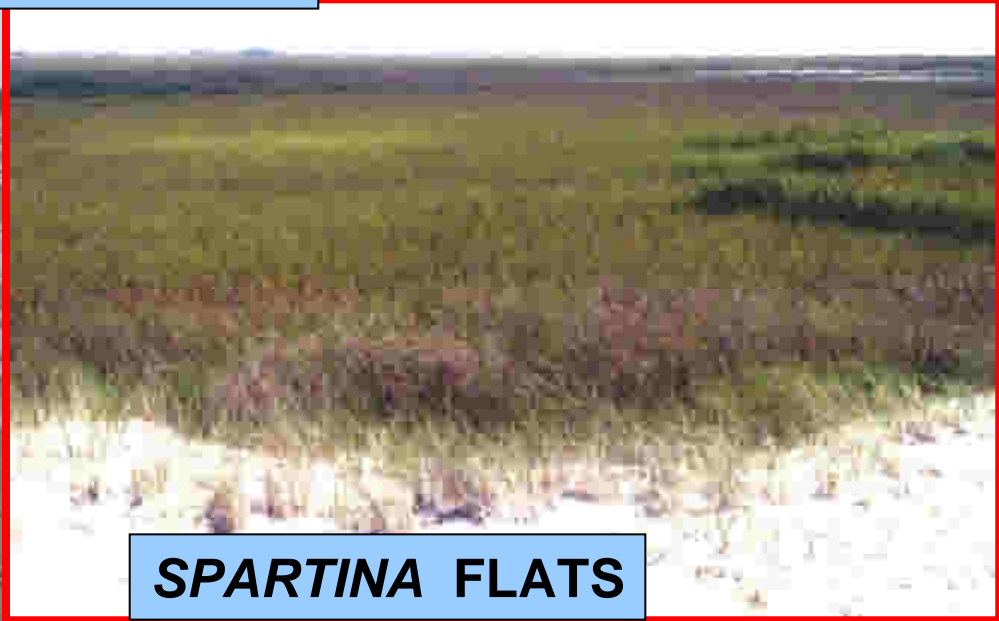
PORTSMOUTH VILLAGE: RATE OF ACCRETION BEACH RIDGES & FOREDUNES: 1940--1983

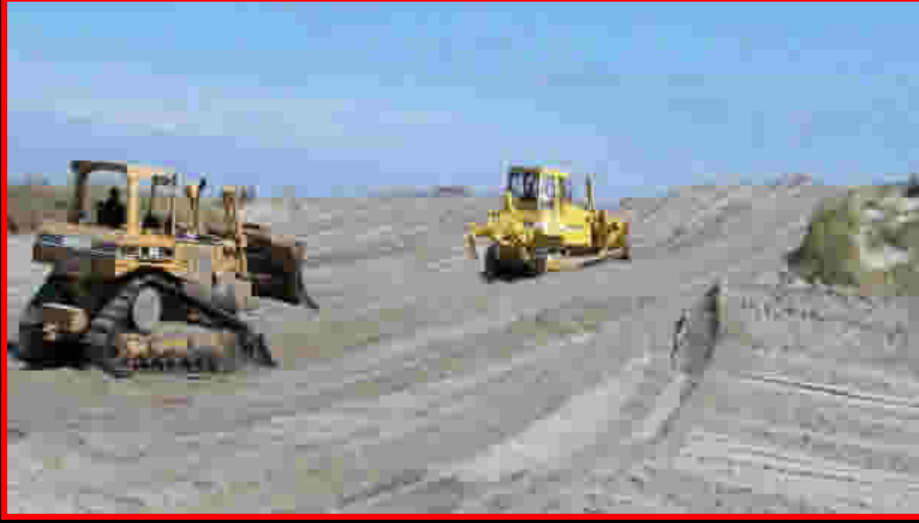
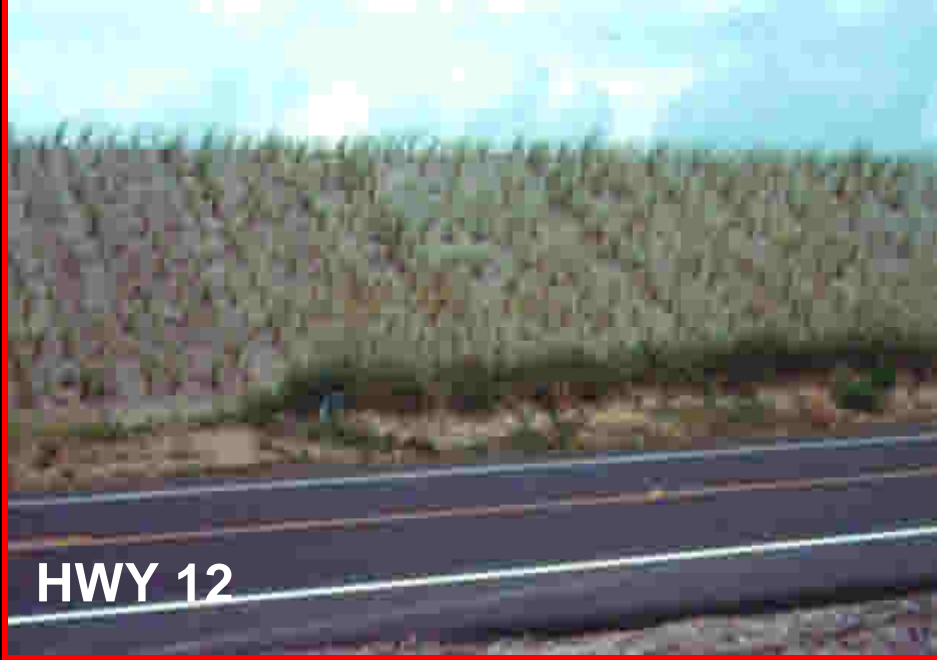
HUMAN PROCESSES:

**CONSTRUCTED BARRIER-
DUNE RIDGES SEVERELY
LIMIT OVERWASH DYNAMICS
AND DO NOT STOP
SHORELINE RECESSSION!**

**THEY ARE TOTALLY OUT
OF EQUILIBRIUM WITH
NATURAL BARRIER
DYNAMICS!**

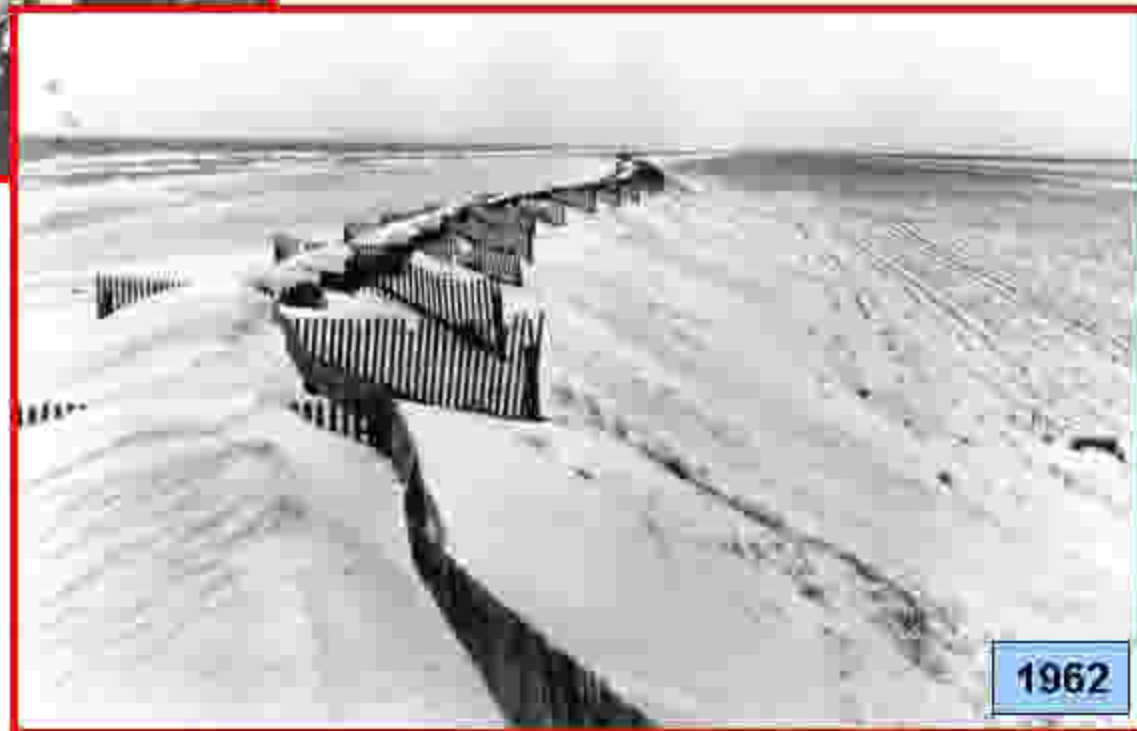
**1962 ASH
WEDNESDAY STORM**

**CONSTRUCTED
BARRIER-DUNE RIDGE
AND PLANTINGS
TERMINATED THE
NATURAL BEACH RIDGE
ACCRETION**

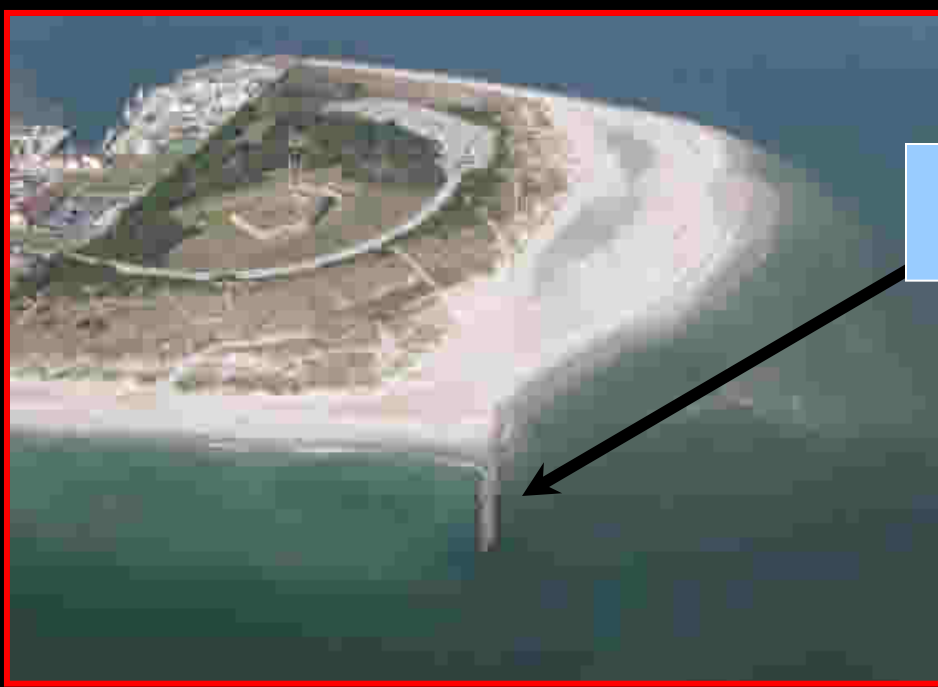
**BEAUFORT INLET TERMINAL
GROIN AT FORT MACON**

**IF TERMINAL GROINS
WORKED, THERE SHOULD
NOT BE A NEED FOR BEACH
NOURISHMENT AT FORT
MACON TO ATLANTIC BEACH!**

SEDIMENT DREDGED FROM BEAUFORT INLET TO NOURISH THE FORT MACON TO ATLANTIC BEACH SEGMENT

1. BEAUFORT INLET DREDGED SINCE 1911

- A. 1911-1961 DEPTH OF - 30 ft
- B. 1961-1978 DEPTH OF - 35 ft
- C. 1978-1994 DEPTH OF - 40 ft
- D. 1994-PRESENT DEPTH OF - 45 ft

2. TERMINAL GROIN BUILT AT FORT MACON IN MID 1960s

3. 1978-2004 FORT MACON & ATLANTIC BEACH (E 6 miles) NOURISHED WITH 13,143,000 yds³ OF SEDIMENT

- A. FORT MACON: 2.9 MILLION yds³
- B. ATLANTIC BEACH: 10.2 MILLION yds³

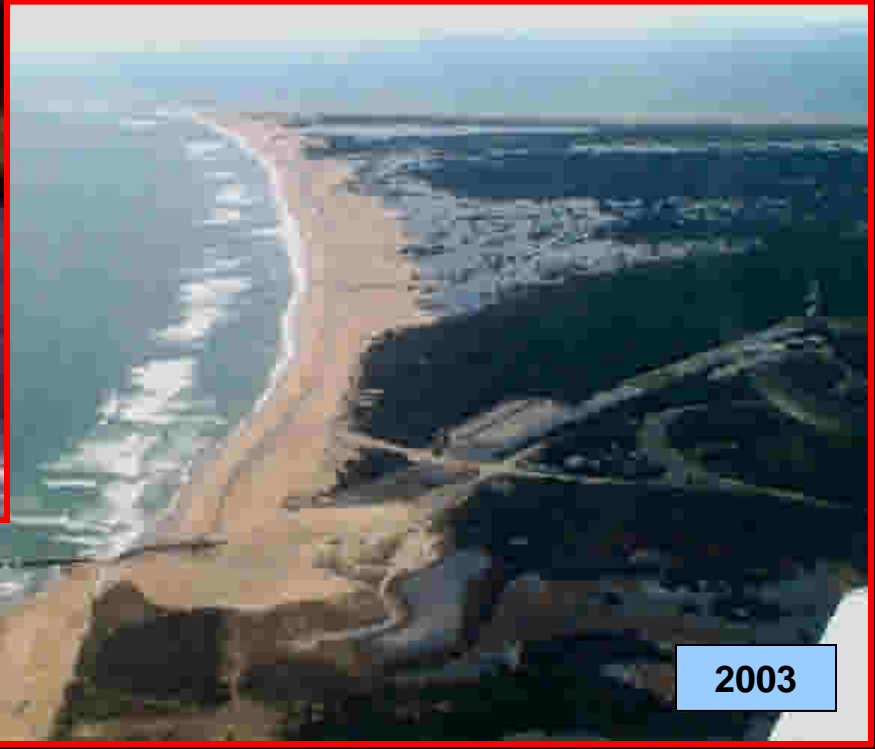
**AT BODIE ISLAND, SEDIMENT
TRANSPORT IS FROM N TO S
ACROSS OREGON INLET TO
PEA ISLAND**

**DREDGING OF OREGON INLET
AND TERMINAL GROIN
PREVENT SAND TRANSPORT
TO PEA ISLAND!**

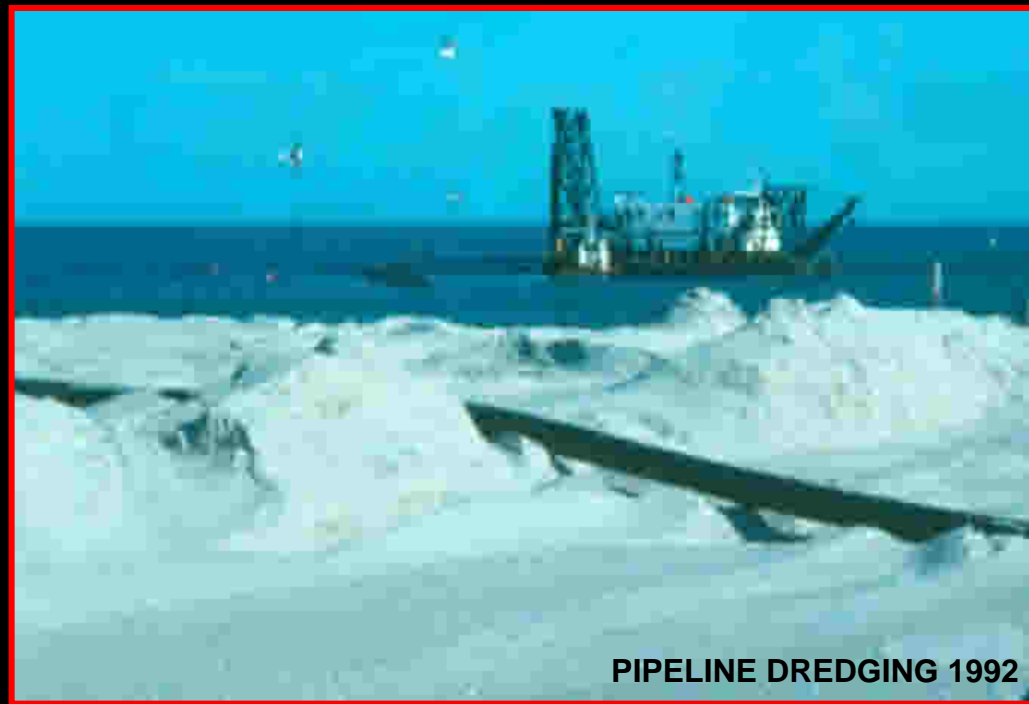
**APPROX. 7.7 MILLION yds³ OF INLET SAND WERE
PUMPED-PLACED ON MILES 1-- 6 OF PEA ISLAND
IN 23 OPERATIONS BETWEEN 1989-2005!**

**HOWEVER, PEA ISLAND'S OCEAN
SHORELINE CONTINUES TO ERODE AT
RATES UP TO 13 ft/yr!**

**PEA ISLAND
EXAMPLE**

**TERMINAL GROIN PERMIT
TO HARDEN OREGON
INLET REQUIRED
NOURISHMENT OF
DOWN-STREAM PEA
ISLAND BEACHES WITH
SAND FROM ANNUAL
INLET DREDGING**

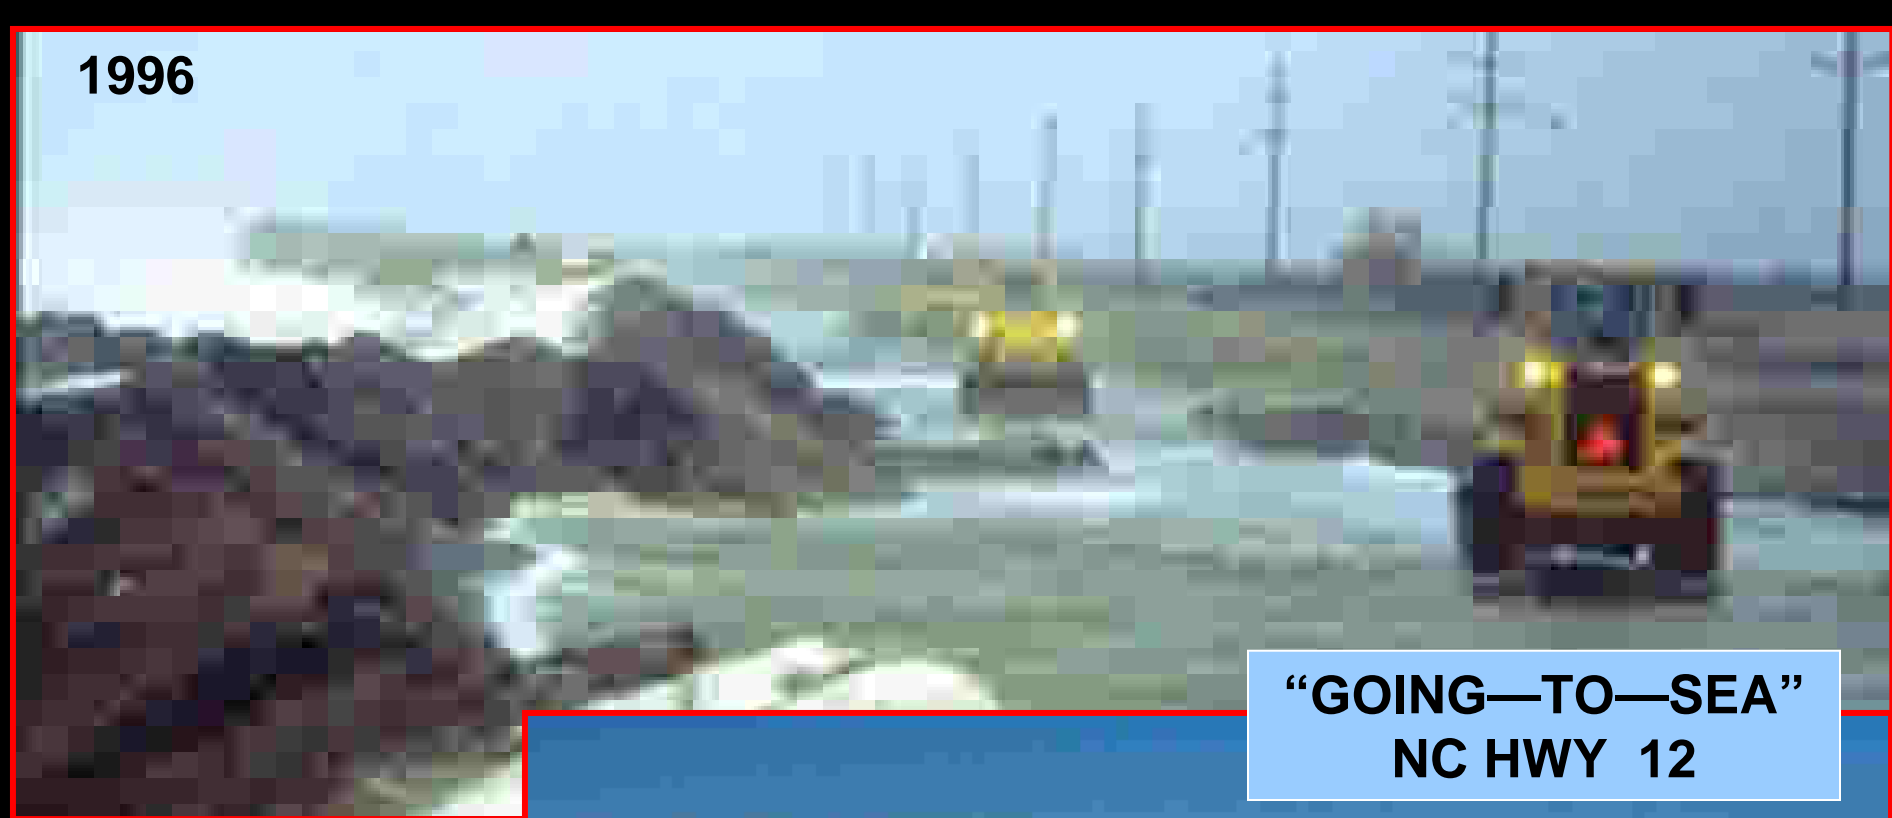
**“GOING—TO—SEA”
NC HWY 12**
