NCCF Oyster Restoration: Williston Creek

Funded by
Albemarle-Pamlico National Estuary Program
and
Fish America Foundation

Project objectives:

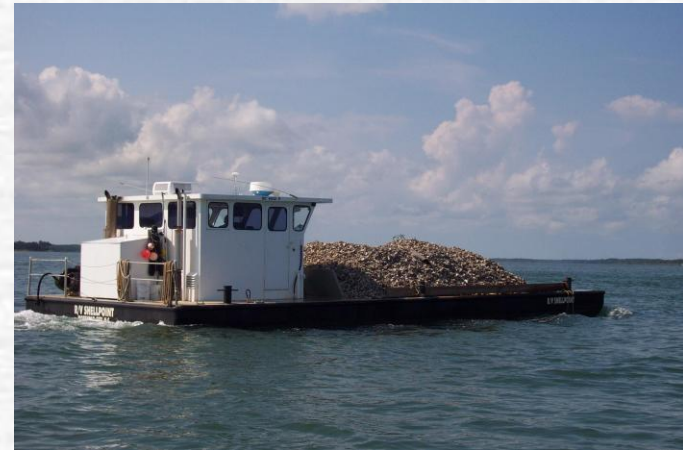
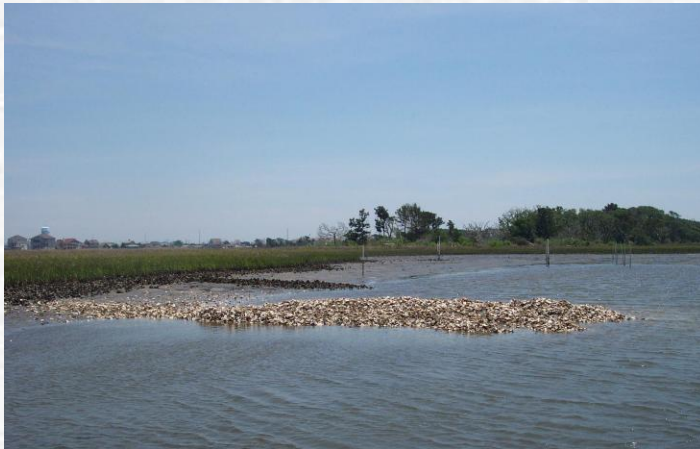
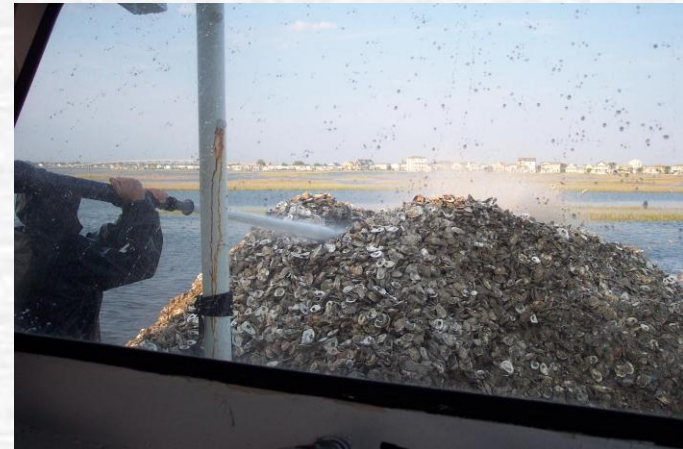
Creation of the Reef

5000 bushels of recycled shell were spread on June 30th by NC Division of Marine Fisheries to create over 2 acres of reef habitat area

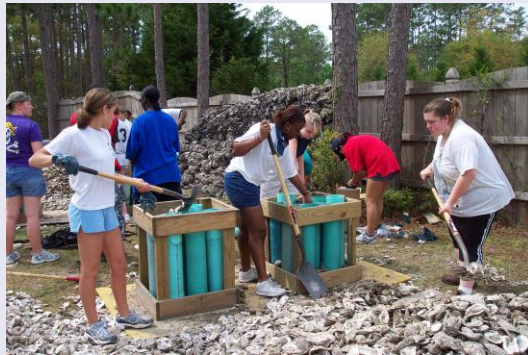
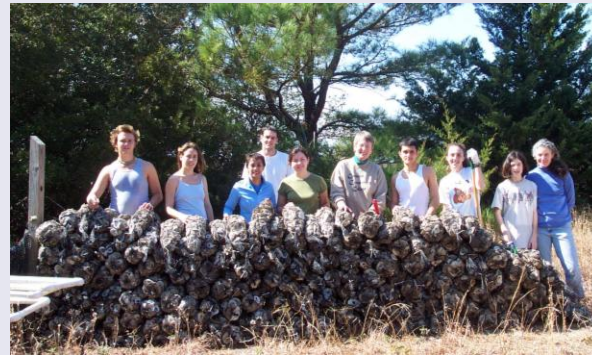
Oyster Relay

300 shell bags were filled with the help of volunteers...

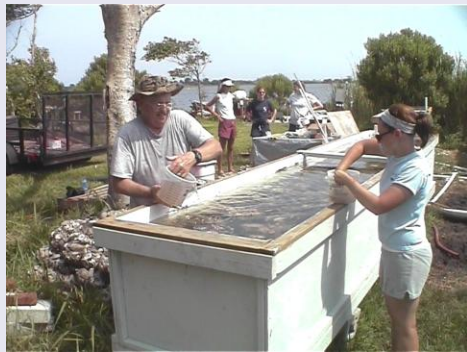
...the bags were placed in tanks and oyster larvae were introduced...

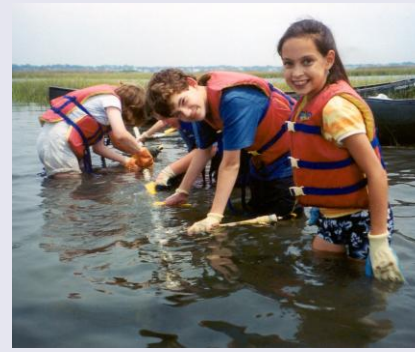
...and the bags and the spat were placed in the sound to mature.

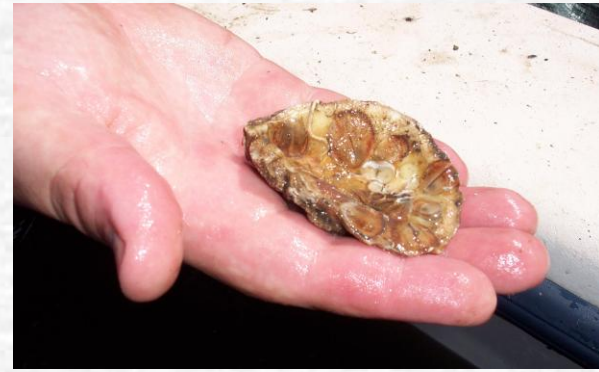
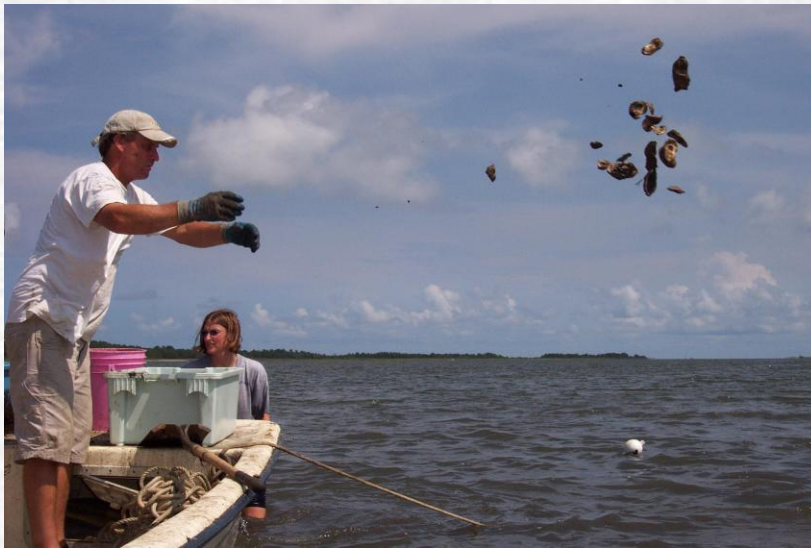
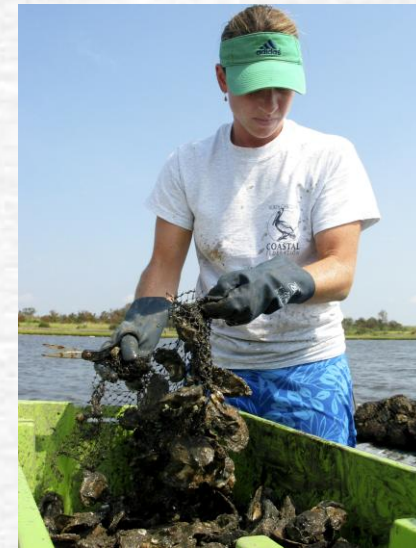
Seeding the Reef with Spat

The set shell was transported to the site by boat and dispersed on July 26th.

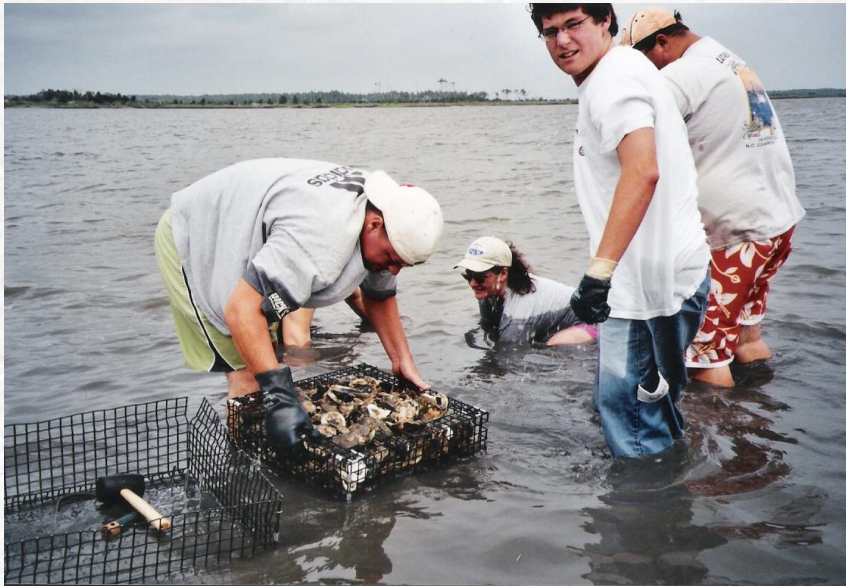
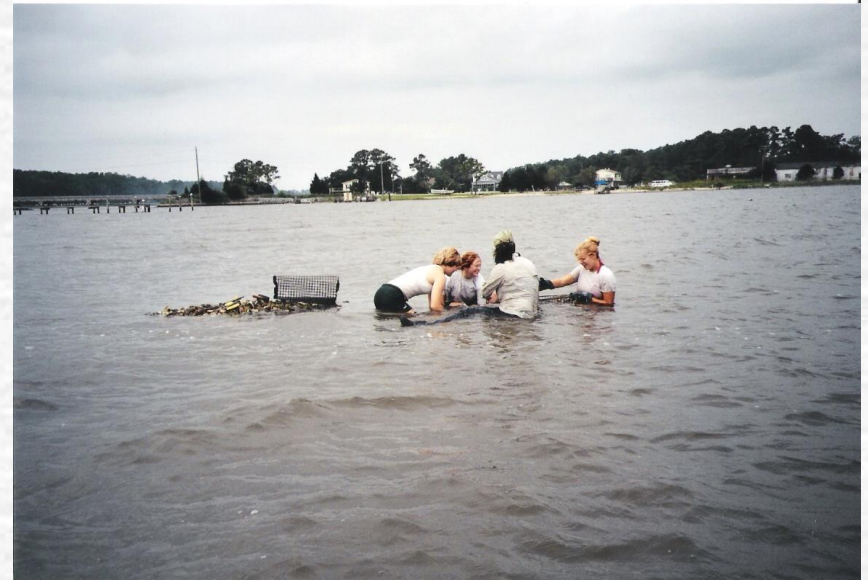
Monitoring- Oyster Cages

On September 10th, local volunteers and students from Carteret Community College installed 12 oyster cages at the site.

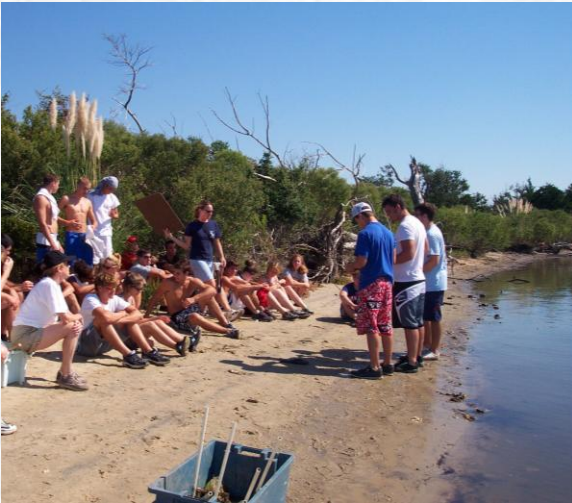
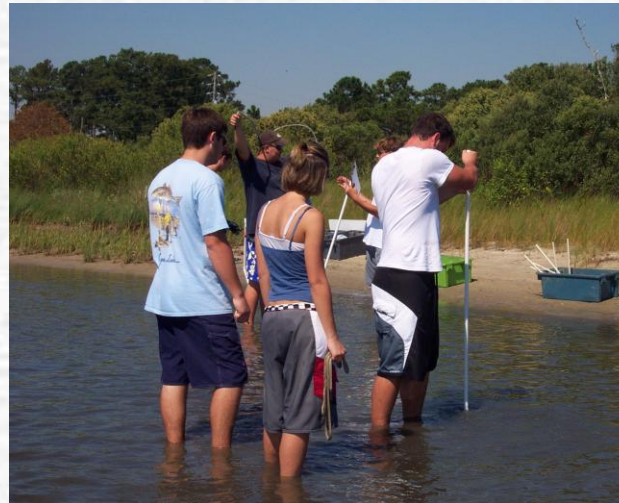
Monitoring- Reference Site

On September 23rd, students from Croatan High School monitored the reference site, located about 300meters northeast of the site.

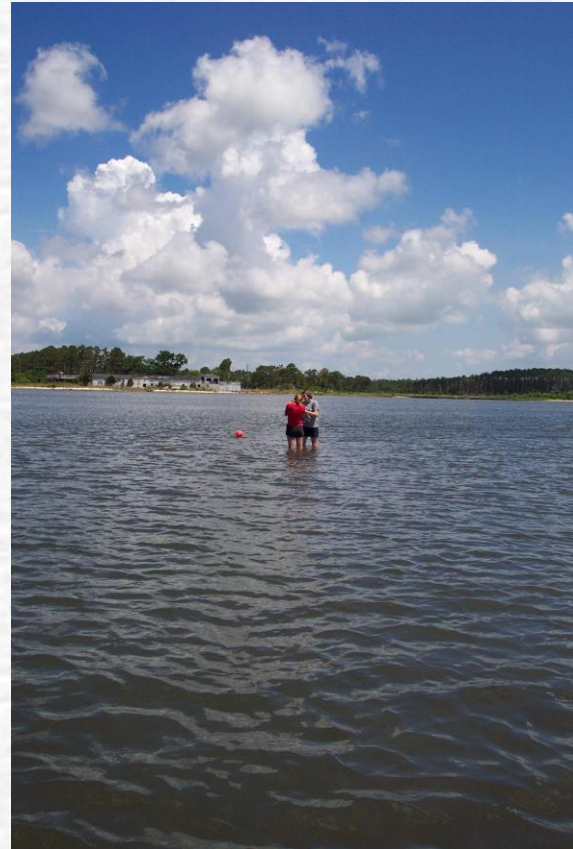
- **Rugosity**- measure of vertical relief-chain method

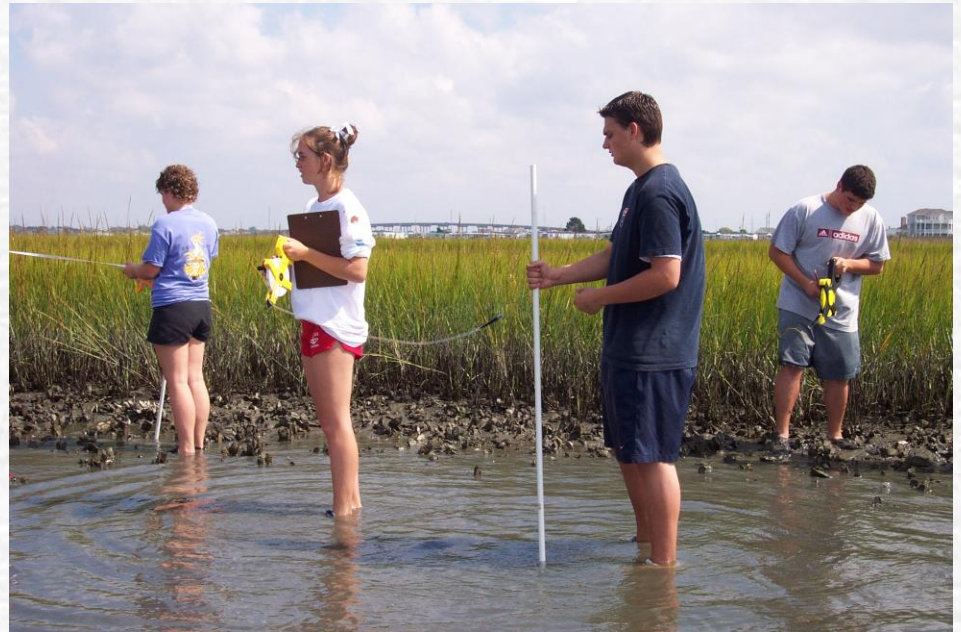
- **Footprint**- area covered by the reef-probe pole method

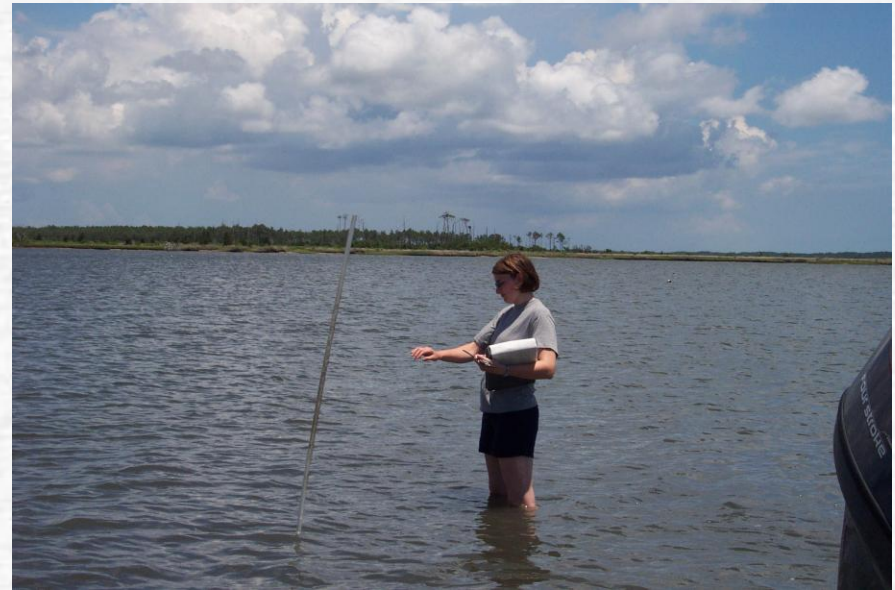
- Sedimentation-
deposition or erosion-
buried sediment tile

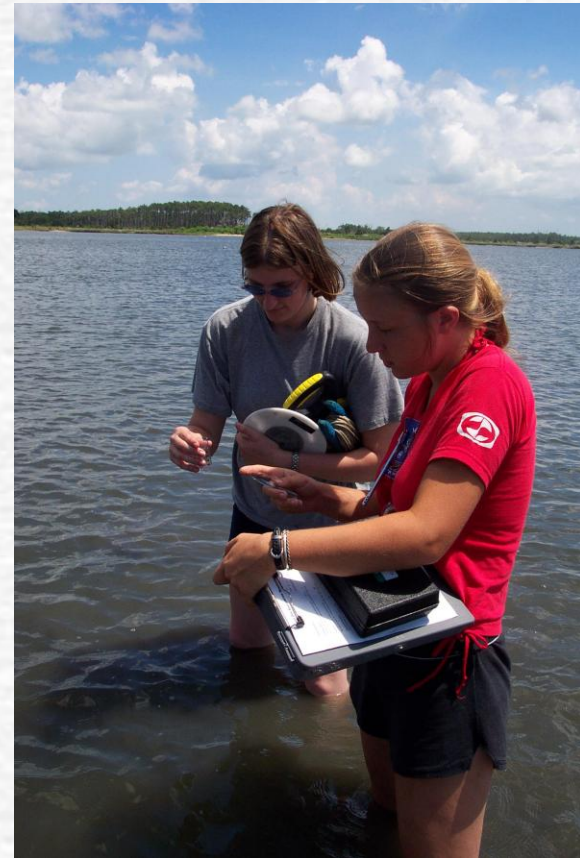
Water Quality

- Turbidity- secchi disc
- Temperature- thermometer
- Dissolved oxygen- CHEMets kit, increments of 1ppm
- Salinity- refractometer

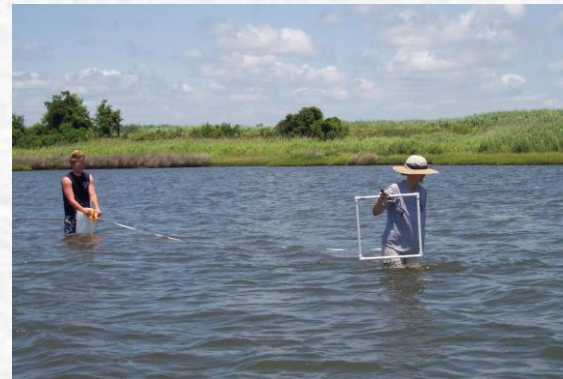
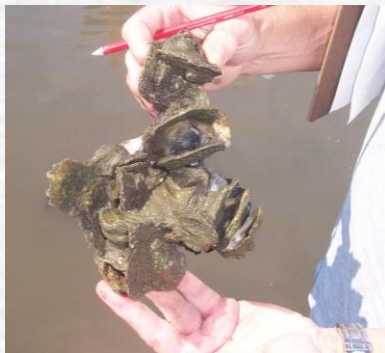
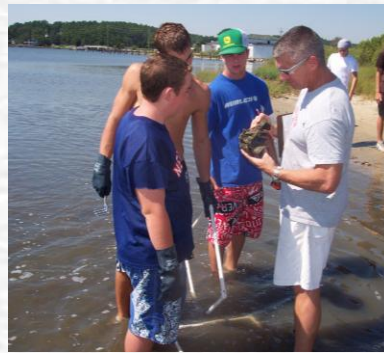
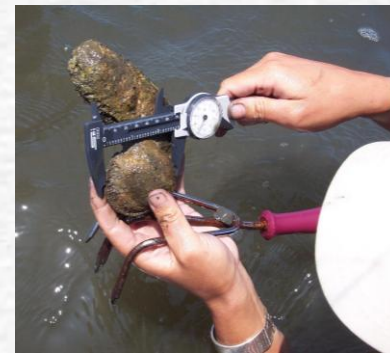
Functional - Cages

- Population size
- Density
- Size of oysters
- Associated fauna

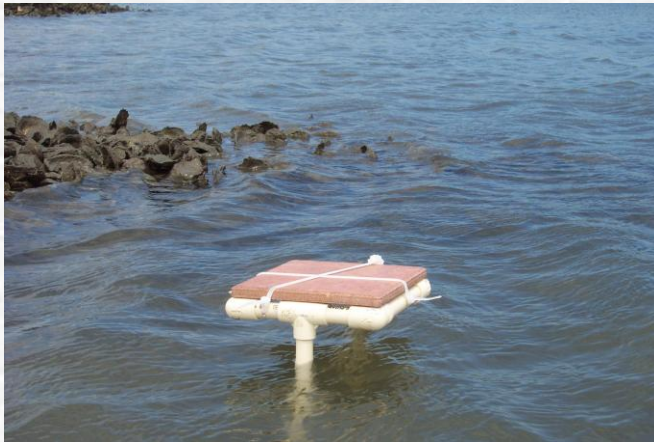
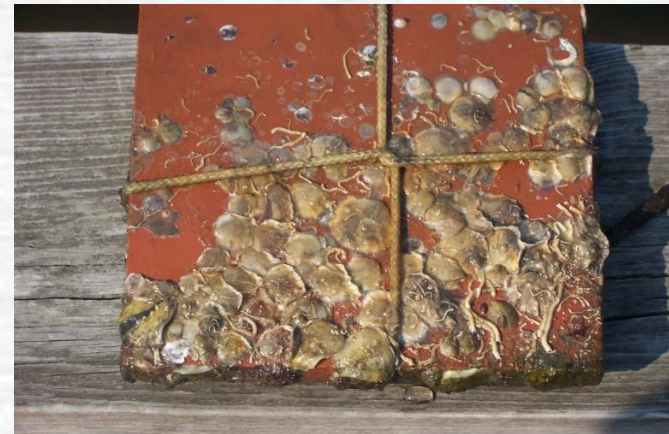
- Functional
 - Settlement/recruitment

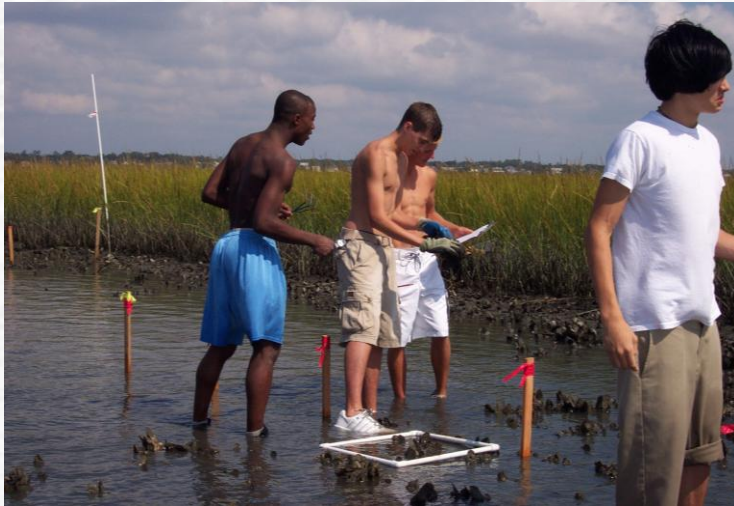
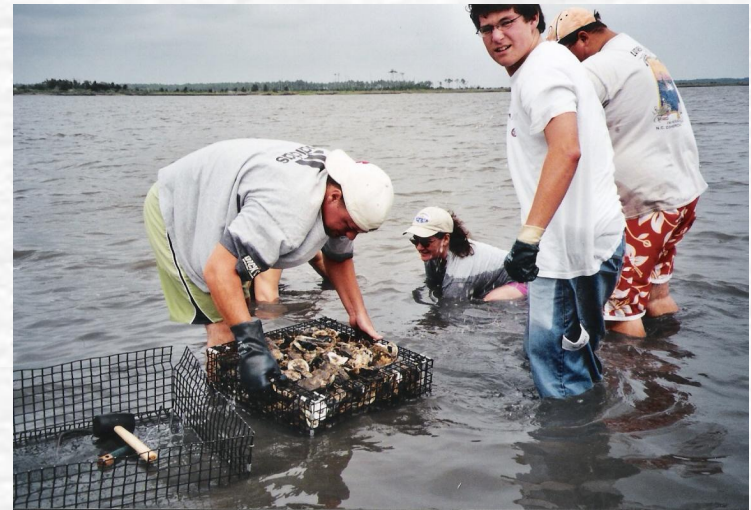
Additional Experimentation

- Evaluation of quadrats versus cages
