Using ecosystem restoration to build climate change resilience into a coastal habitat complex

Brian Boutin | November 17, 2011

Initial on-the-ground focus: Alligator River NWR

Point Peter Road demonstration site

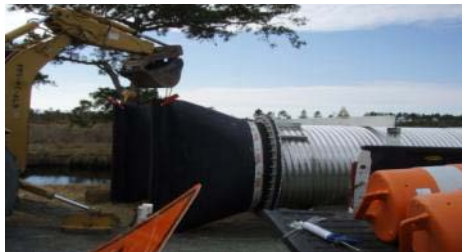
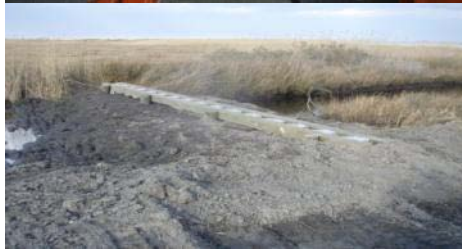
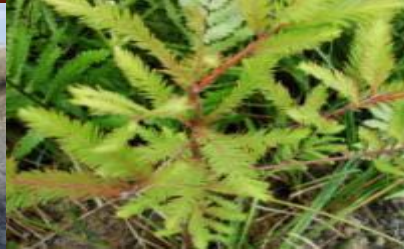
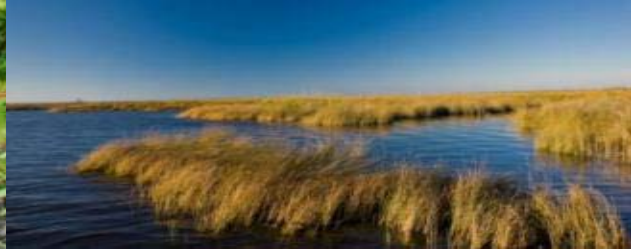
Four components

1. Salt-tolerant tree plantings
2. Hydrologic manipulation
3. Invasive species control
4. Nearshore oyster reefs

Significant impacts evident

- ❖ Shoreline erosion
 - ❖ ~5 m per y^{1,2}
- ❖ Invasive species
- ❖ Saltwater intrusion³
- ❖ Vegetation transition

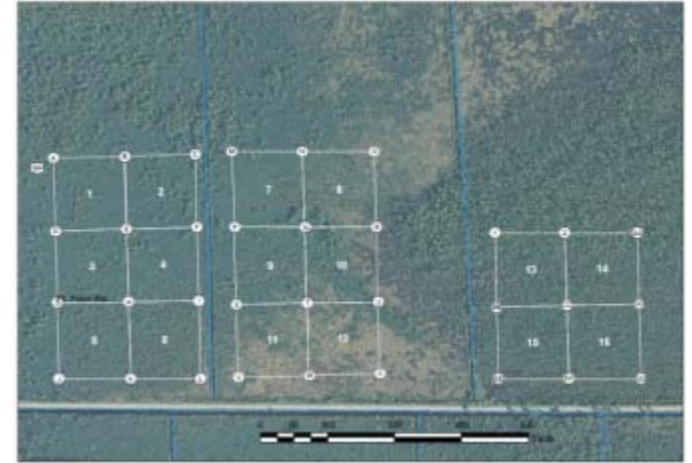
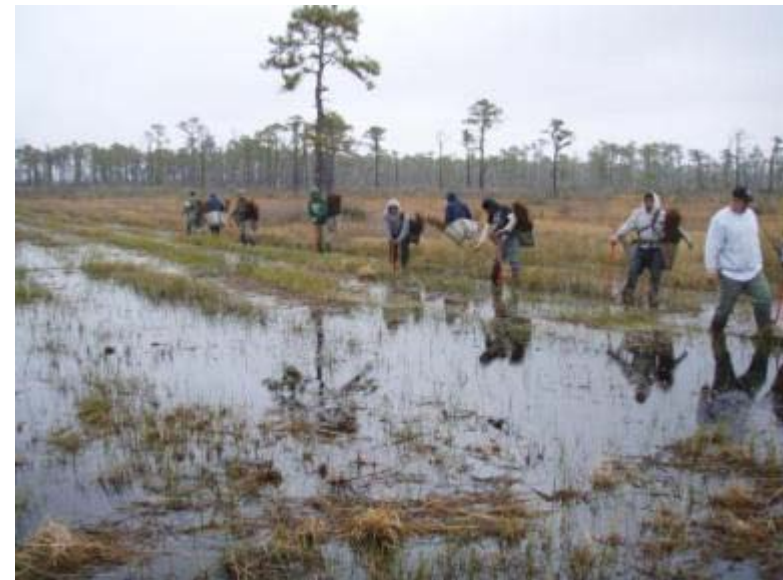
Experimental salt-tolerant tree plantings

- ❖ 80 acres total in 40 acres of planting area and 40 acres of control
 - ❖ 4 planting treatments
- ❖ 11,500 bald cypress; 2,000 black gum; 6,750 pond pine
- ❖ Planted March 2010

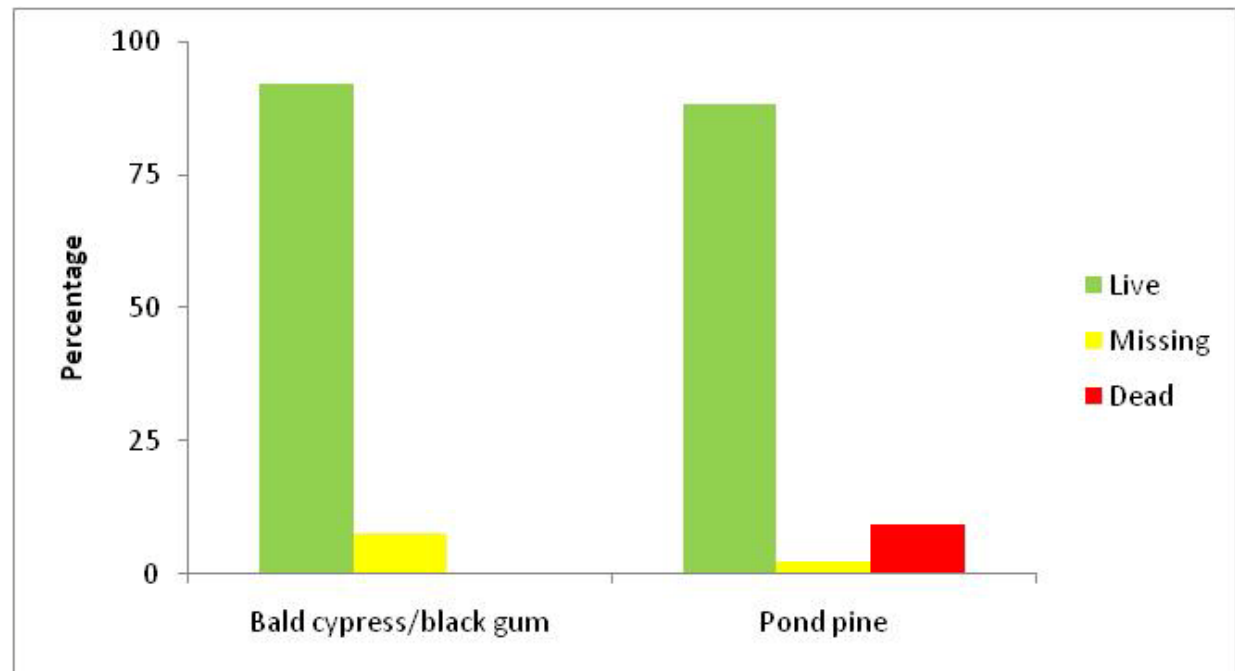
Experimental salt-tolerant tree plantings

Note: Hurricane Irene placed sound water (16 PSU) on the tree plots for 2 weeks

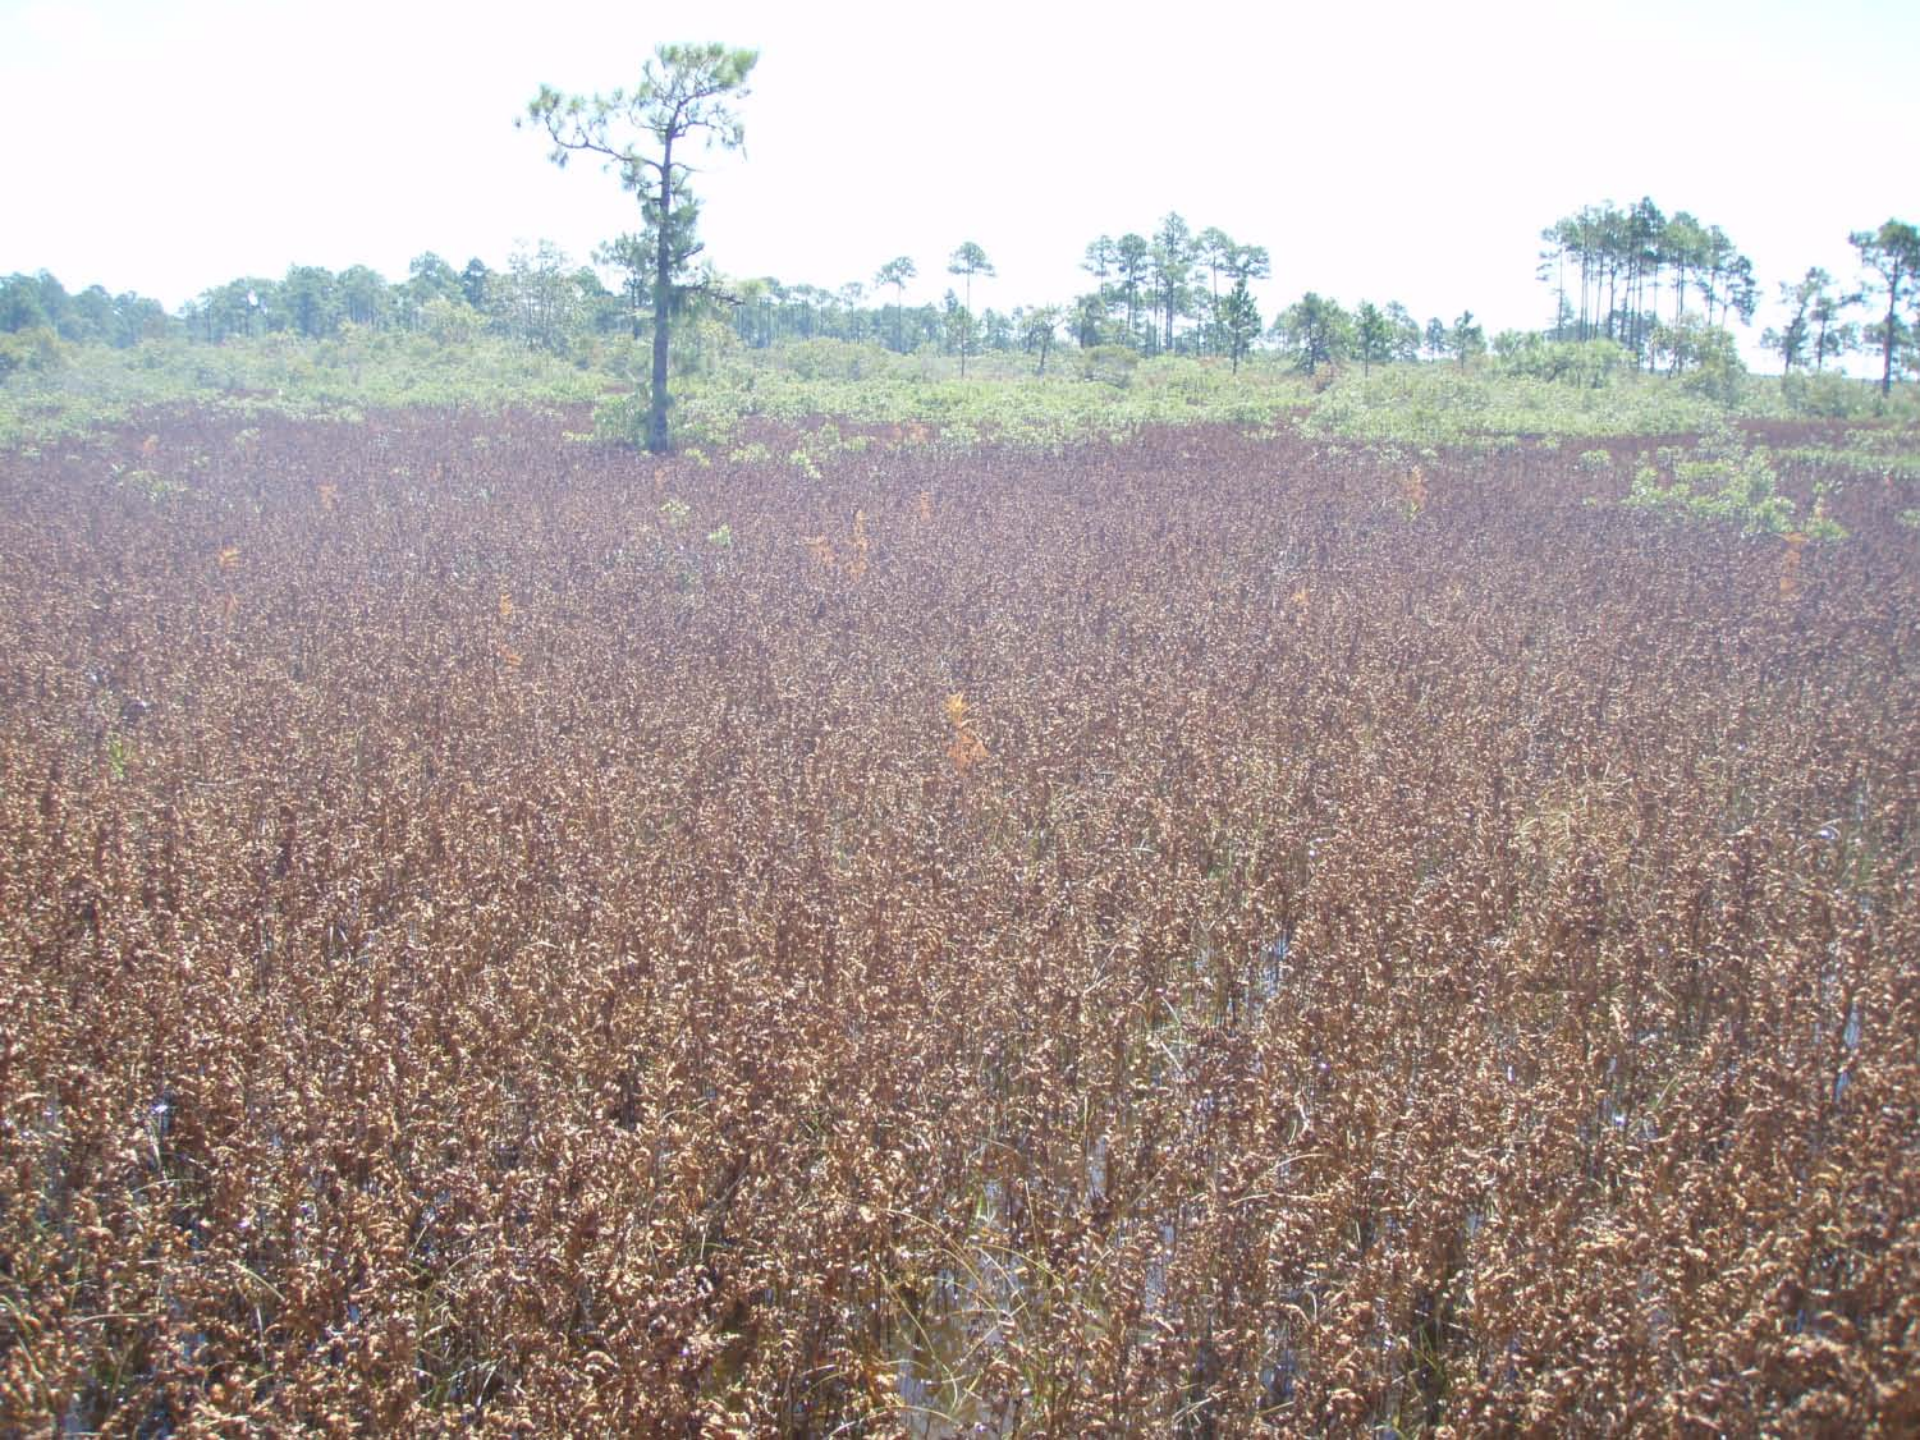
Hydrologic manipulation

❖ Water control structure

- ❖ Flashboard risers
- ❖ Tideflex check valves
- ❖ Three culverts placed under the road to encourage wetland connectivity

❖ Completed March 2011

❖ Sheet pile ditch plug

- ❖ Secondary drainage ditch
- ❖ Completed December 2010

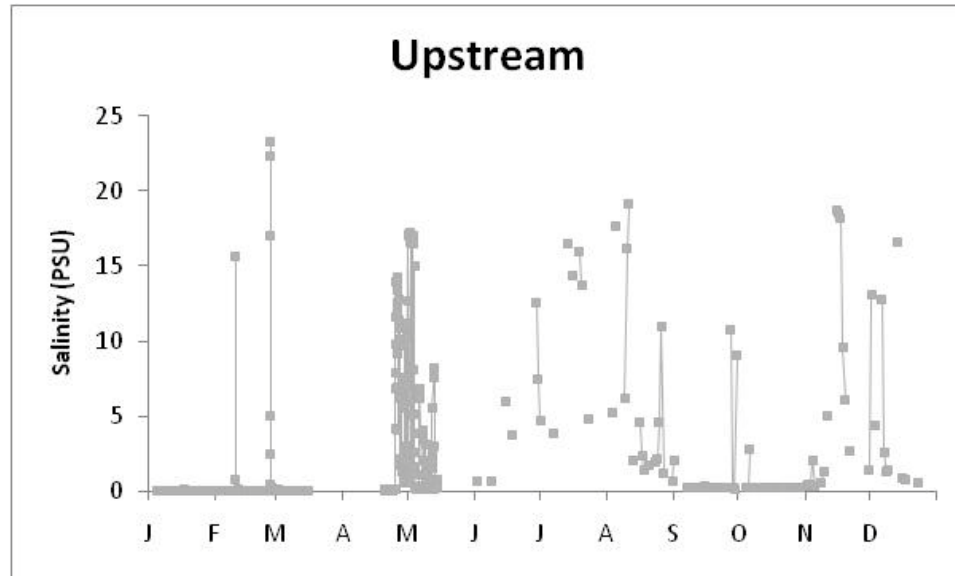
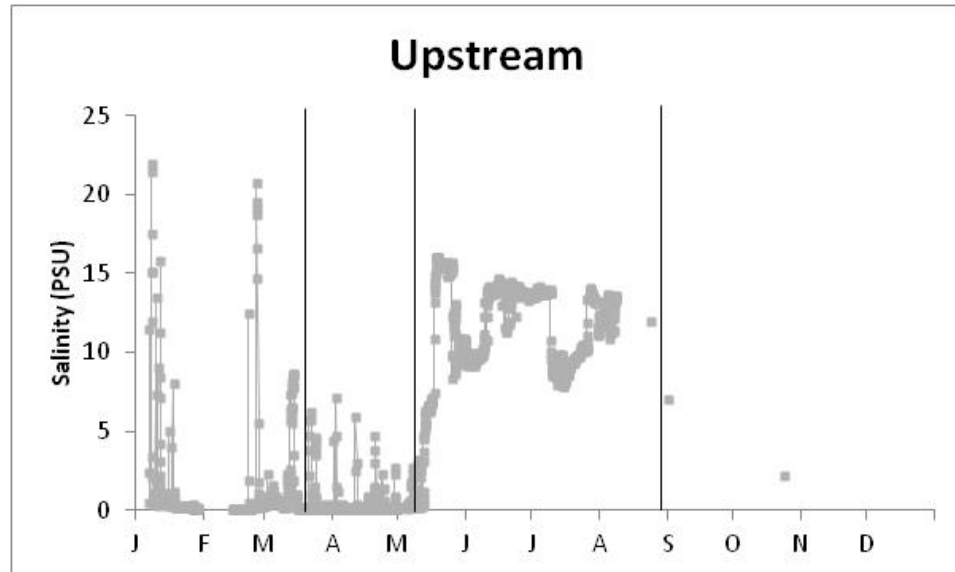
Hydrologic manipulation

2010

2011

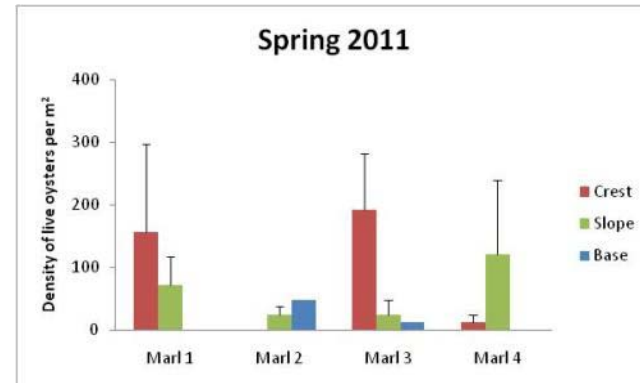
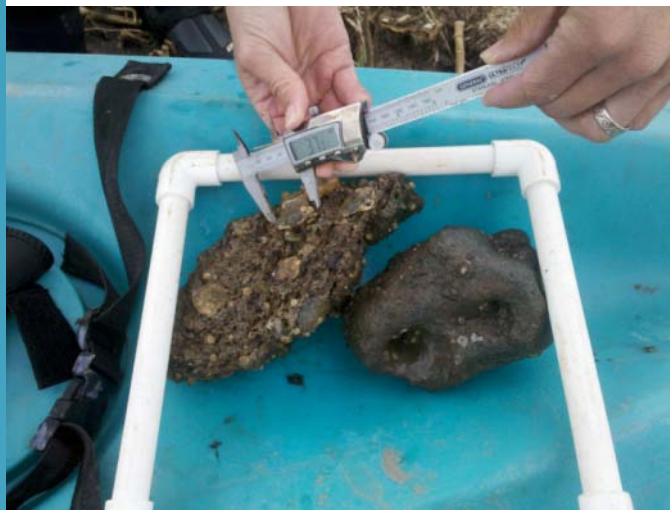
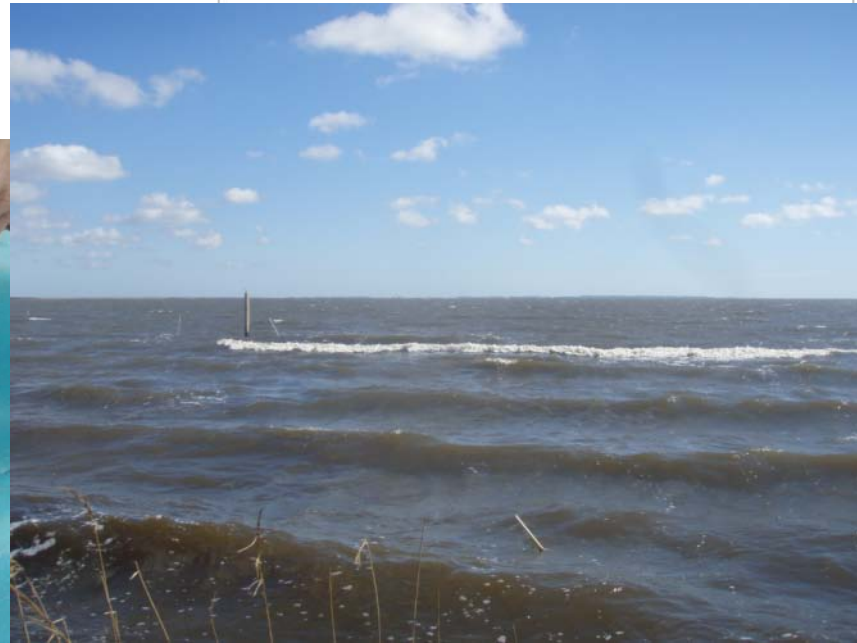
Nearshore oyster reefs

Marl (limestone)

- ❖ 400 linear feet
- ❖ Reefs installed June 2010

Oyster shell bags

- ❖ 400 linear feet
- ❖ First 150 feet installed December 2010

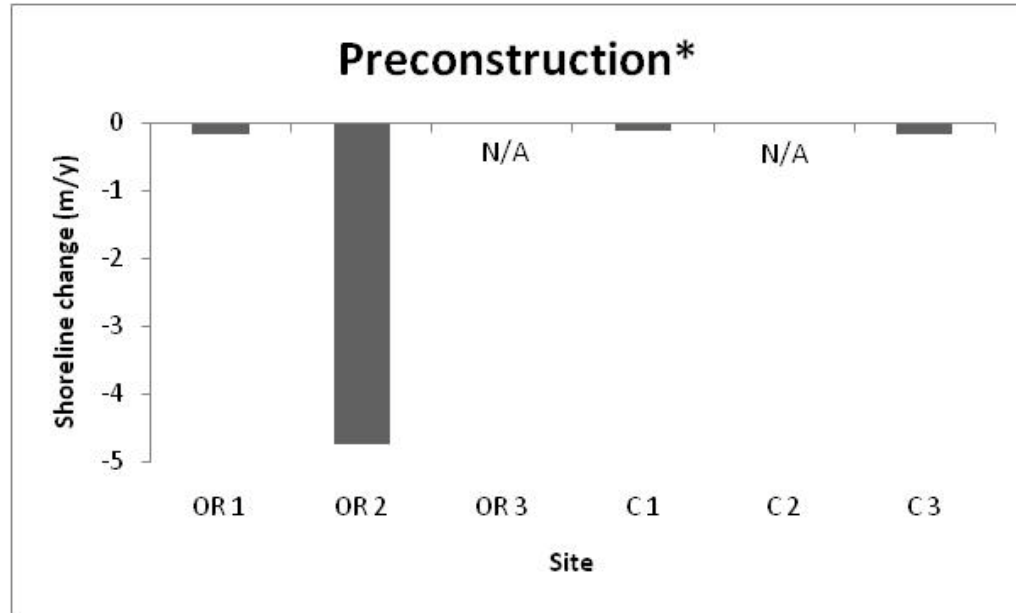
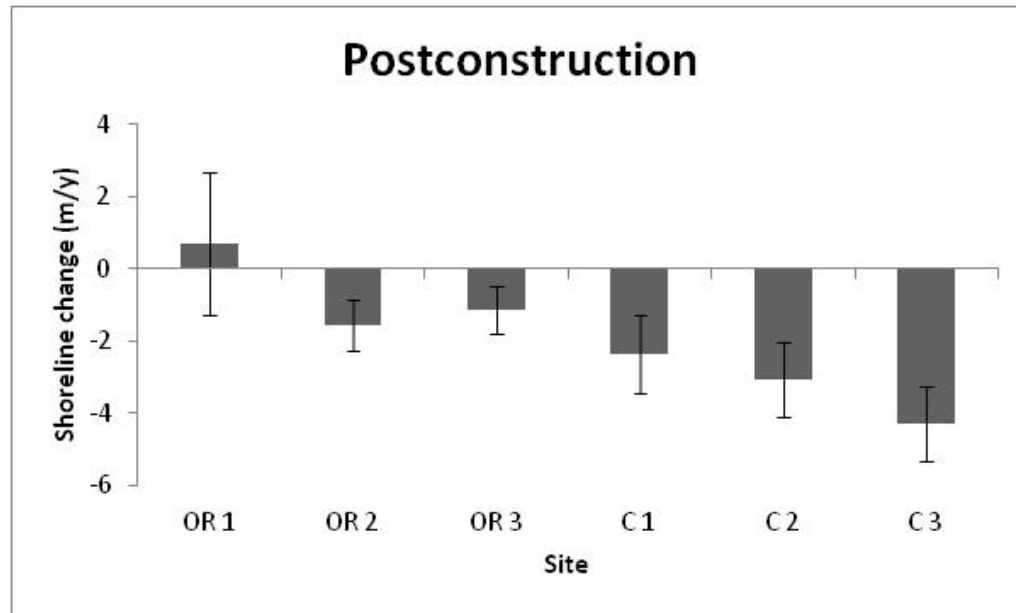
Nearshore oyster reefs

*aerial photographic analysis indicates 5+ m of erosion per y

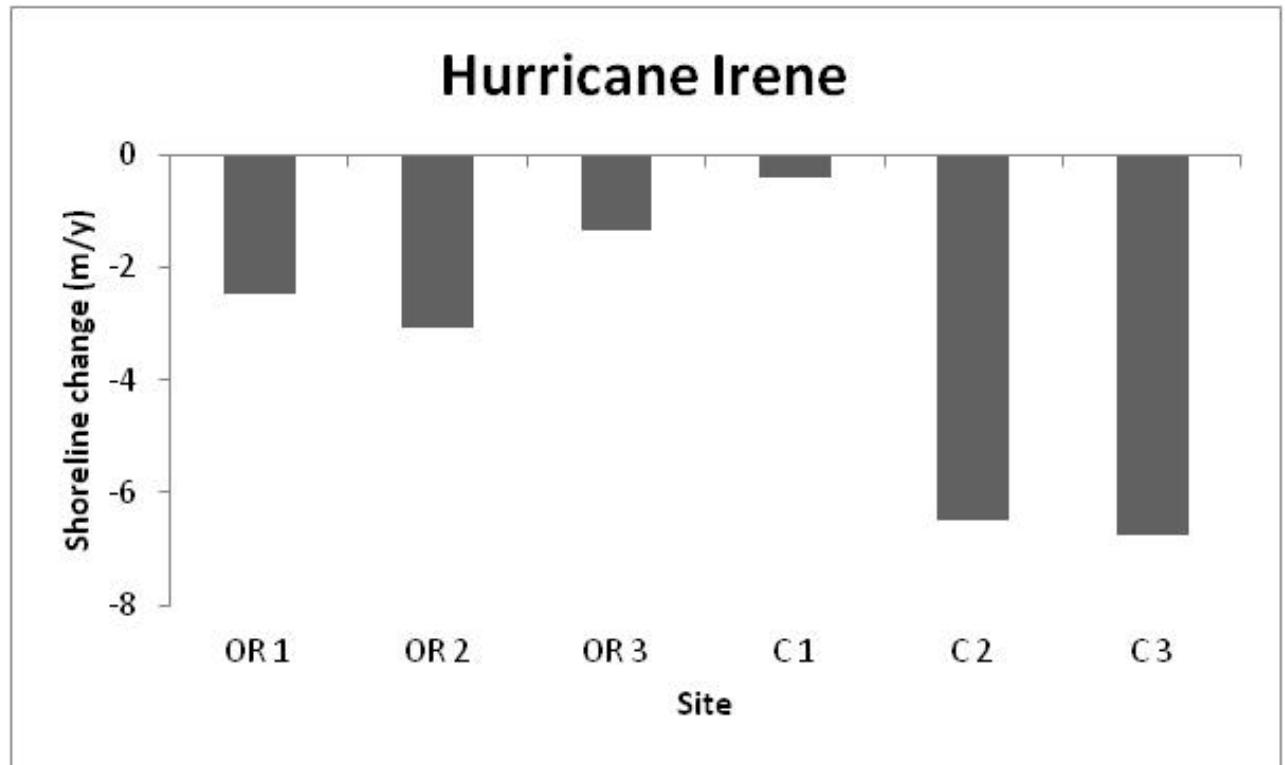
Hurricane Irene

Note: measurements taken 2 months post-hurricane

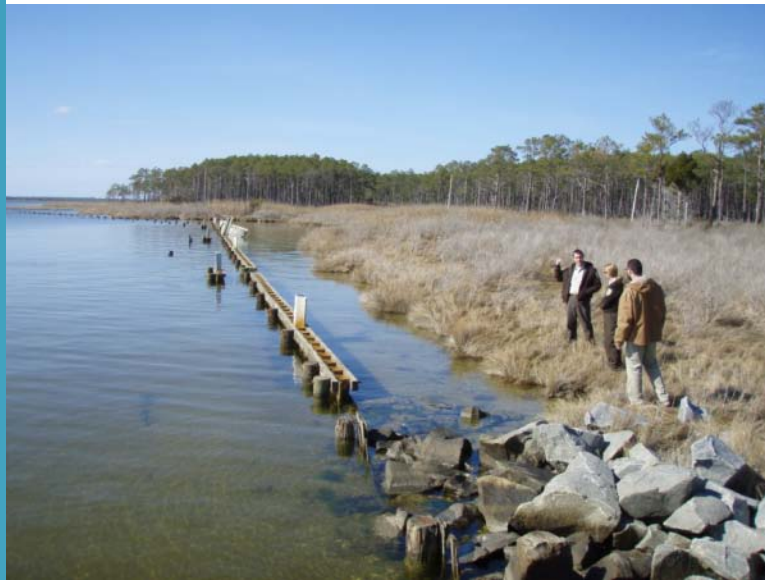
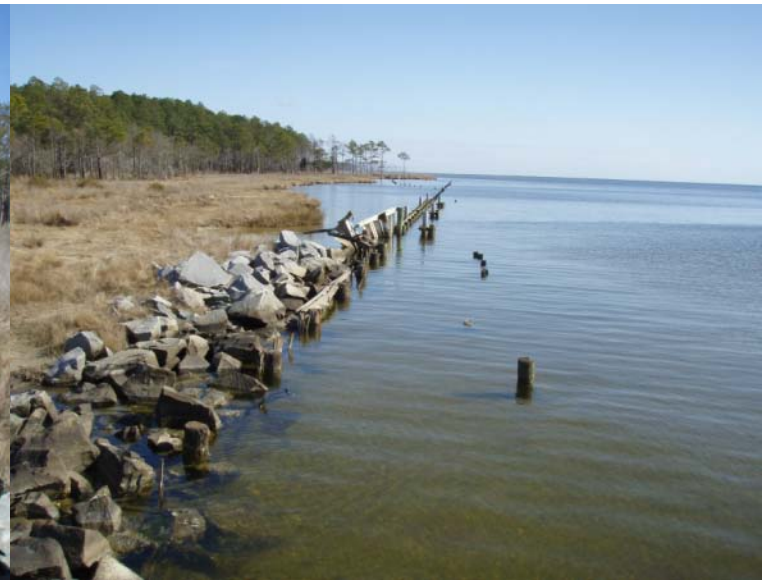
Expansion of coastal adaptation

Nags Head Woods Ecological Preserve

- ❖ Oyster reefs
- ❖ Submerged aquatic vegetation
- ❖ Brackish marsh vegetation
- ❖ Maritime salt shrub vegetation
- ❖ Grading of high-bank shoreline
