North Carolina Sea Grant - Final Grant Report for Albemarle-Pamlico National Estuary Program
Title: Landscaping with Nature in Currituck County
May 19, 2010 – September 30, 2010

Stormwater Pond Retrofits: Accomplishments

EXHIBIT A: Pond 1 and 3 Retrofit Site Design

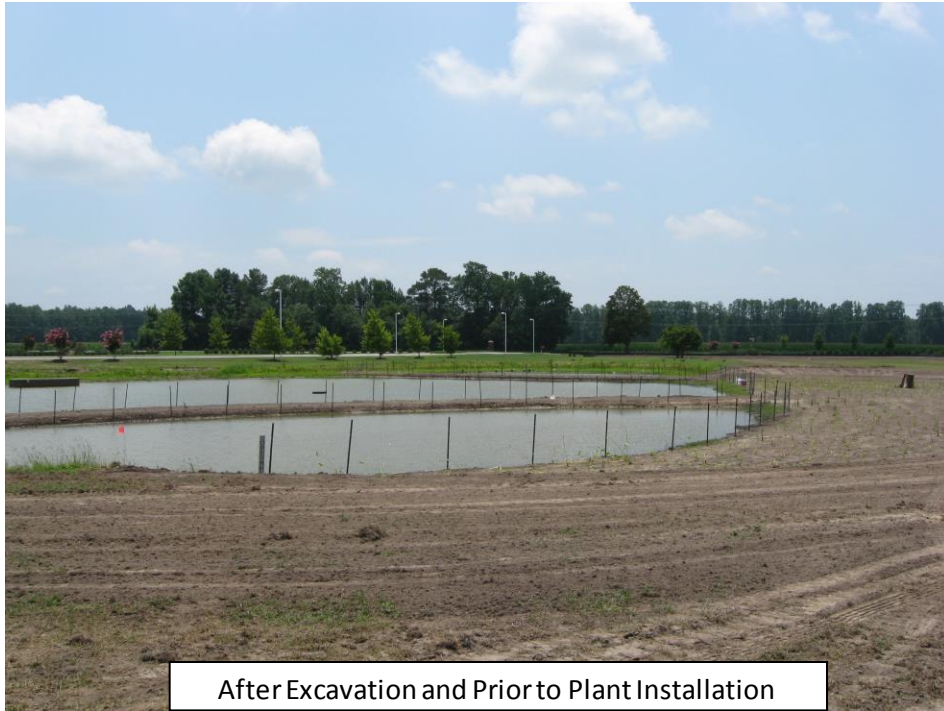
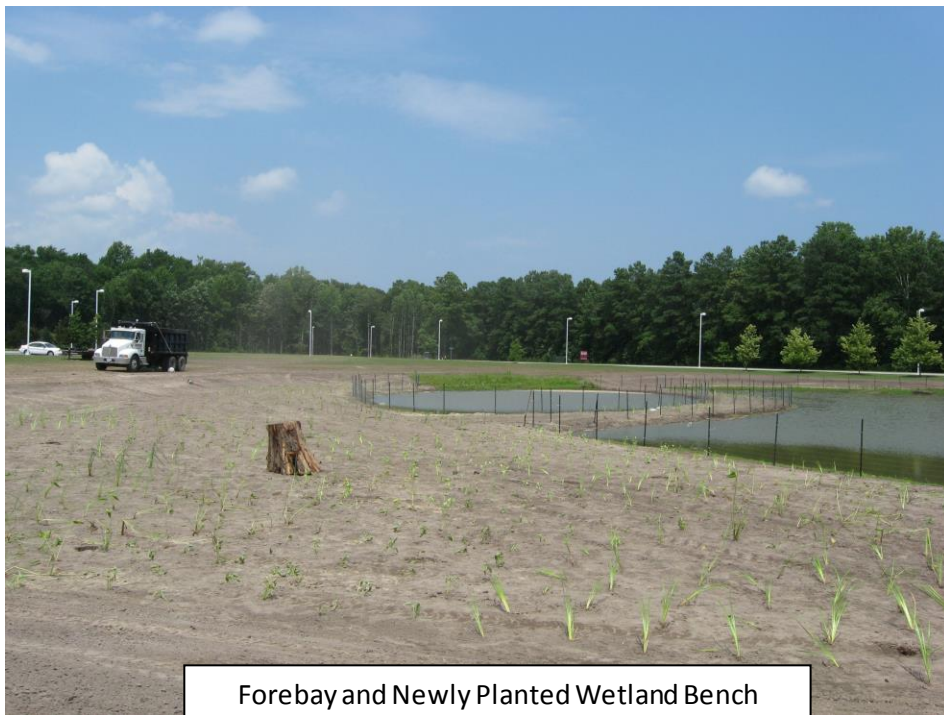
Exhibit B: Pond #1 During Grading and Planting

For Pond 1, an aquatic shelf of 60 feet wide (at the widest point) with an average depth of 3 inches was excavated around 350 feet around the pond. Two existing forebay berms were repaired of pre-existing storm breeches, topsoil was added to the berms and the wetland benches, and wetland plants were installed. A vegetated riparian buffer of 10 feet in width around the entire perimeter of all three ponds was seeded with native perennials and grasses. This buffer will deter future use of the pond by Canada Geese, provide additional stormwater treatment from sheet flow, and provide wildlife habitat. The buffer is to be mowed only twice per year, to a height of 6-8" in order to provide the noted benefits. For Pond 3, an aquatic shelf was added along approximately 100 feet of the pond perimeter, topsoil and plants were added, and topsoil and plants were added to the berm as well.

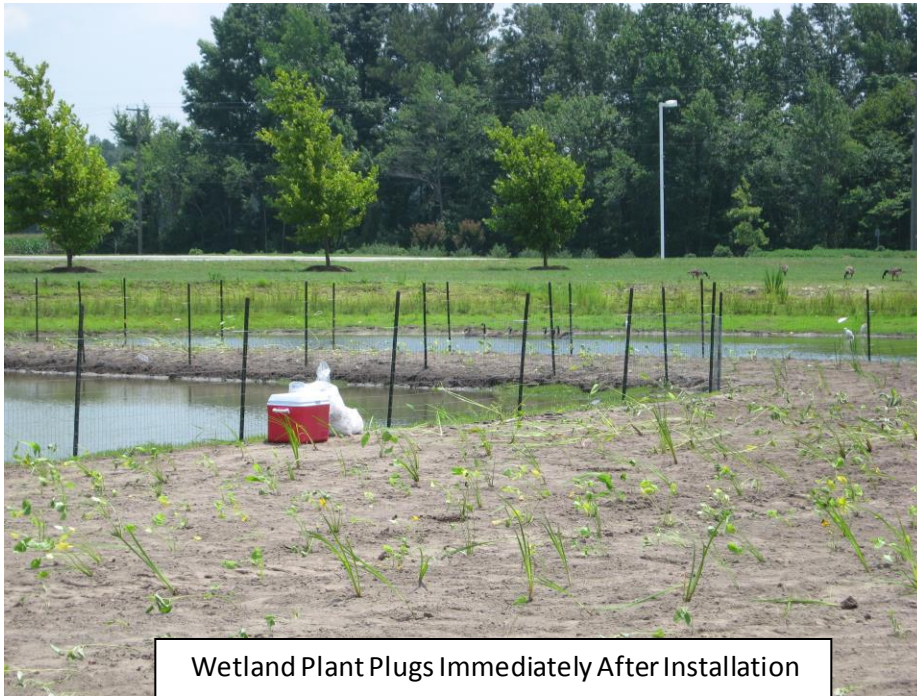
Wetland Plant Plugs Immediately After Installation

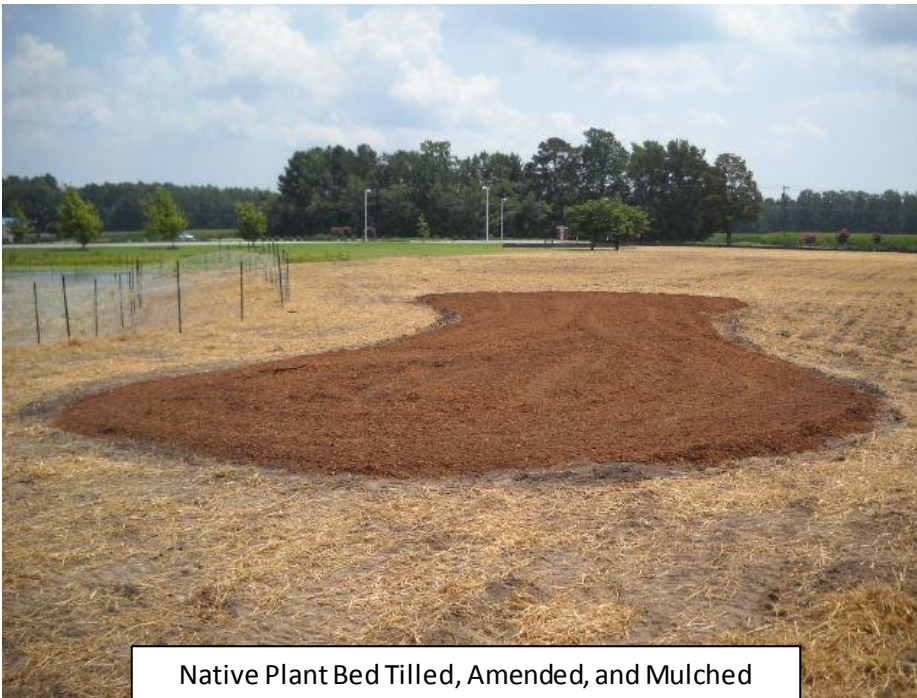
Native Plant Bed Tilled, Amended, and Mulched

In July, the construction contractors prepared the bed for the wildlife garden by tilling approximately 1200 square feet of ground to a depth of eight inches, amending it with soil media, and placing a 4 inch layer of mulch on top. The plants, trees, and garden benches were selected with input from NC Sea Grant, the Currituck County Cooperative Extension horticulturist, and Currituck County environmental

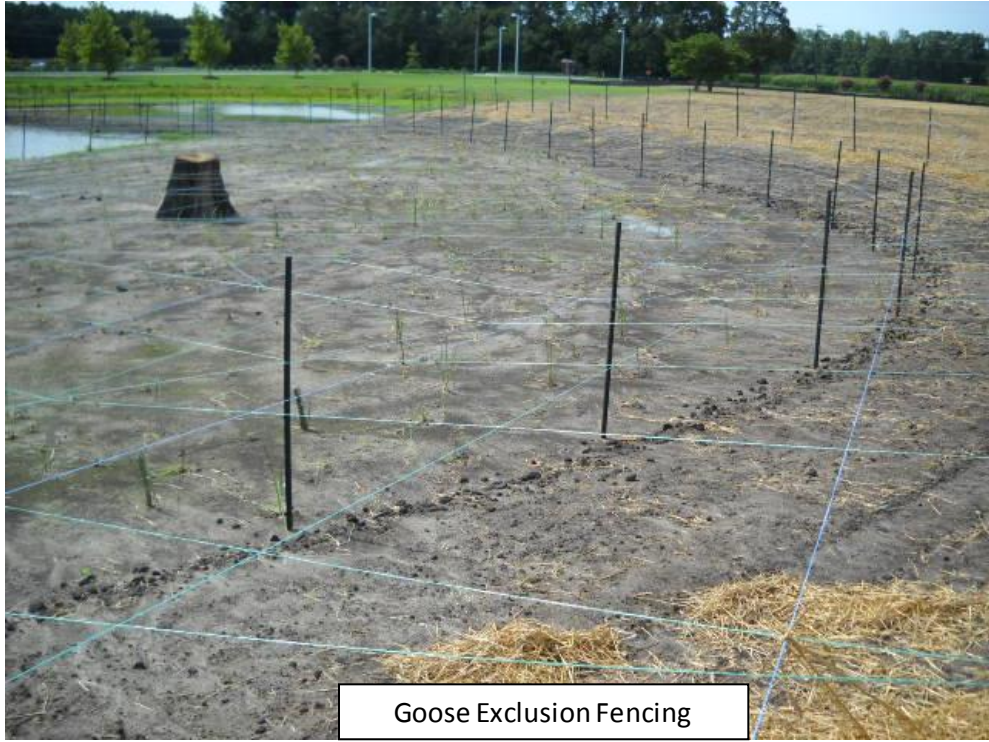
Goose Exclusion Fencing

Due to the high population of Canada Geese at the site (in excess of 70 birds after goslings hatched in 2010), temporary exclusion fencing was installed to prevent grazing on the newly installed tender plants. Overall, this technique has proven to be effective and will remain in place until the riparian buffer is well established, probably early summer of 2010. The last photograph in Exhibit B shows the exclusion fencing.

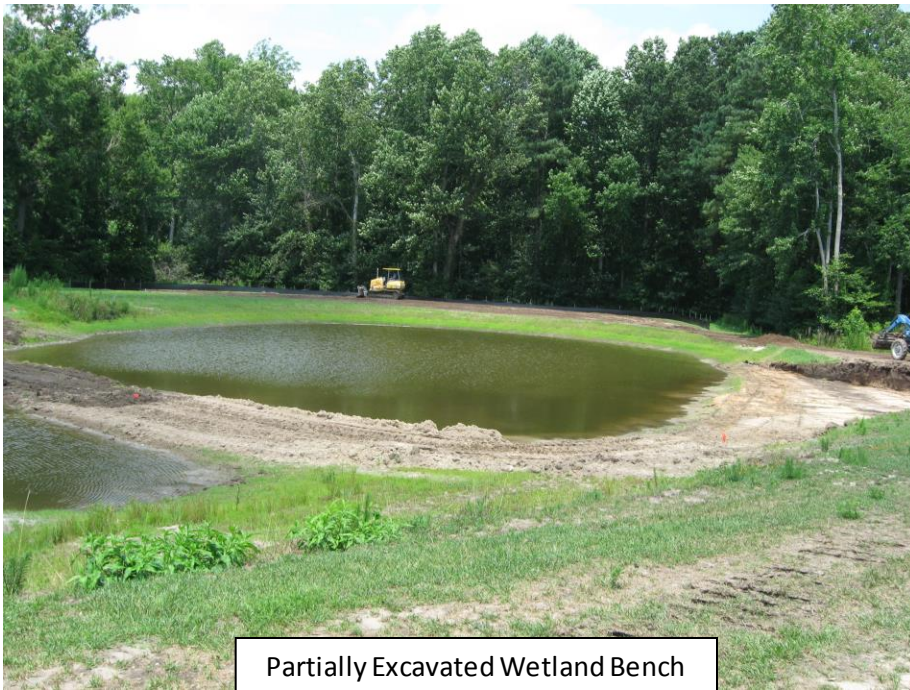
Exhibit C: Pond #3 (Rear Pond) During Construction/Grading in July 2010

Partially Excavated Wetland Bench

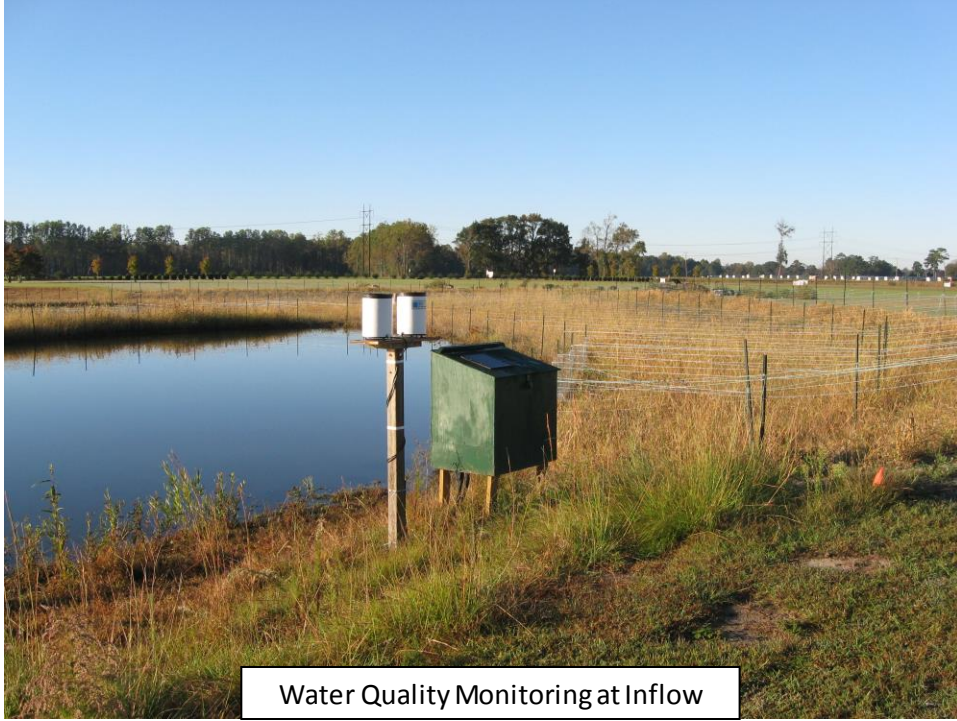
Exhibit D: Pond #1 October 23, 2010

Water Quality Monitoring at Inflow

As an addition to this project, partners were identified and funds were leveraged from NC Sea Grant in the amount of \$7,350 to assess improvements in water quality treatment from the stormwater pond improvements (addition of wetland and shoreline vegetation). NC State University's Department of Biological and Agricultural Engineering (BAE) supplied and installed automated water quality samplers in August at both the inflow and outflow of Pond 1. The equipment will remain in place for one year in an effort to collect data from 15 to 20 storm events. Samples will be collected and tested by staff from UNC's Coastal Studies Institute (CSI) for total suspended solids and nutrients. Grab samples will also be obtained by CSI at least six times throughout the year during dry weather to enable comparison of removal rates during storm and non-storm flows. For your reference, Exhibit D contains photographs of the Pond #1 taken on October 23 which include the monitoring equipment located near the inflow pipe.

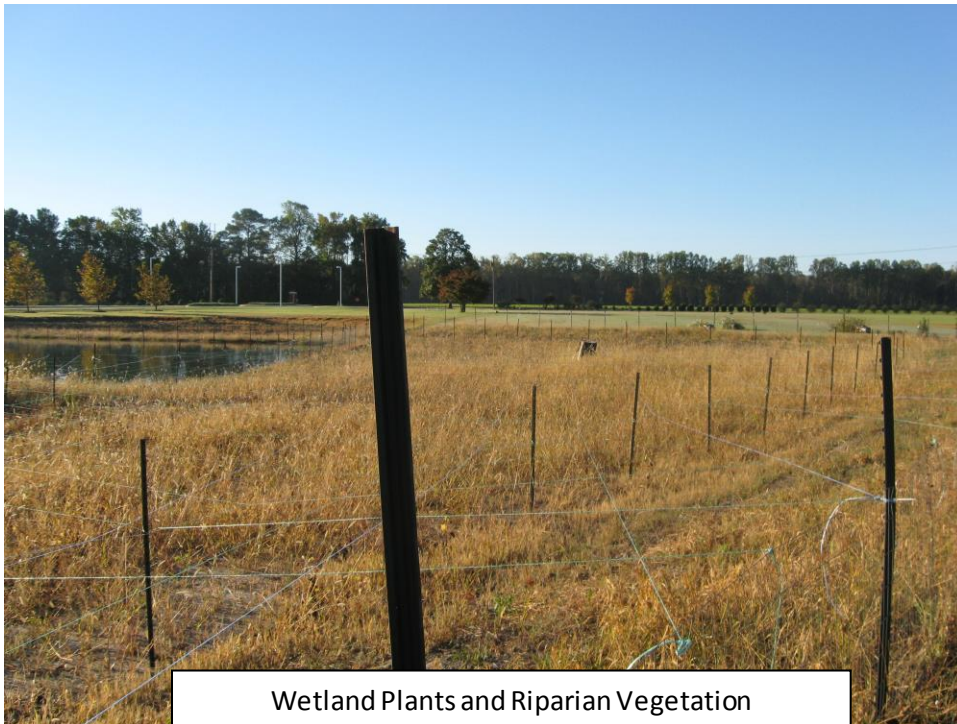
Wetland Plants and Riparian Vegetation

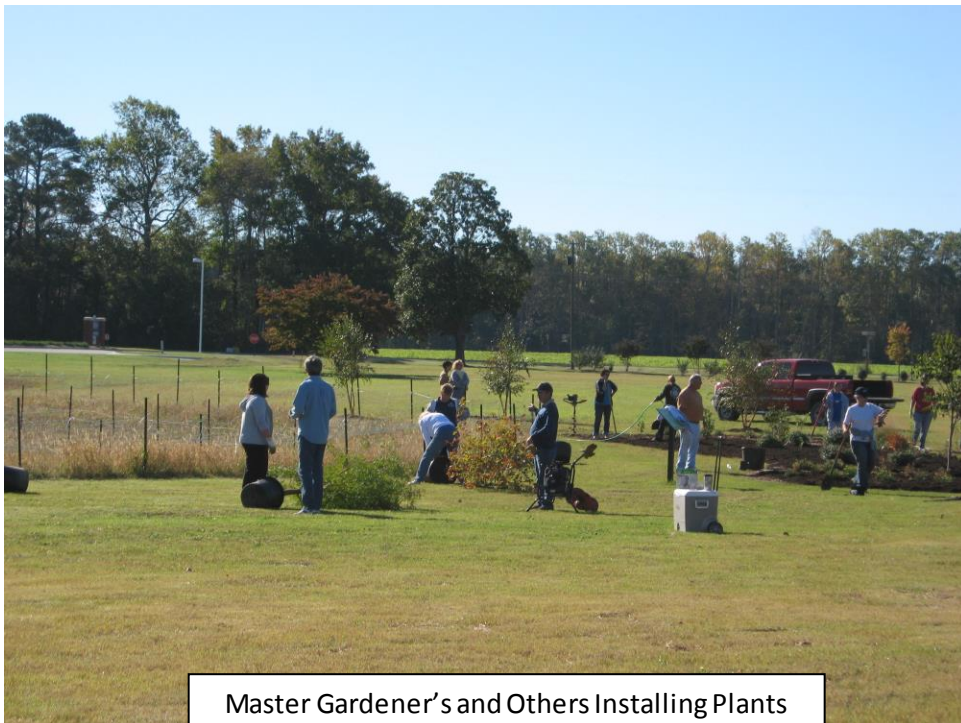
Exhibit G: "Wildlife Garden" - October 23, 2010

Master Gardener's and Others Installing Plants

Although outside the timeframe of this grant, the garden was planted on October 23 and photographs of the planting and end product are included in Exhibit G.

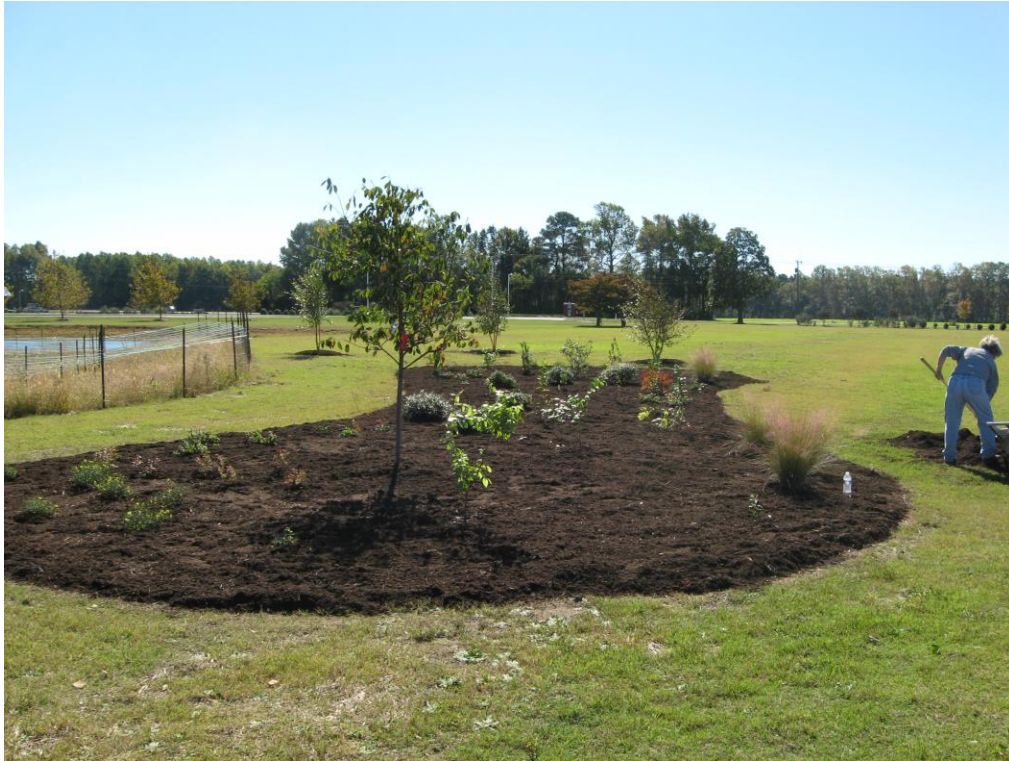
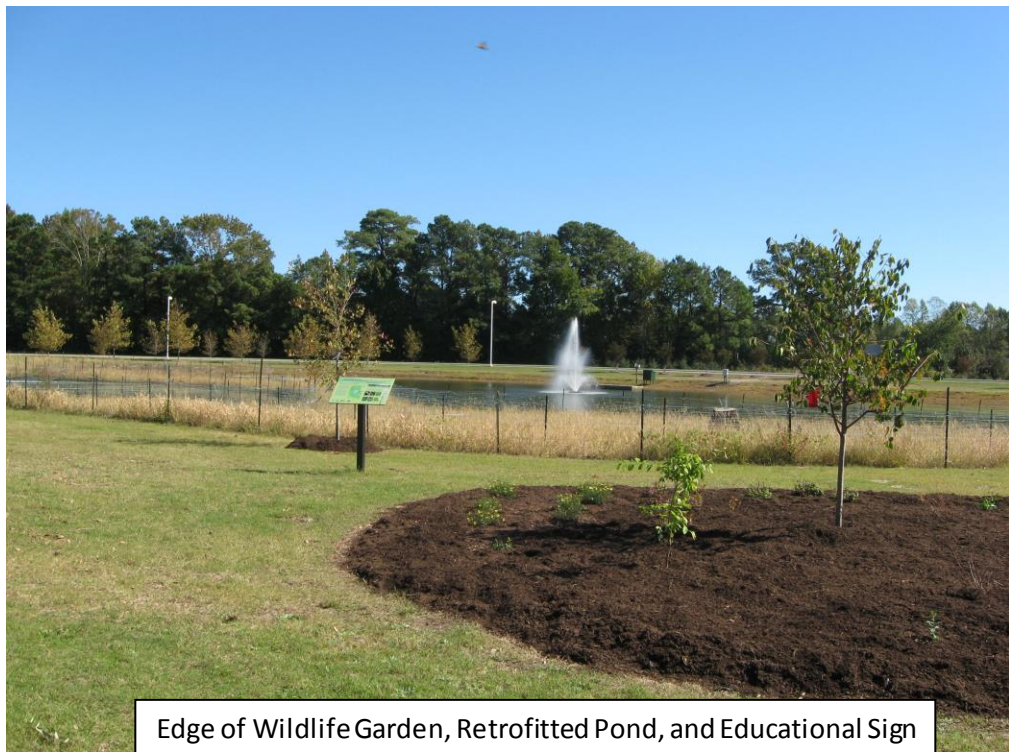
Exhibit G: continued wildlife garden, etc

Edge of Wildlife Garden, Retrofitted Pond, and Educational Sign
