Final report for the Albemarle-Pamlico National Estuary Program (APNEP) project. “Recycling fishing gear to enhance shellfish productivity and improve local water quality.”

Report Date: September 6, 2011

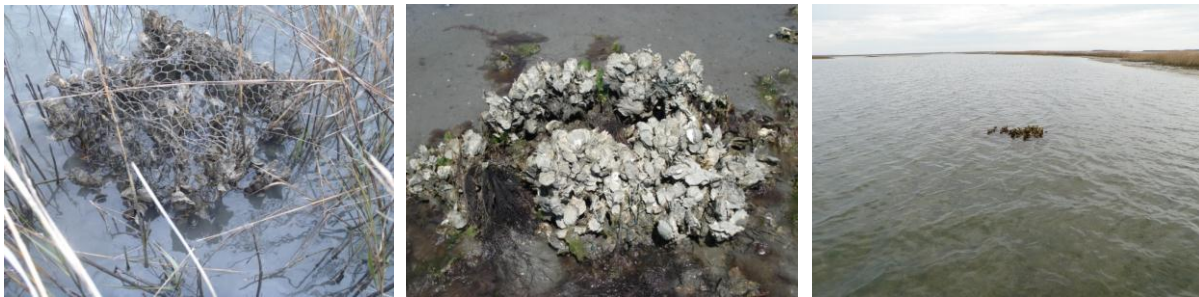
Figure 1. Derelict crab pots found in Middle Marsh already colonized by oysters.

Our observations and anecdotal experience suggest that crab pots, if located in the right conditions, could serve as ideal settlement and feeding habitat for eastern oysters in shallow water environments (Fig. 1). Mechanistically, the vertical structure provided by crab pots raises spat off the bottom where small predators (mud crabs, drills) are less likely to forage effectively, and enhanced flow equates to enhanced oyster growth. Moreover, crab pots are likely unsuitable habitat for biogenic borers that can flourish in marl or scattered shell (Niels Lindquist, pers. comm.).

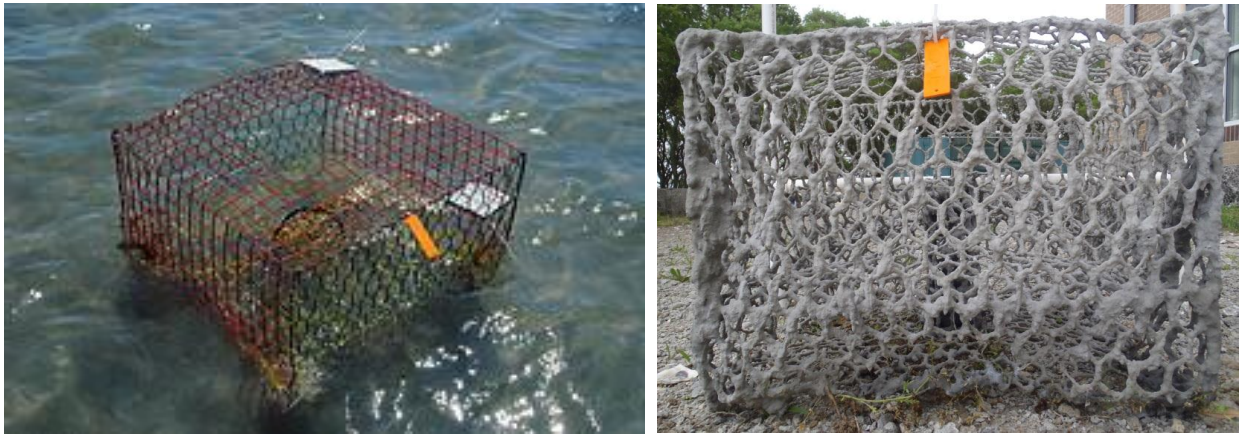
Figure 2. Examples of refurbished, recycled crab pots deployed as oyster settlement substrate. Note the removal of entrance funnels (both images) and addition of 1. Exit portal at top (left); 2. settlement plates (left), concrete coating (right), ID tags (both), and rebar anchor (left).

collect ~ 320 derelict crab pots (50% of the pots were obtained from the debris removal program in VA, while the remaining 50% were obtained from the NC sweep). These pots were transferred to UNC-IMS and refurbished prior to deployment. All pots were cleaned (powerwashed) and refurbished by removing all entry funnels, leaving 4 easy-to-access holes in the lower chamber, and cutting a 15cm hole in the roof of the upper parlor. Thus, crabs, fishes and turtles should be able to access pots without becoming entrapped. All pots were assigned a unique ID number and labeled with a permanent plastic tag. Individual pot characteristics were documented, such as overall condition (e.g., decay level, physical damage), color, and coating type (see attached Excel file). One third of the pots (evenly distributed among VA and NC style pots) were given two coats of concrete to further test for effects of material type on oyster settlement (Fig. 2).

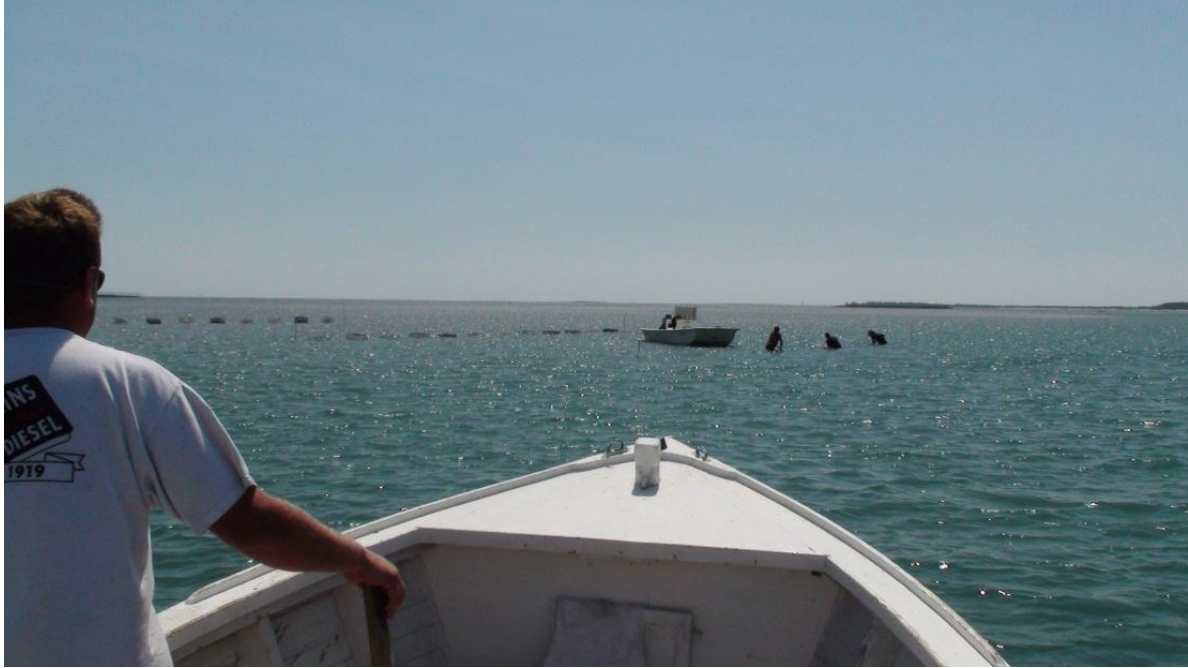
Figure 5. Sets of 12 crab pots deployed at “shallow” (~ -0.4 m NAVD88; left) and “medium” depths (~ -0.7 m NAVD88, center) in the Rachel Carson National Estuary Research Reserve. This photo shows the PI and commercial fishermen deploying the 12 “deep” pots (~ -1.0 m NAVD88; submerged).

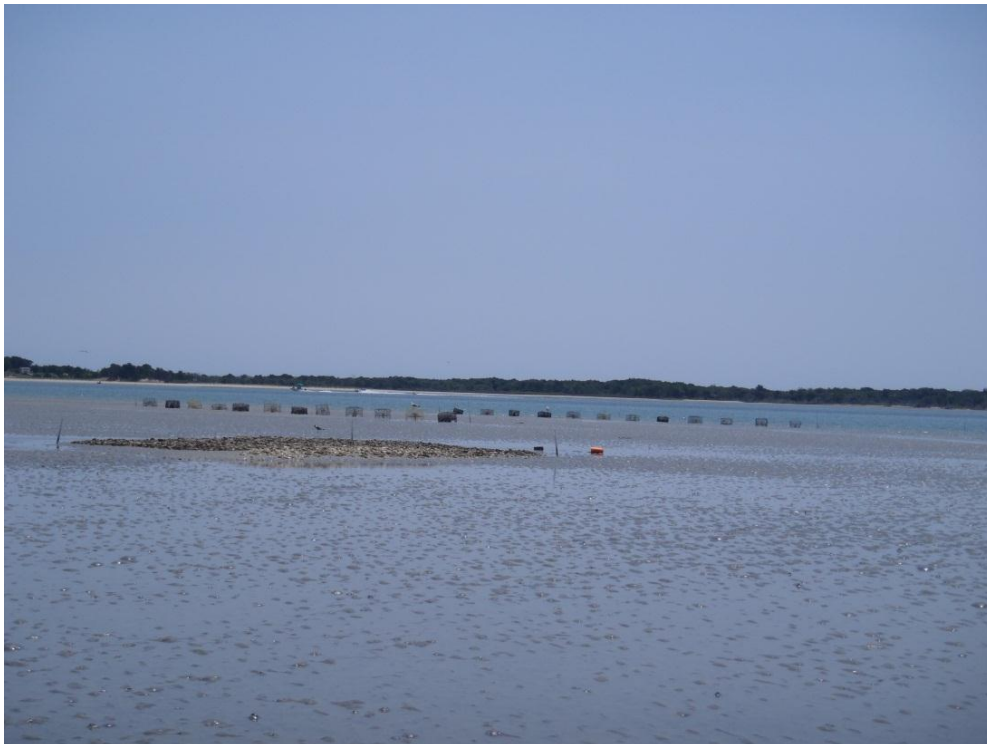
Figure 6. The 36 Middle Marsh crab pots deployed in proximity to one of the 32 cultch shell oyster reefs (foreground) constructed in the spring of 2011 by Lindquist, Fodrie and Rodriguez utilizing APNEP funding. Photo by Jim Hawhee.

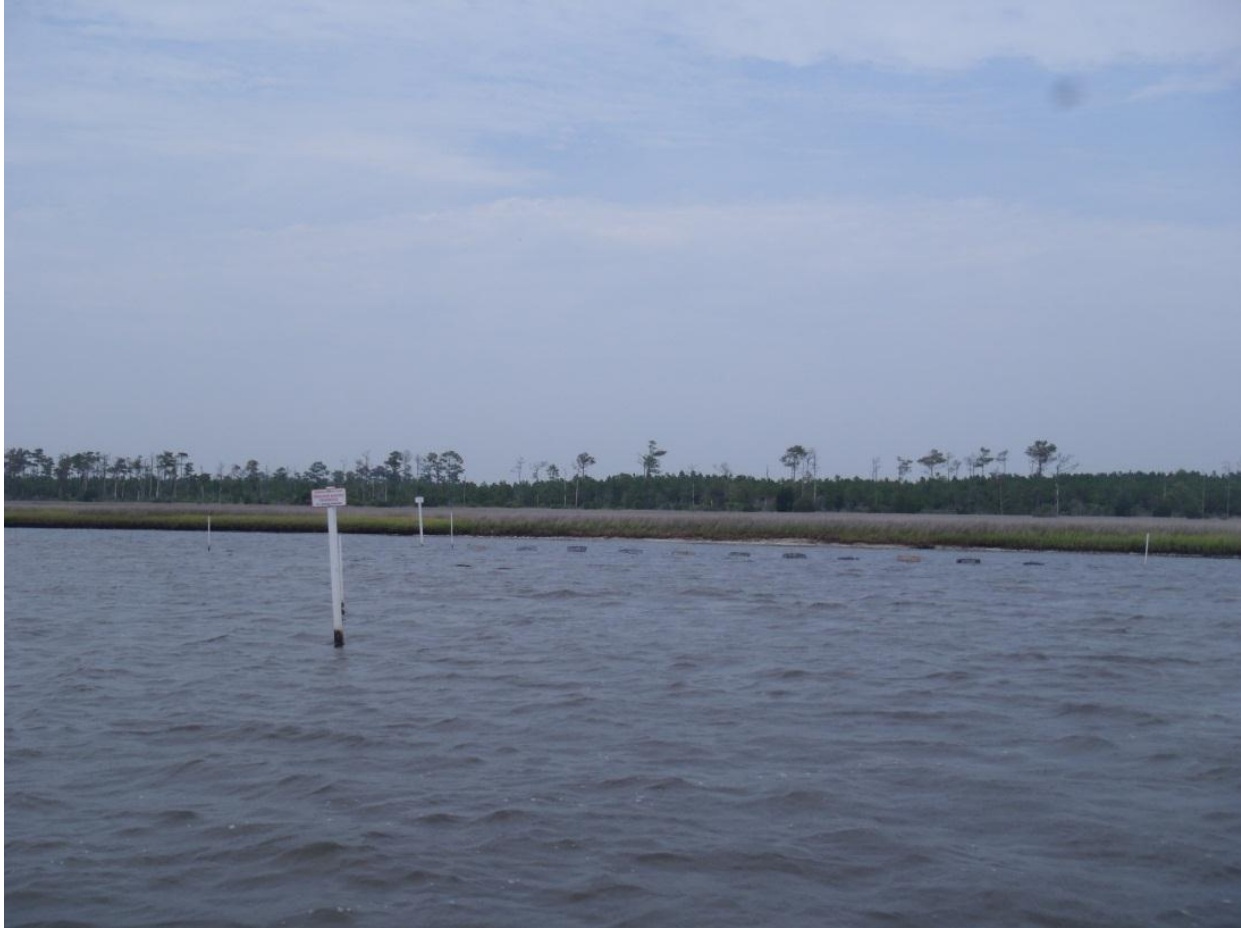
Figure 7. Crab deployed against the marsh bank within Oyster Creek. Only the “shallow” set of crab pots ($N = 12$) are visible. The remaining 24 crab pots deployed in oyster creek are in 2 lines that run parallel to the “shallow” set, but are submerged at the time this picture was taken.

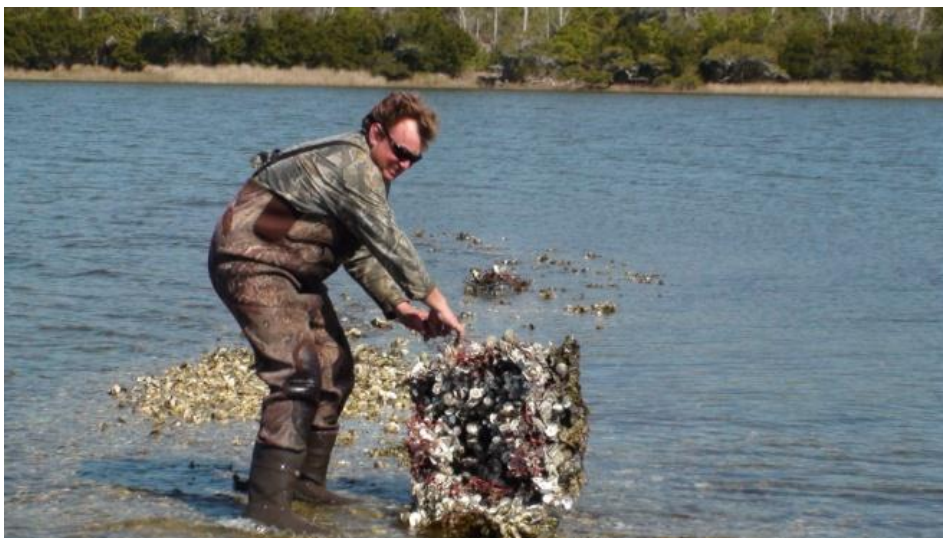
Figure 8. Commercial Fishermen handling a derelict crab pot covered in oysters during a recent survey of intertidal shorelines in the Back Sound area.

Following deployment, pots have been allowed to collect oyster spat and other fouling organisms naturally (ongoing, see preliminary observations below). We also began conducting stratified random surveys within the North River–Straits–Back Sound region (including all to the Rachel Carson NERRS) to document the occurrence, condition and oyster coverage of intertidal derelict crab pots. We have randomly identified ten 1km sections of shoreline for surveying. All pots encountered during these shoreline surveys are being imaged using a standardized photoquad. Using these images, we will evaluate how salinity, depth, habitat context and pot type/condition affect the settlement and growth of oysters (Fig. 8).
