River Herring Habitats

SEARCHING THE CHOWAN RIVER BASIN

CHAPTER 2
THE CHOWAN RIVER CORE WETLAND RESERVE AND THE
DEVELOPMENT OF THE MODEL TO IDENTIFY AND
PRIORITIZE THE PRESERVATION AND RESTORATION OF
RIVER HERRING HABITAT 11

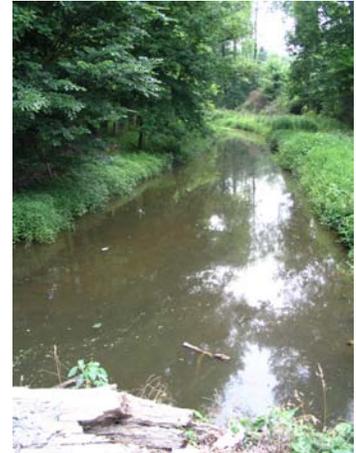
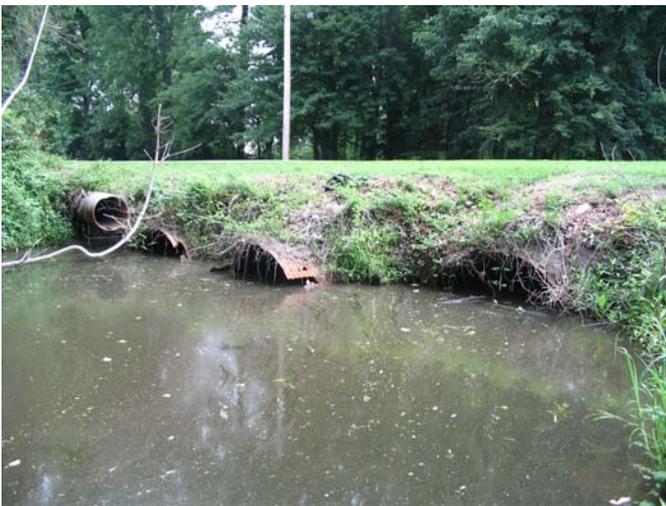
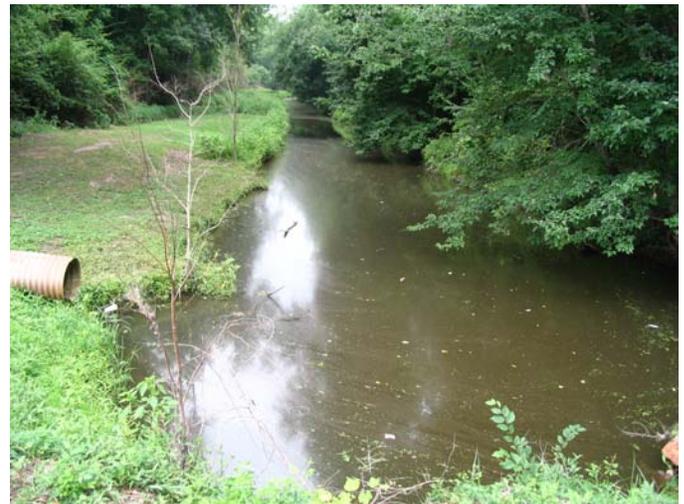
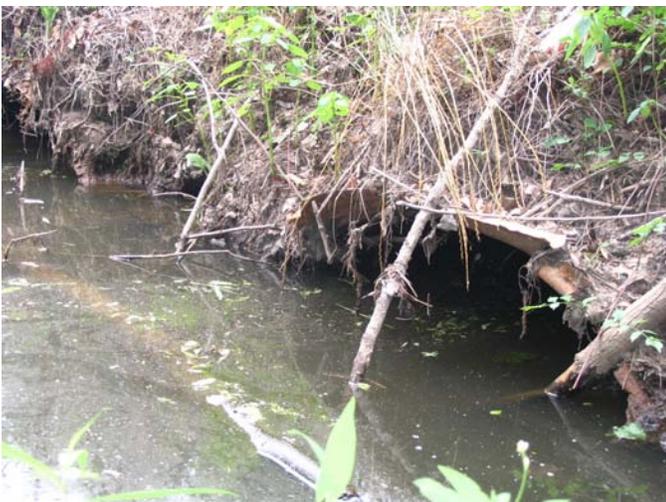
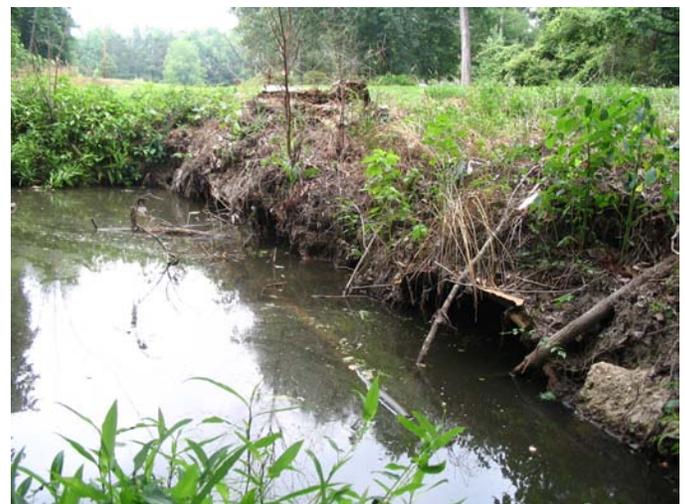
Site ID: 2

than one foot, and the depth was no more than three feet in the center of the channel.

Flow through the culverts was minimal. Two turtles and a few small fish were observed in the upstream habitat.

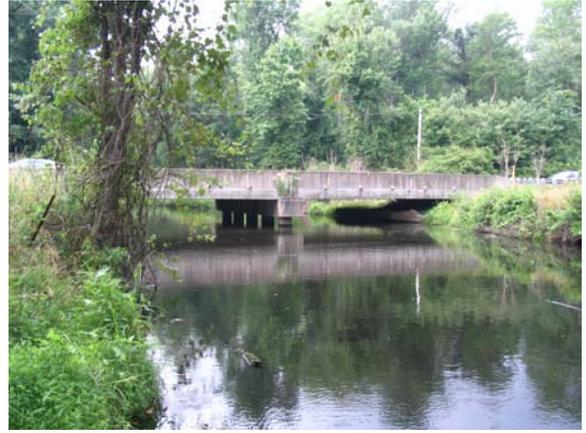
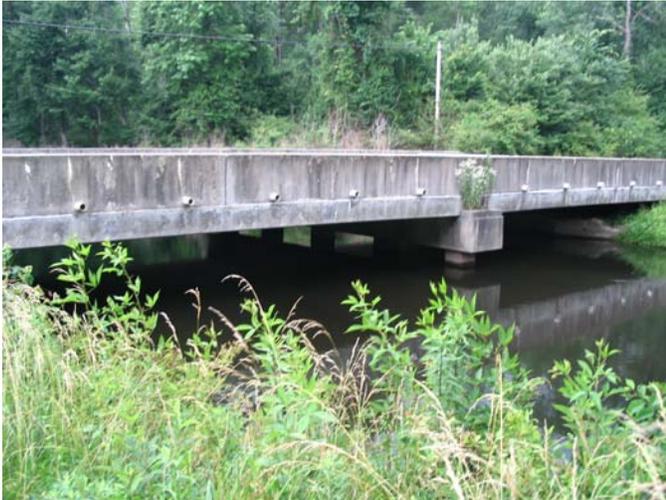
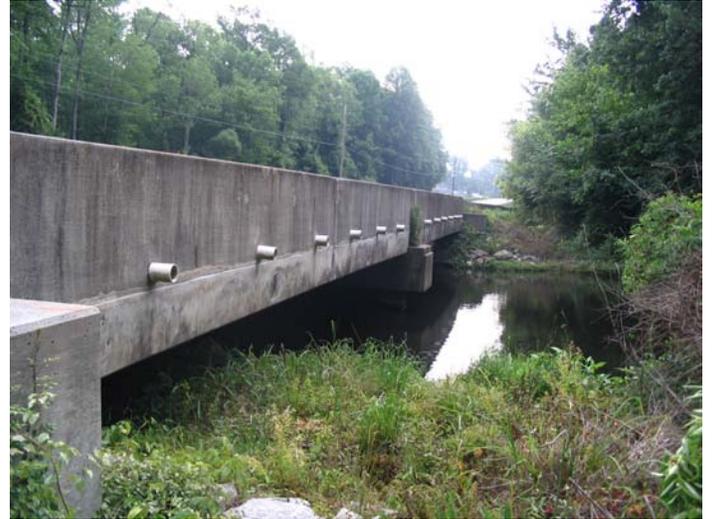
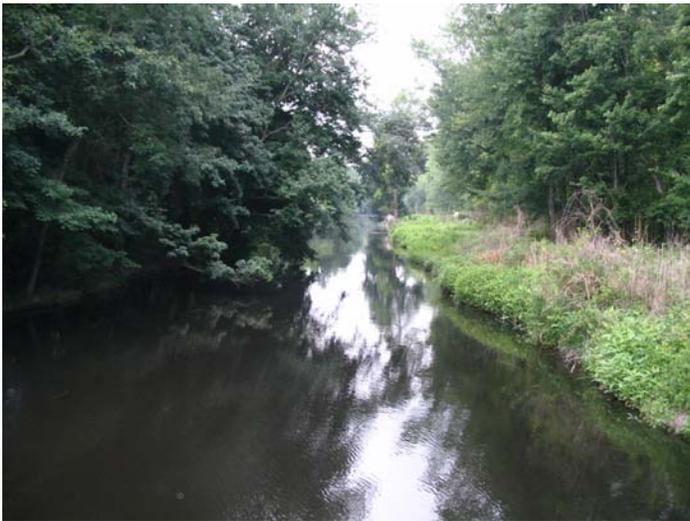
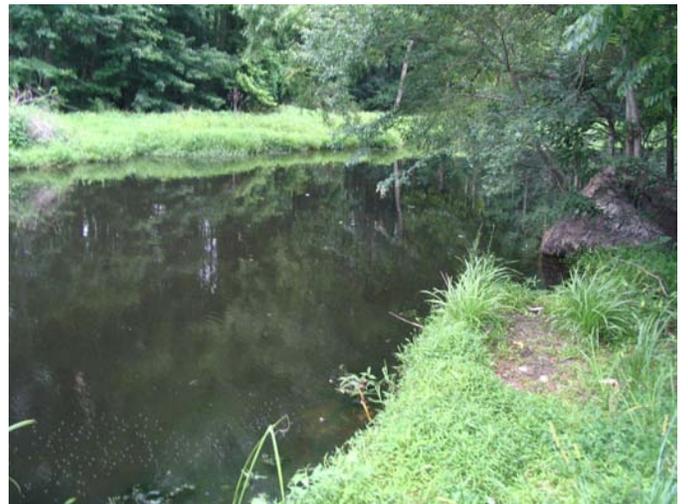
Site ID: 3
Type: Bridge
Location: NC 32
Water Body: Pollack Swamp
Date Sampled: 6/20/2007

Collier reported a vegetative dam located at this spot, but none was observed. At this location there is a concrete bridge with approximately three feet of clearance over the stream. The stream has a slow flow. Both upstream and downstream habitat looks adequate for spawning.

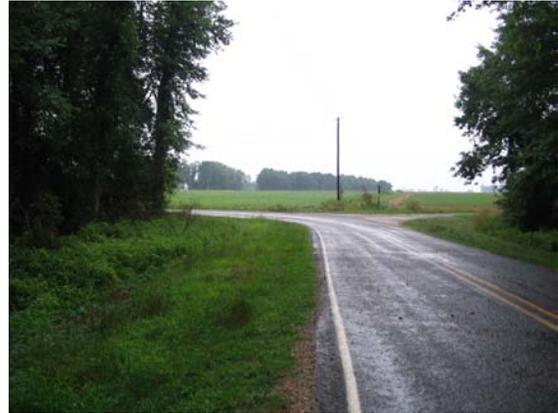
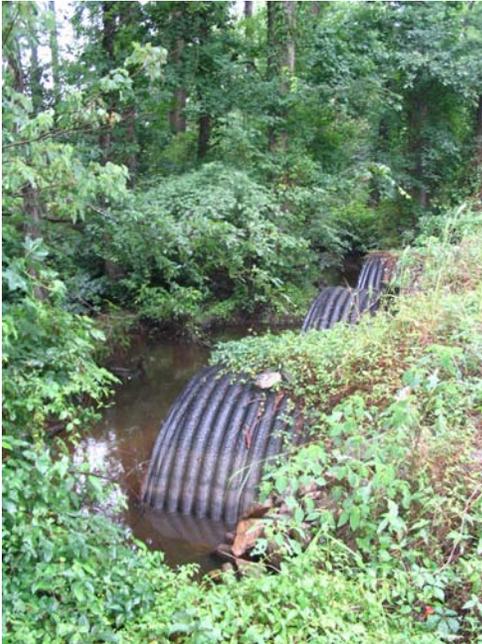
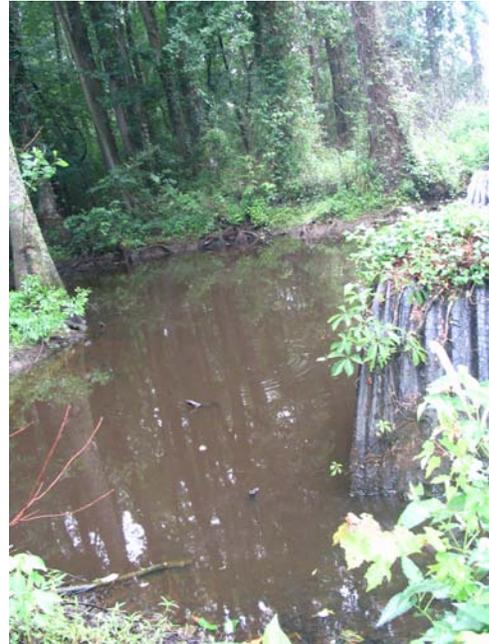
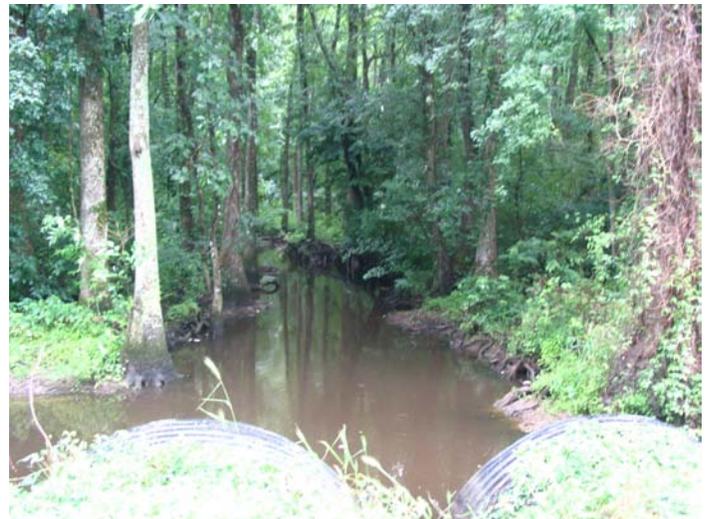
Site ID: 4
Type: Pipe Culvert
Location: off NC 32 (SR 1309 and 1306)
Water Body: Indian Creek
Date Sampled: 6/20/2007

The obstruction observed at site four was three pipe culverts. The culverts appeared to be relatively new. The pipe culverts had approximately three feet of clearance over the stream. The stream had less than one foot visibility and had a slight flow. Habitat upstream and downstream looked adequate for river herring. Adjacent to the stream at this location were agricultural fields with a buffer of forest along the stream bank.

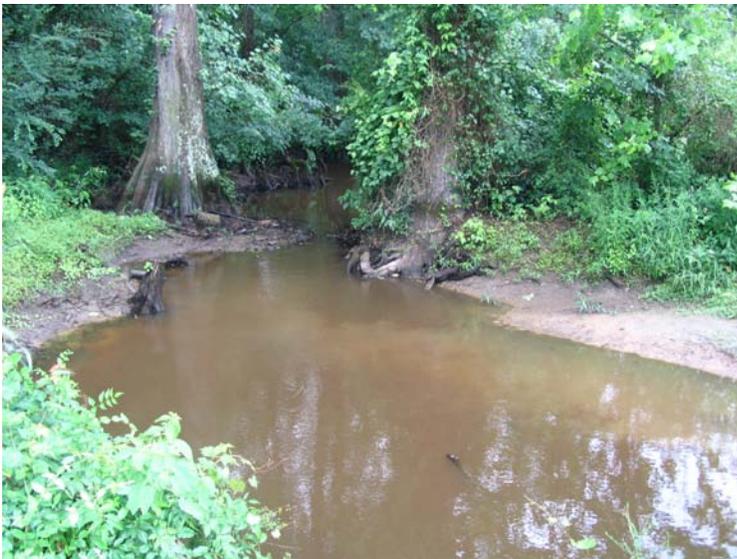
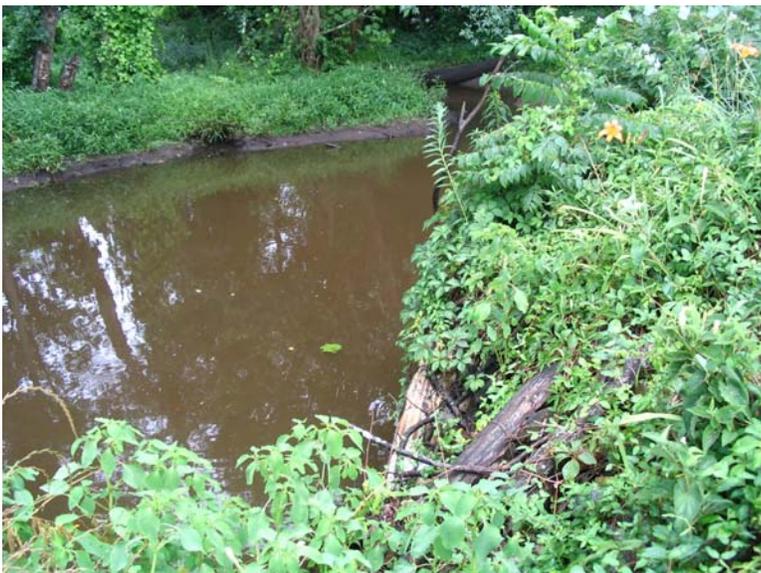
Site ID: 5

Observations: It was hard to get an adequate look at the pipe culverts at this site, due to the growth of vegetation around the structure. There appeared to be two culverts with a diameter of approximately three feet each. The distance from the top of the culvert to the creek was approximately two feet. The creek appeared to be shallow. The land around the creek was forested.

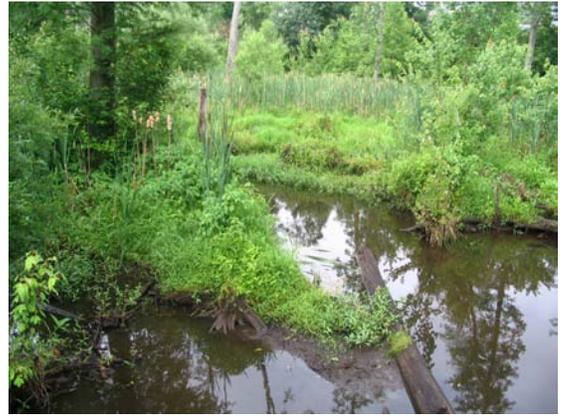
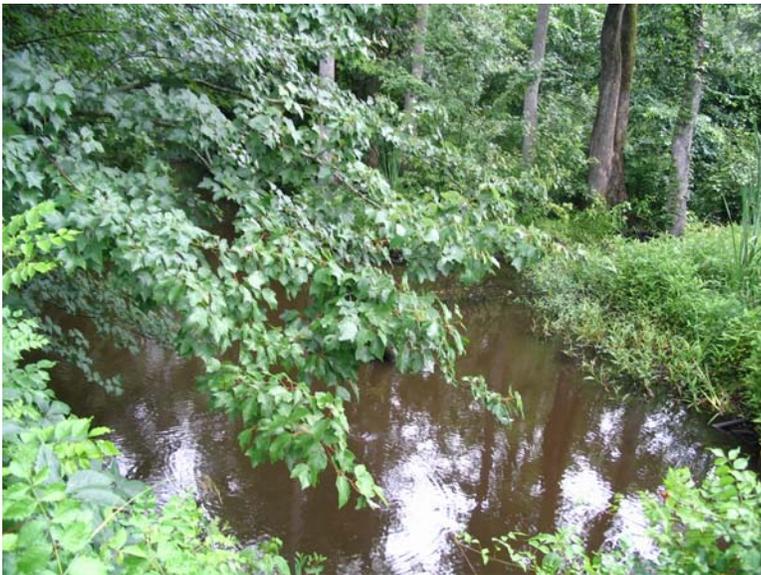
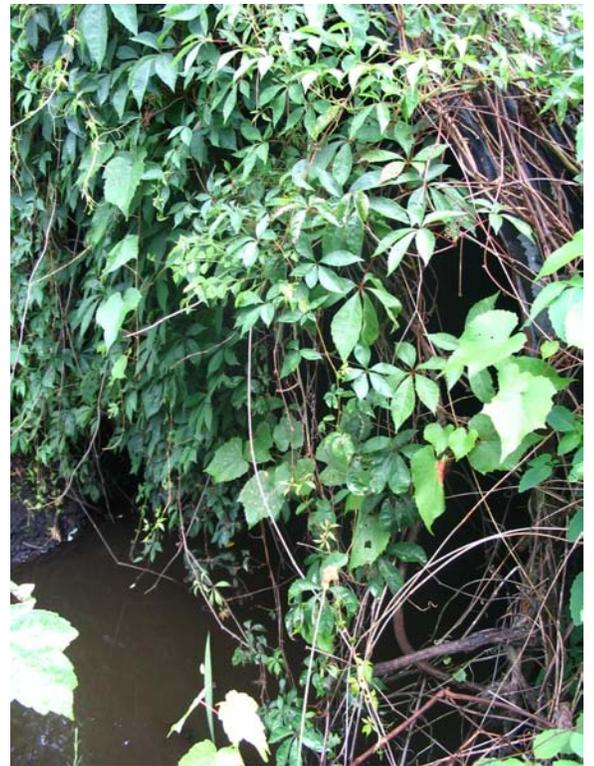
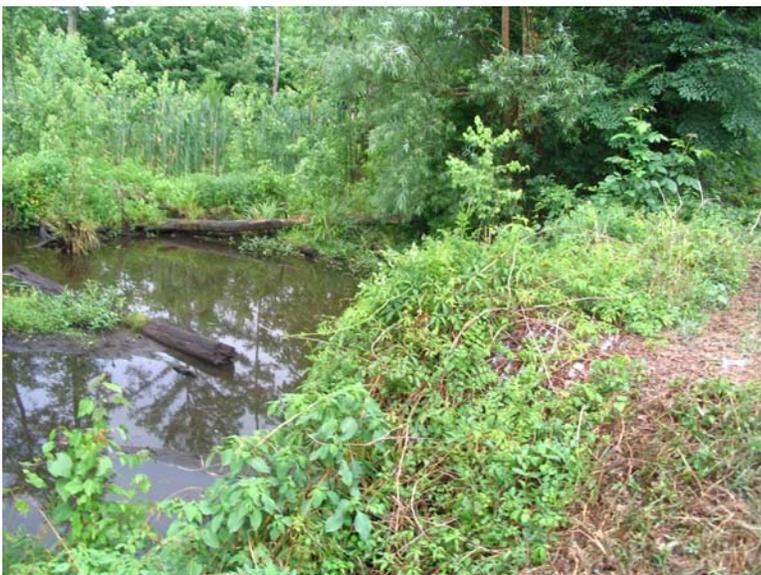
Site ID: 6
Type: Pipe Culvert
Location: off NC 32 (SR 1308)
Water Body: Indian Creek
Date Sampled: 6/20/2007

Observations: At this site there were two pipe culverts with a diameter of approximately six feet. The culverts had a significant amount of vegetation growing on them, which made it appear that they have been here for awhile. The vegetation appeared to restrict the amount of light that could enter the culvert. The distance from the top of the culvert to the creek was approximately four feet. The site was surrounded by forest and marsh and appeared to be adequate habitat for river herring.

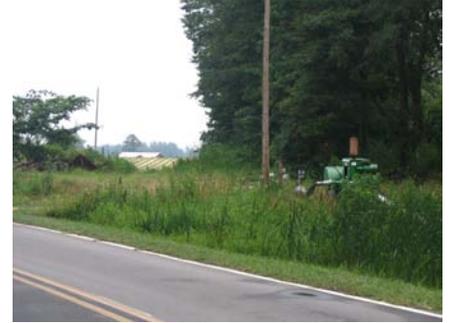
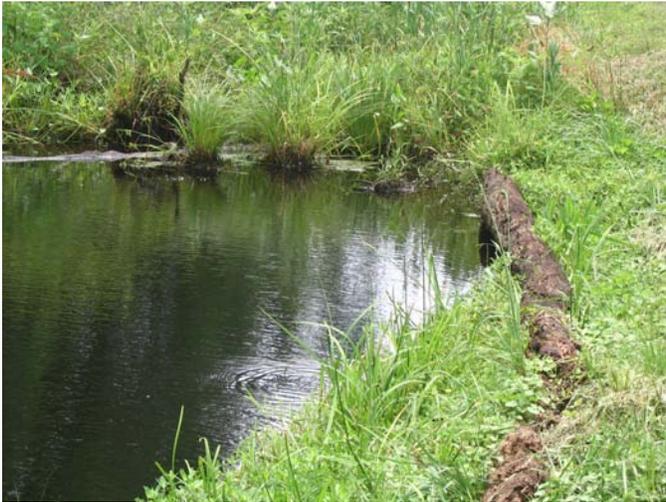
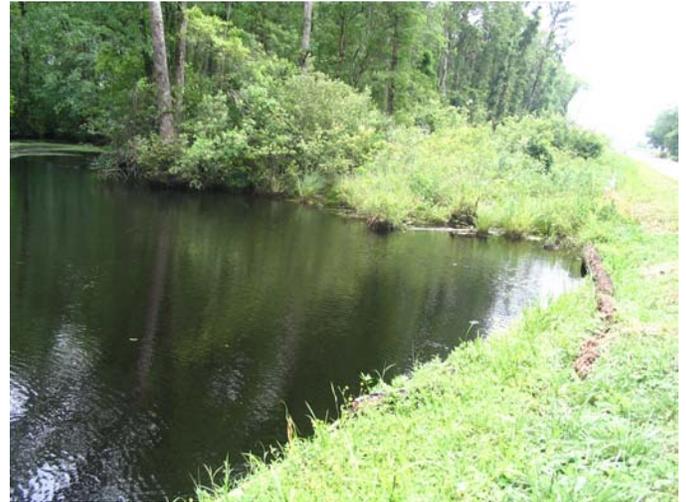
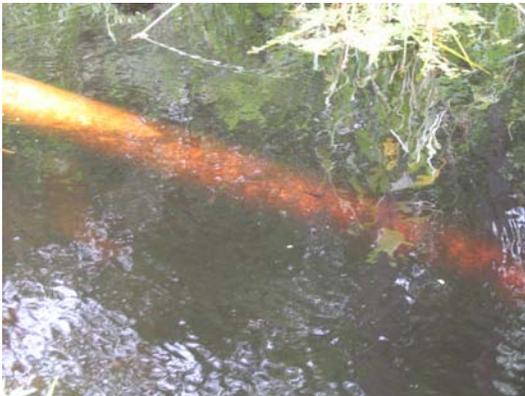
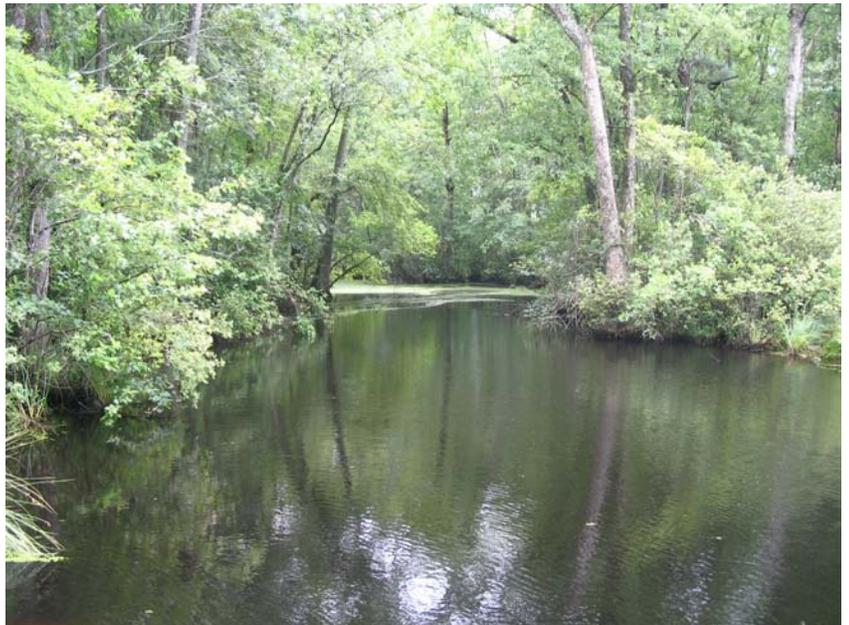
Site ID: 7
Type: unknown
Location: off NC 32 (SR 1232)
Water Body: Stumpy Creek
Date Sampled: 6/20/2007

Observations: The obstruction at this site is unknown because the creek came right up to the road. It might have been a bridge as listed by Moser and Terra. It may have also been a pipe culvert or a RCRB. Either way this obstruction would not adequately meet the requirements for passage by river herring. Many little fish were observed swimming and the area did seem to potentially be good habitat for river herring. The area surrounding the creek was agricultural land, with a forested buffer along the creek bank.

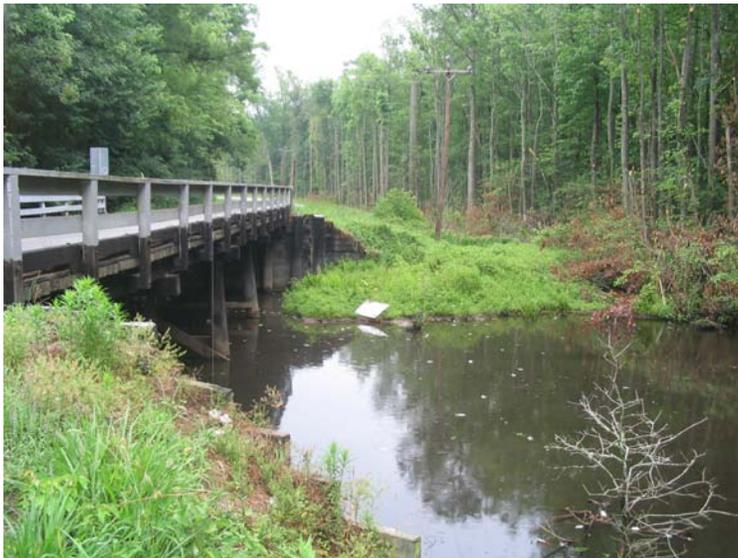
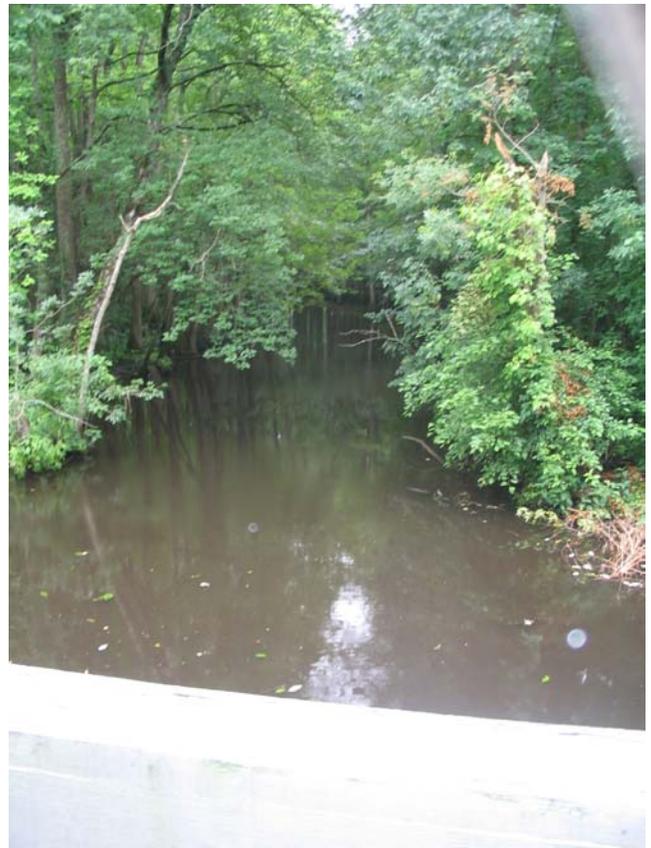
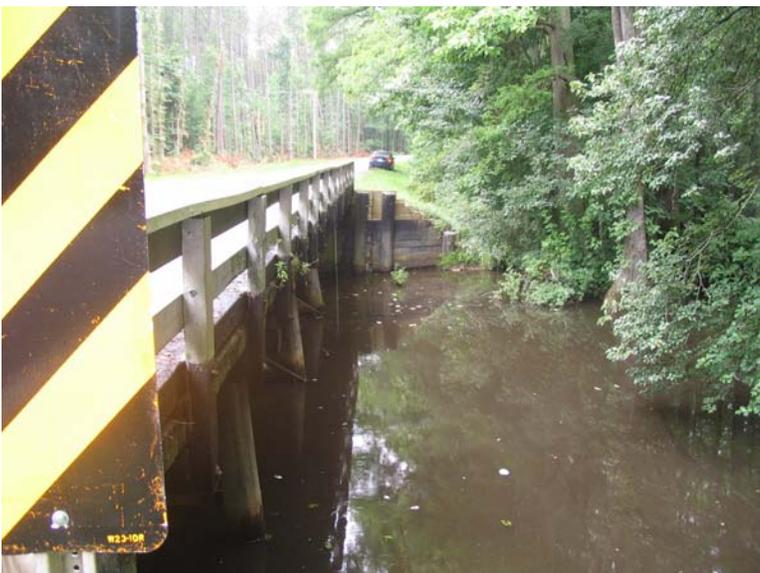
Observations:
Located off of NC 36 between Tyner and Gatesville, site nine is a bridge over Trotman Creek. It is approximately five feet over the creek. The habitat at this site is good, and would be adequate for river herring. The area surrounding the creek is forested.

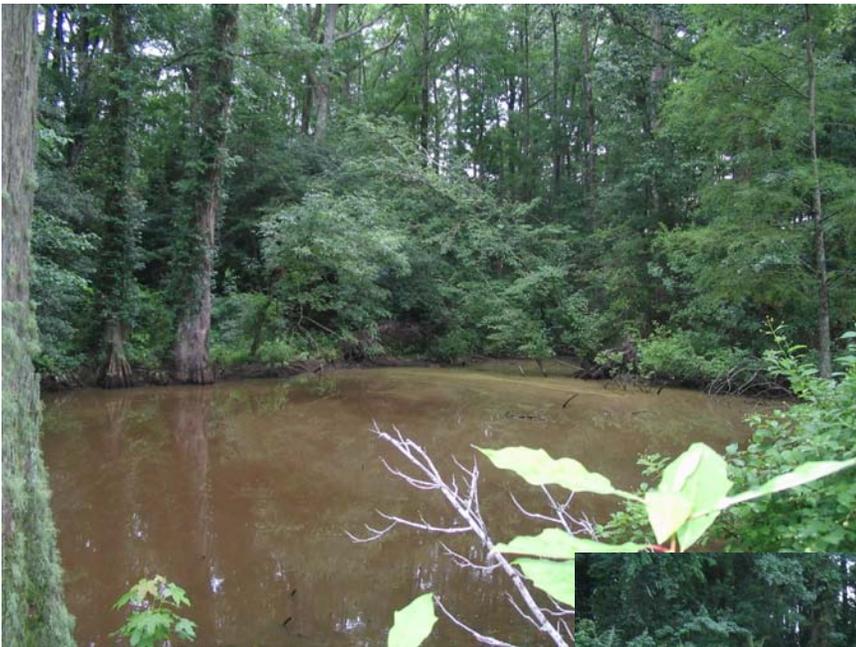
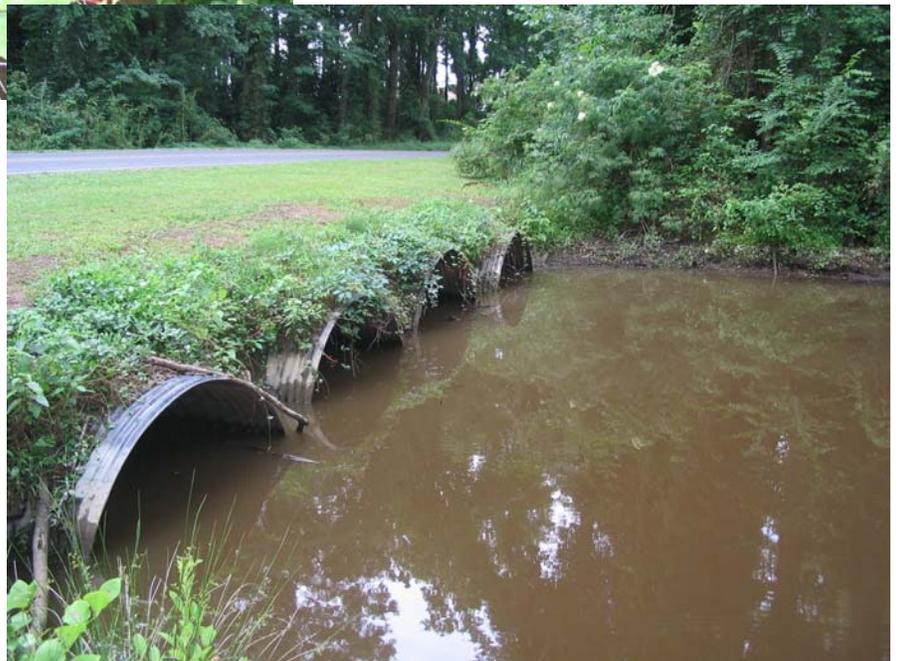
Site ID: 10

There are four metal pipe culverts at site ten. The diameter of each culvert is approximately four feet. There is only a slight amount of vegetation hanging over the opening. The culverts show slight deterioration, but are otherwise in good condition. The length of the culvert is approximately forty-five feet. The habitat in the surrounding area is forested. Walton Pond is a tributary off of Trotman Creek.

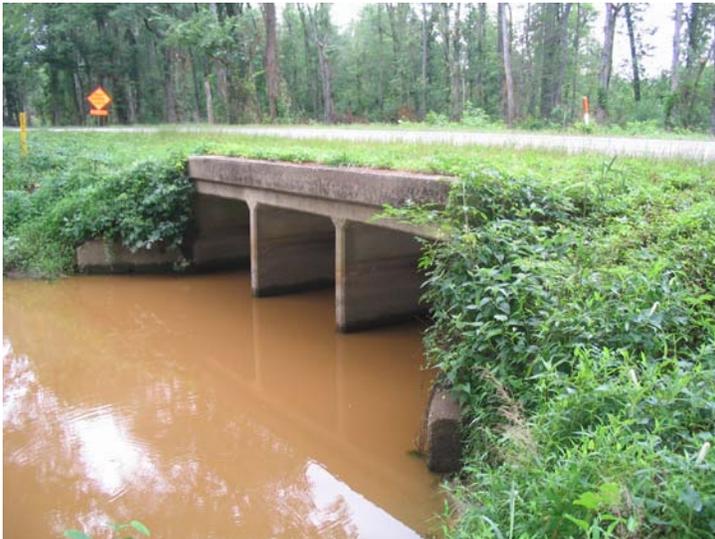
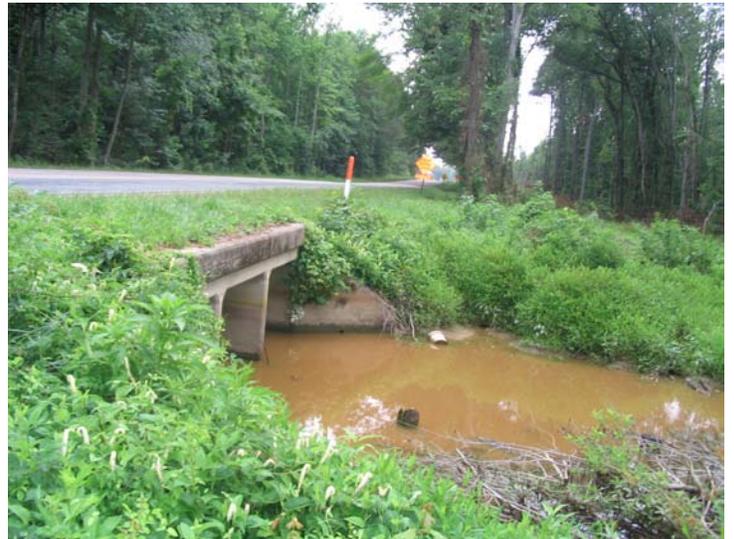
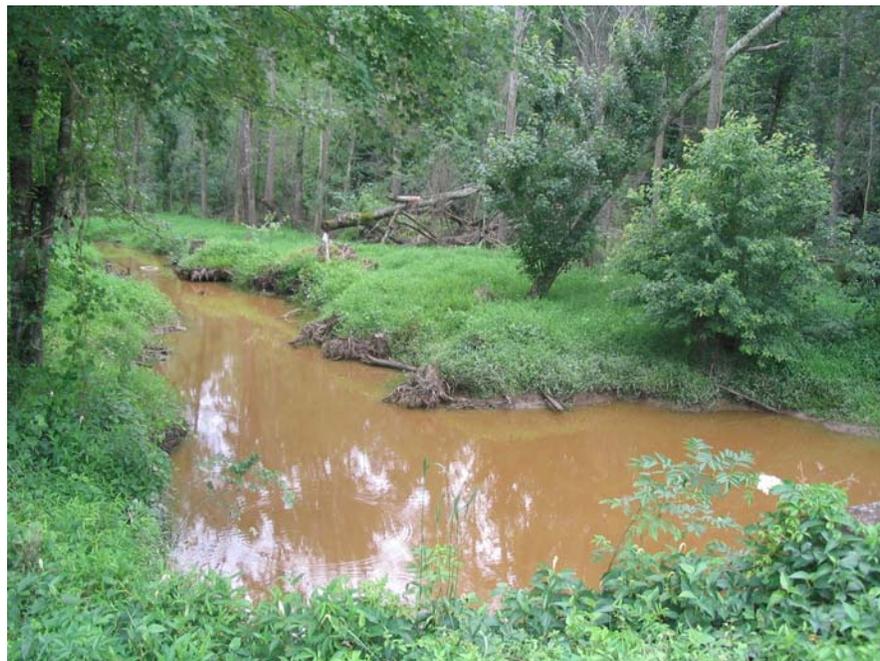
Site ID: 12
Type: RCRB
Location: on NC 32
Water Body: Walton Pond
Date Sampled: 6/20/2007

Site twelve is a RCRB on NC 32 outside of Gatesville. It is over Walton Pond, which is a tributary of Trotman Creek. The bridge has approximately a four foot clearance over the stream. The habitat upstream looks adequate for river herring. There is minimal flow in stream, and there is minimal visibility.

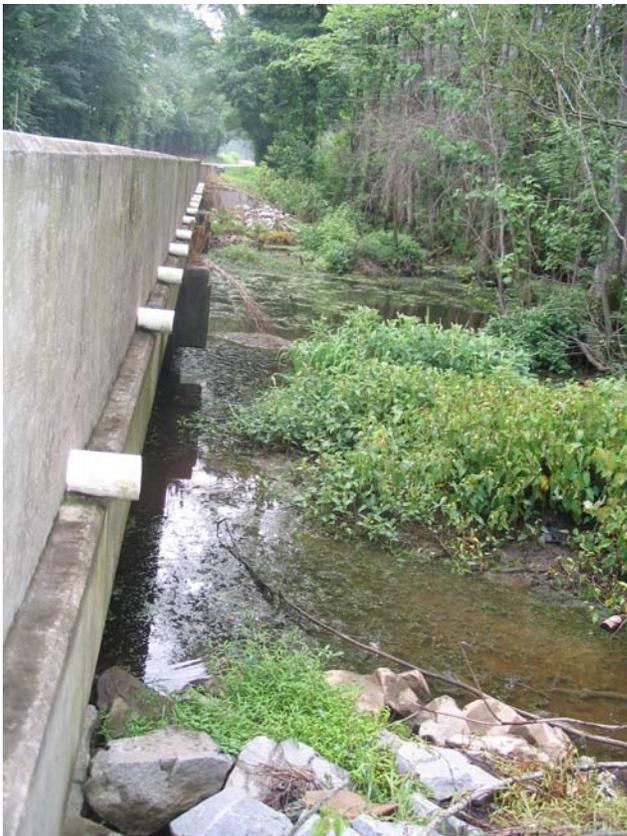
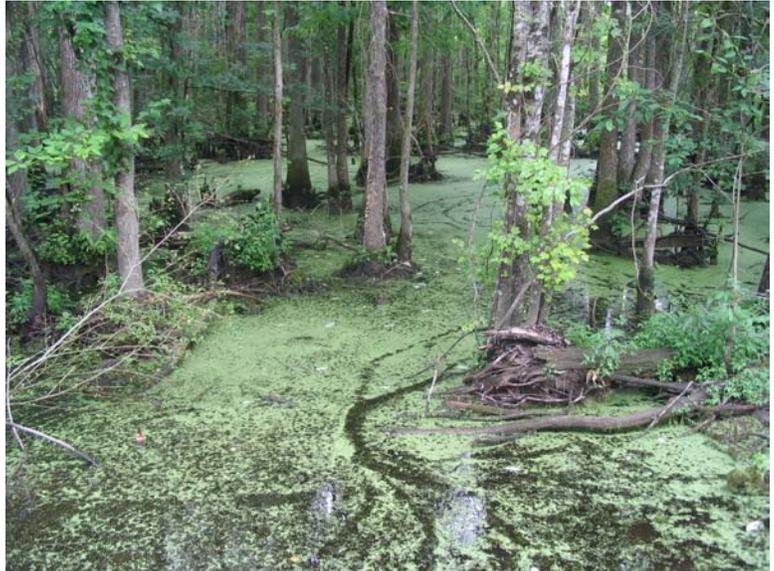
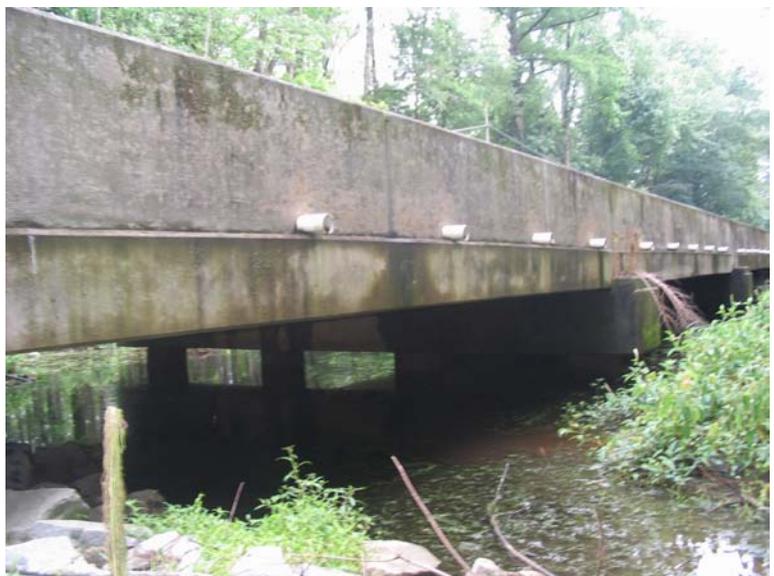
Site ID: 15
Type: Bridge
Location: off NC 37 (SR 1220)
Water Body: Cole Creek
Date Sampled: 6/20/2007

Site fifteen is located between Gates and Gatesville, off of NC 37. At this site is a bridge over Cole Creek. The bridge is approximately three feet over the water. One white egret was observed in upstream habitat. Area around stream is forested. The stream is stagnant and there are many downed trees.

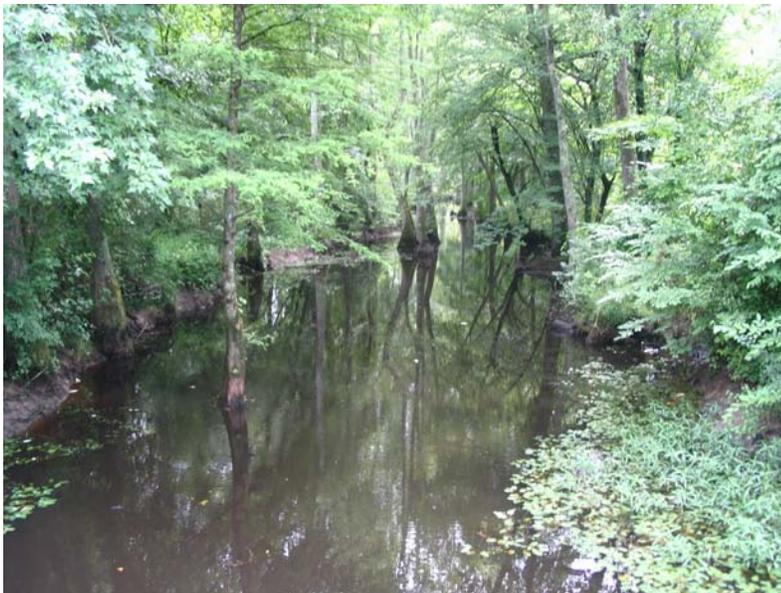
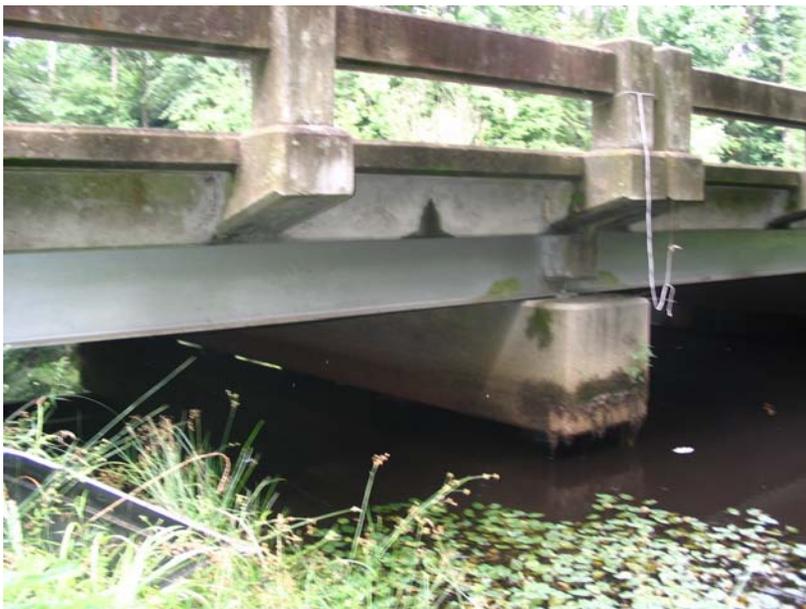
Site seventeen is a small bridge located between Gates, Gatesville and Sunbury. The bridge is approximately three feet over the water. There is minimal flow in the river. The surrounding area is a forest buffer and then there are agricultural fields beyond the buffer. The habitat looks adequate for river herring.

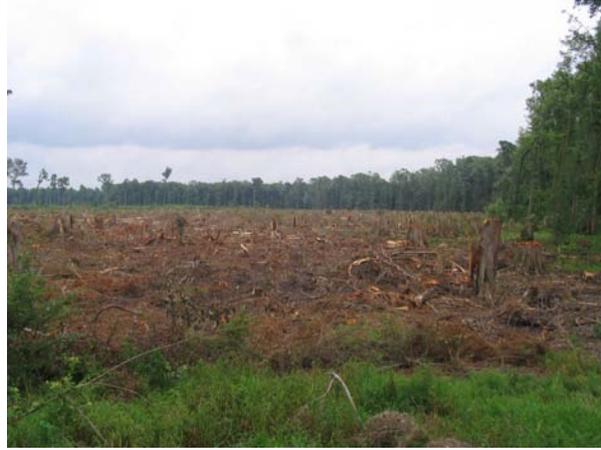
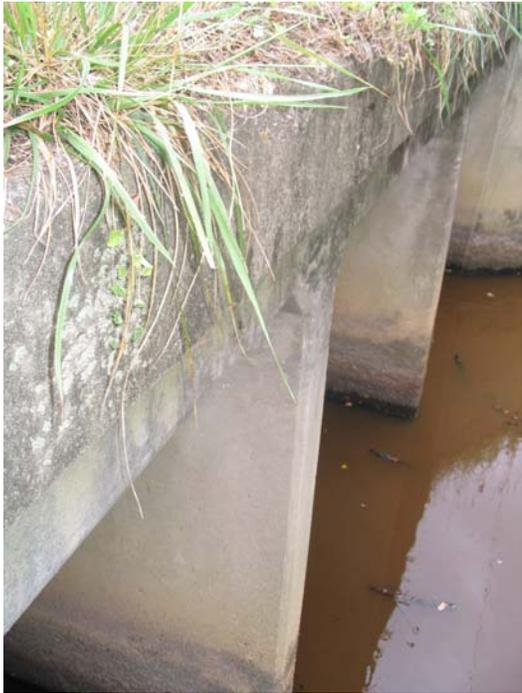
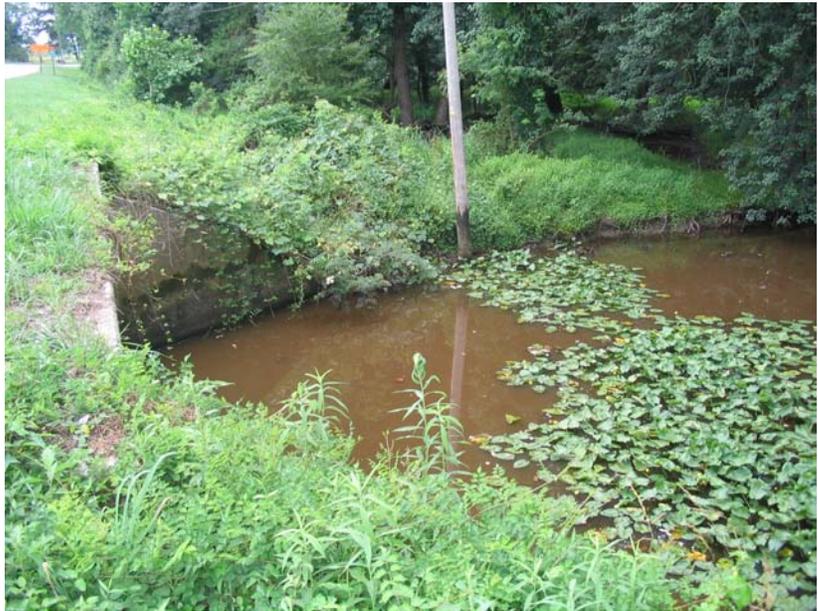
Site ID: 18

Moser & Terra, as well as NC DOT list this as a Bridge, but it was actually a RCRB. The stream was approximately five feet below the top of the RCRB. There was a forest buffer along the stream. Beyond that there was clear cutting on either side. This was a small stream and the clear cutting may have an impact on the quality of the habitat.

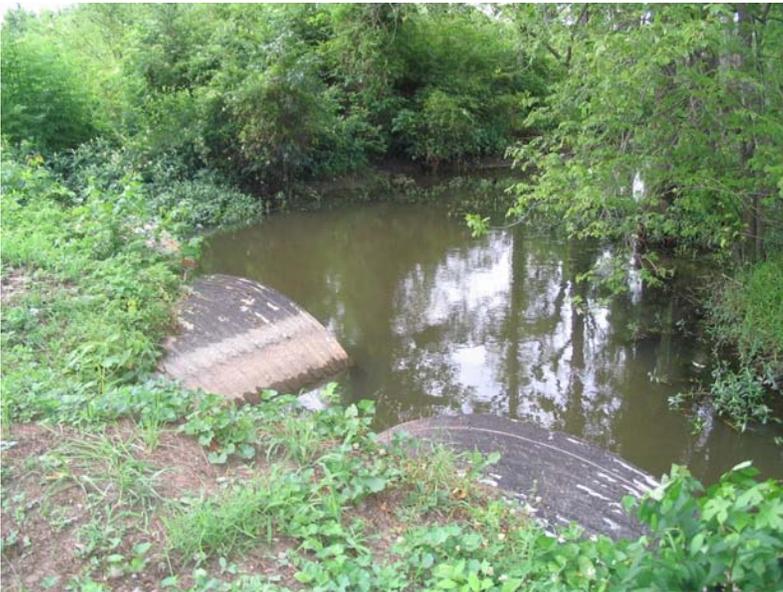
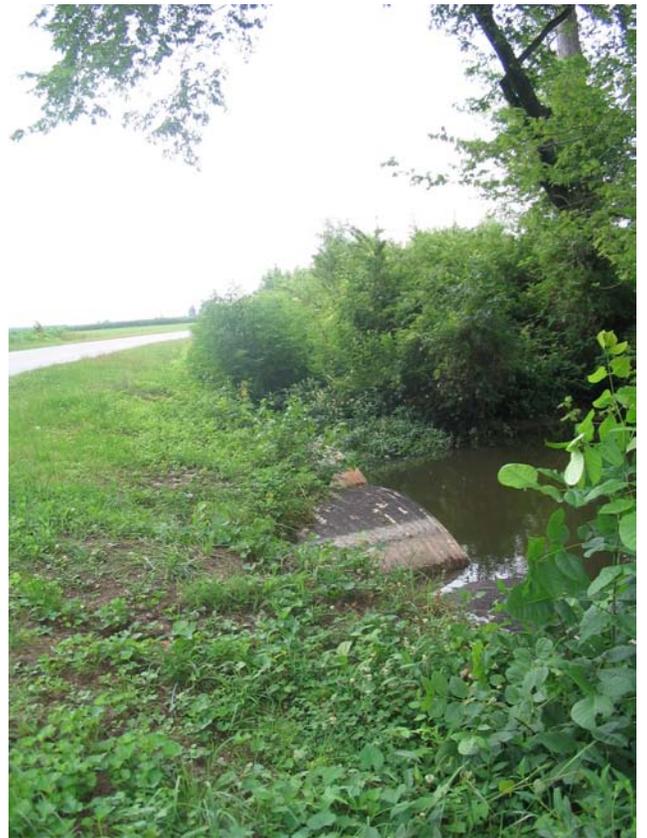
Site ID: 20

The site had three black pipe culverts. There is a significant amount of agricultural fields beyond the stream buffer, which is forested. Only the top two feet of the culvert is exposed, but the best estimate is that it is six feet in diameter. There is no observable flow in the river.

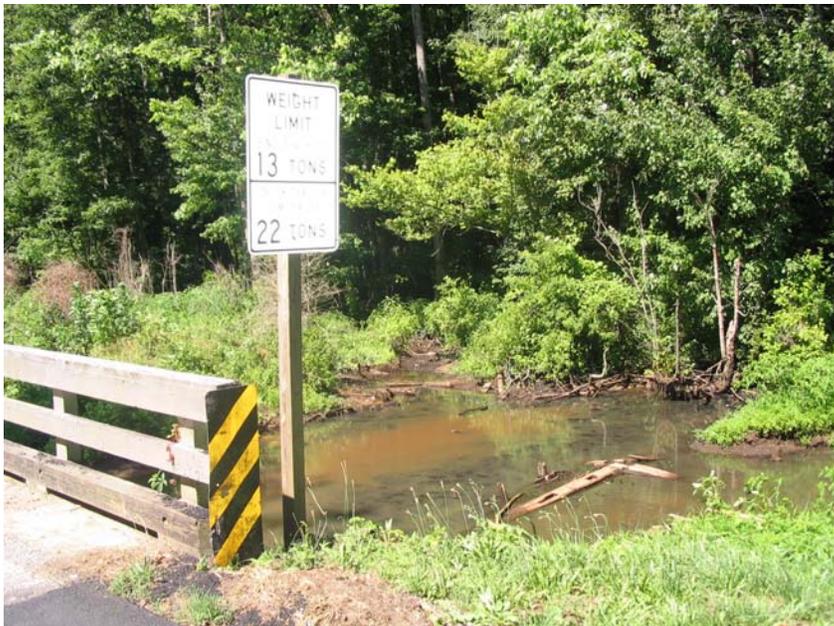
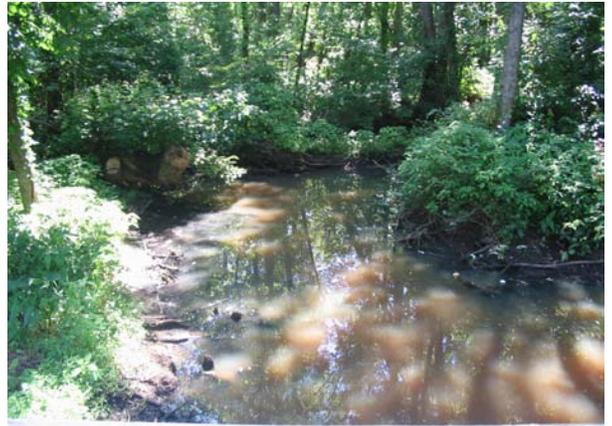
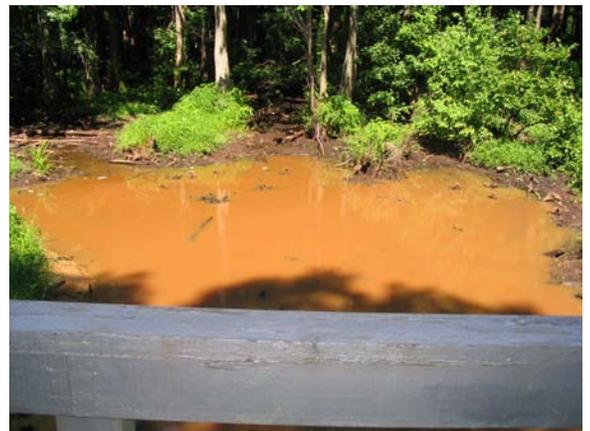
Site ID: 24 & 25

Site twenty-four and twenty-five are two older bridges over Black Walnut Swamp. Black Walnut Swamp is a tributary off the mouth of the Chowan. The stream is very shallow and some reaches appear to be dried out.

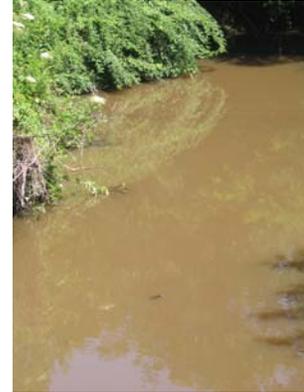
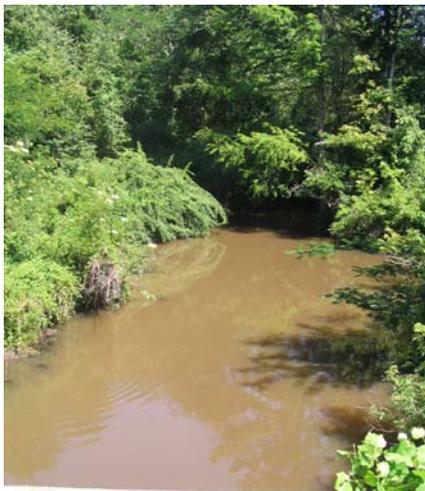
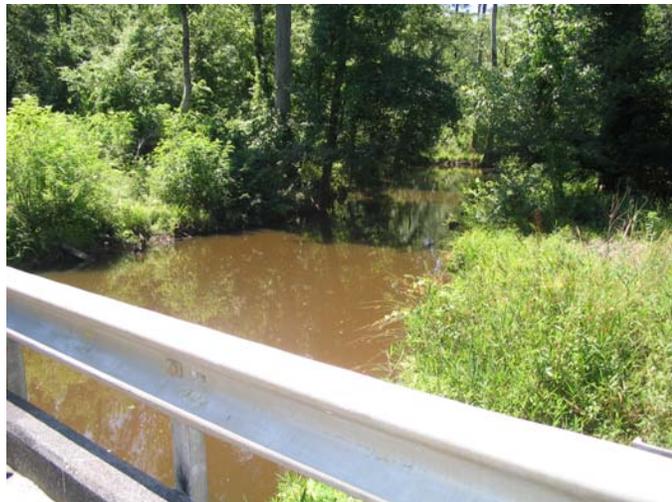
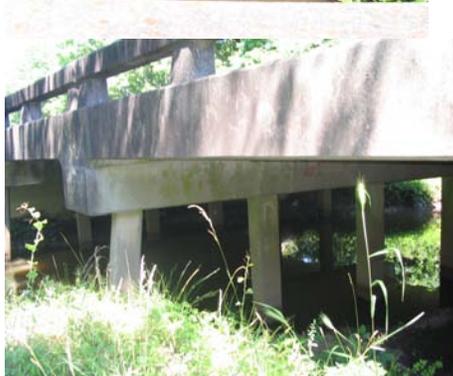
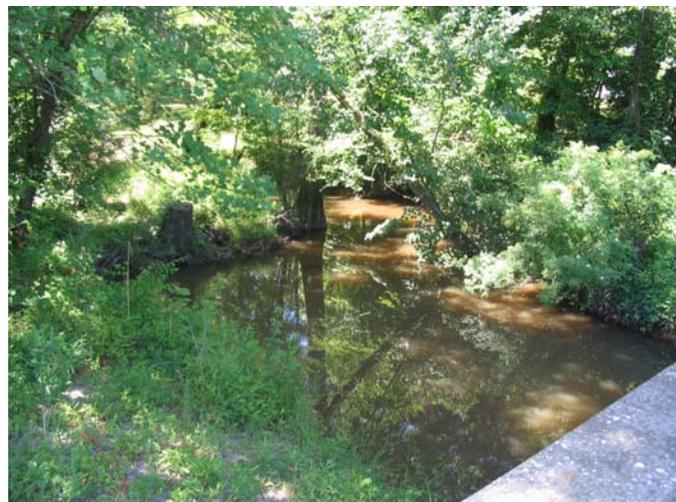
Site ID: 26
Type: Bridge
Location: over NC 45
Water Body: Salmon Creek
Date Sampled: 6/21/2007

Site twenty six is a bridge over Salmon Creek along NC 45. The bridge has approximately a four foot clearance over the stream. This site was originally classified as a beaver dam by Collier. However, no natural obstruction was observed wither upstream or downstream from this site. Further, river herring are known to be able to penetrate a beaver dam when migrating to spawn. The area along the stream is forested and appears to be adequate habitat. Turtles were observed basking on logs and swimming in the river.

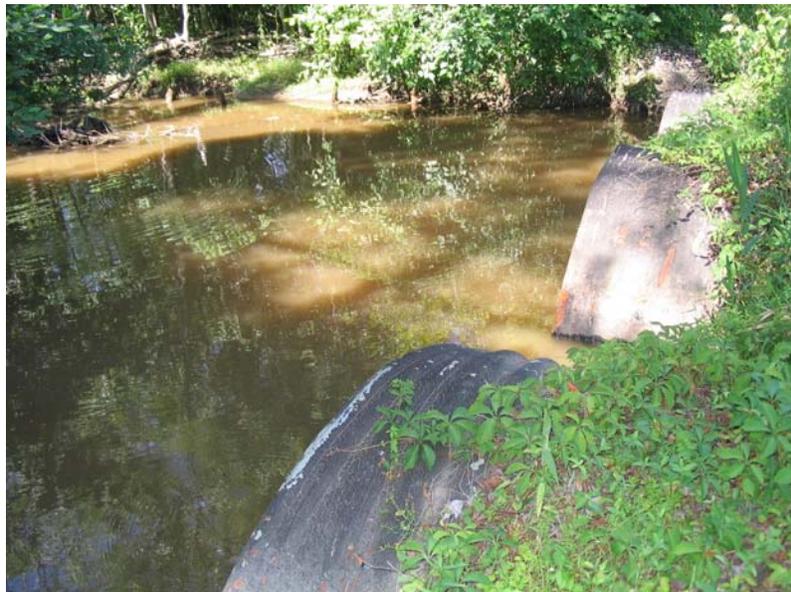
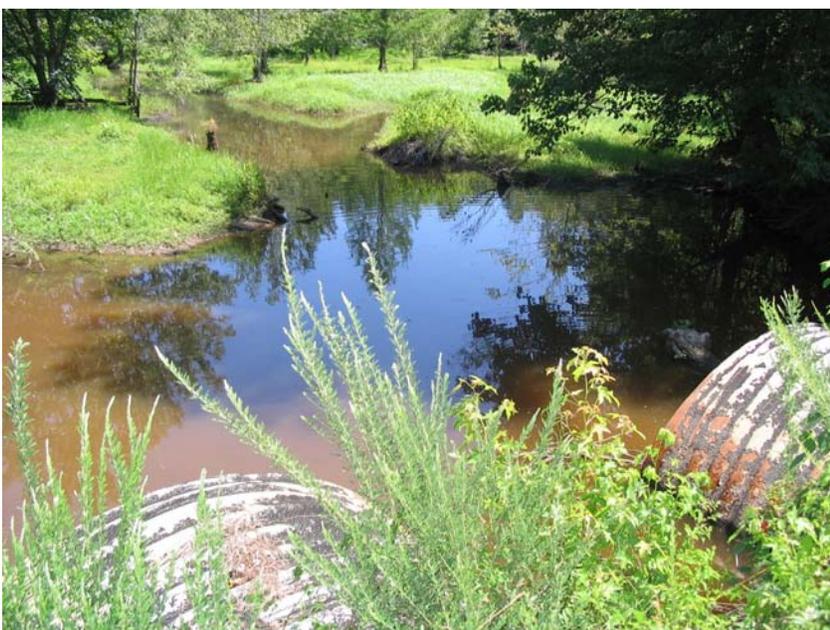
Site ID: 27

Off of NC 45, site twenty-seven has three pipe culverts, each with approximately a six foot diameter. The culverts are fifty-eight feet in length. The habitat looks adequate for river herring. The surrounding area is mostly forested, with some agriculture. Turtles were observed basking.
