River Herring Habitats

SEARCHING THE CHOWAN RIVER BASIN

CHAPTER 2
THE CHOWAN RIVER CORE WETLAND RESERVE AND THE
DEVELOPMENT OF THE MODEL TO IDENTIFY AND
PRIORITIZE THE PRESERVATION AND RESTORATION OF
RIVER HERRING HABITAT 11

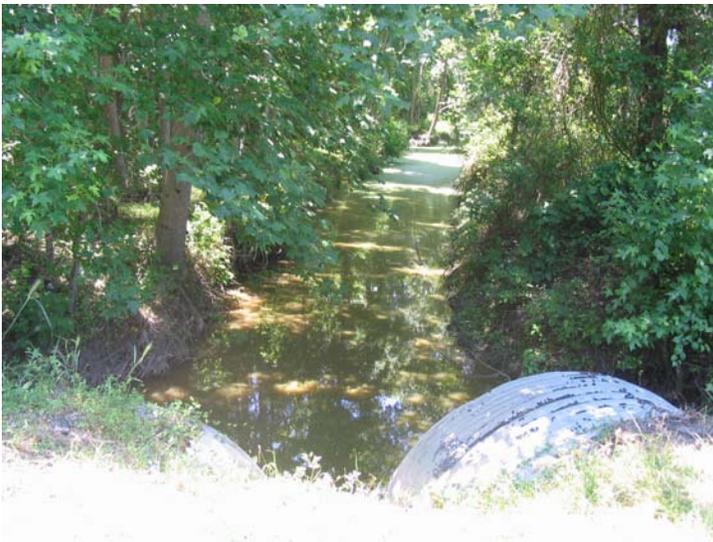
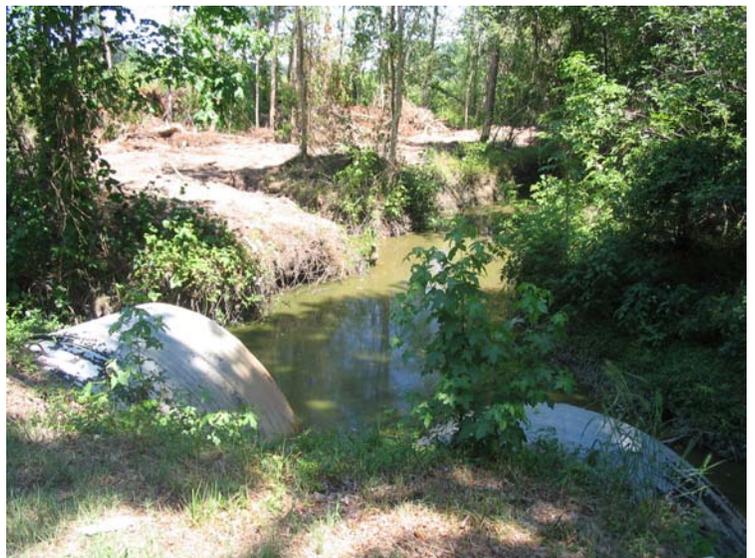
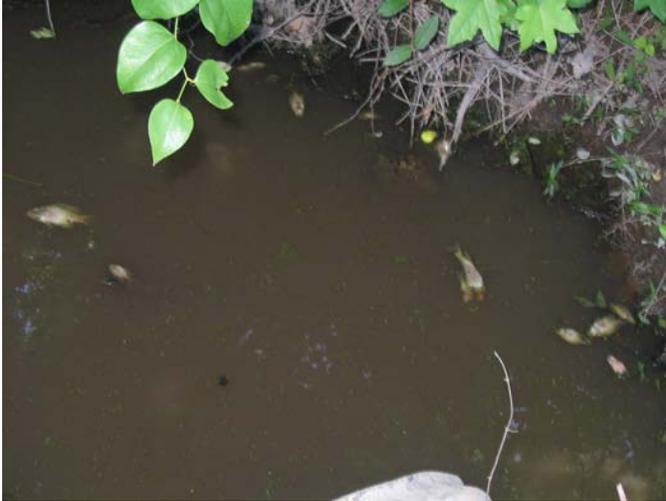
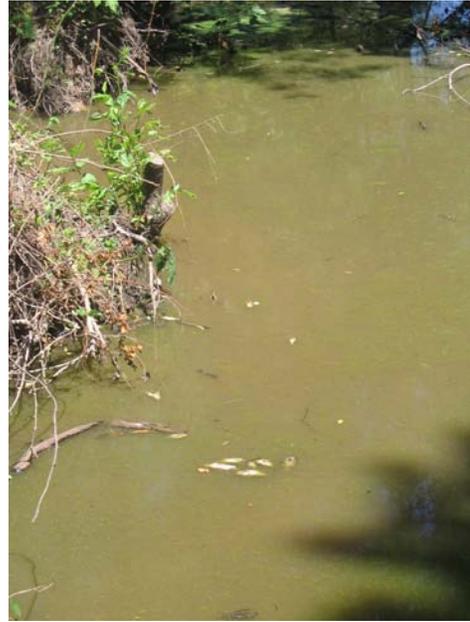
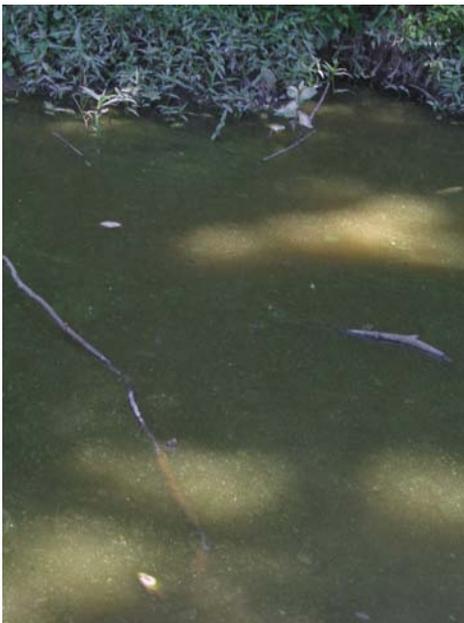
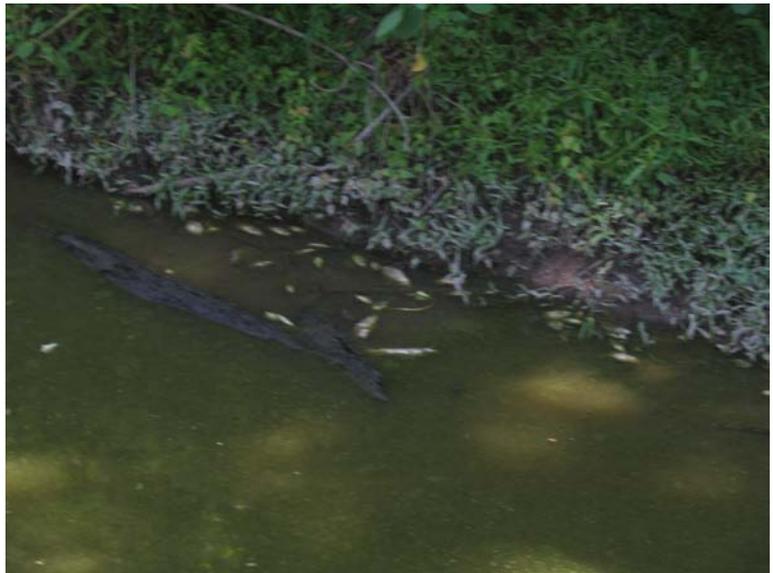
Site ID: 28

There is cleared land on either side of the upstream habitat at site twenty-eight, with a few trees remaining. The downstream habitat is forested. The culverts are metal, with a diameter of approximately six feet. They are fifty-one feet apart.

At site twenty-eight there were approximately eighty dead fish observed in the river. An estimated twenty were downstream of the culvert entrance. At the upstream side at least sixty were observed. These fish were within ten feet of the mouth of the openings of the culverts. The fish ranged from approximately two to six inches in length (observed). The previous day there had been a few torrential rain storms. The weather on this day was sunny and clear.

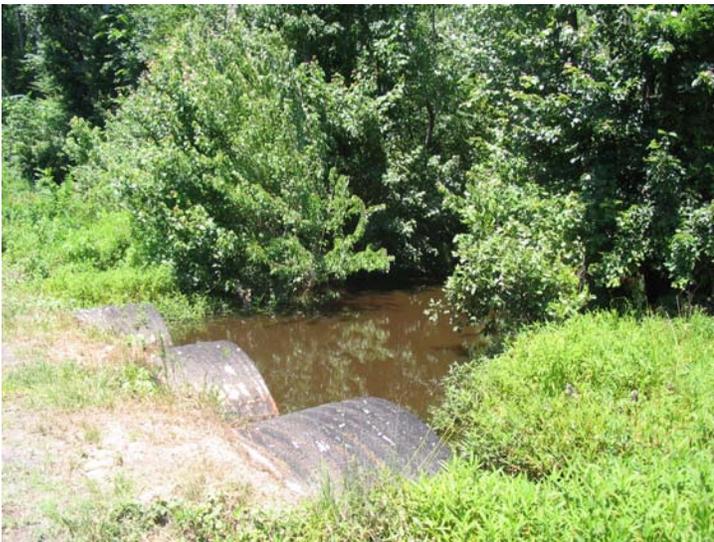
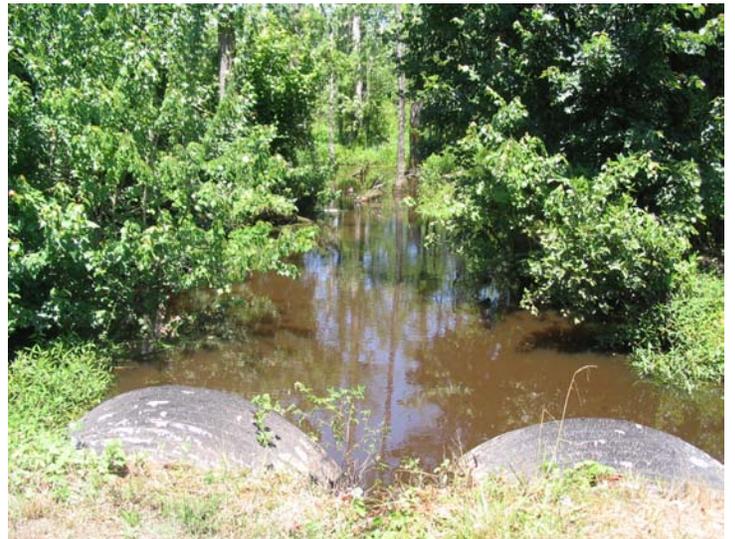
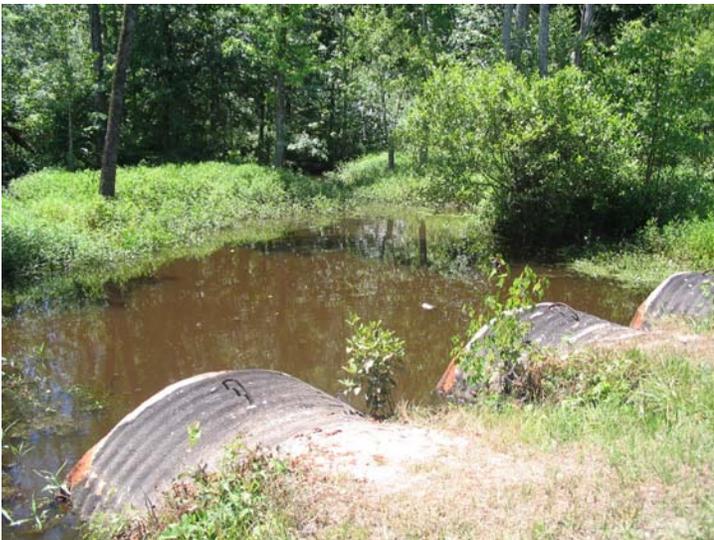
Site ID: 29

There were three black pipe culverts at this site. The culverts were approximately five feet in diameter. The area surrounding the stream was forested. There were two turtle basking near the edge of the stream. The flow in the stream was minimal.

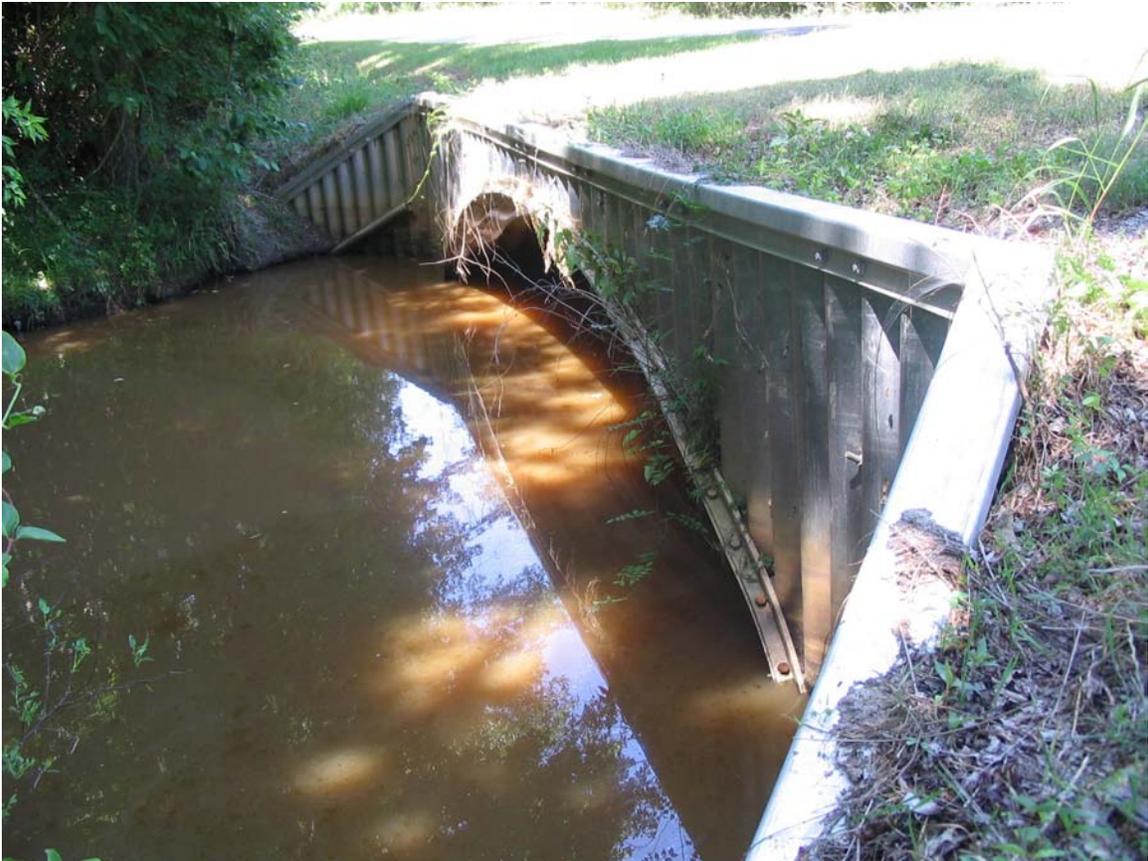
Site ID: 31

This site had an aluminum pipe culvert approximately twelve feet in diameter. The stream appeared to be relatively deep, however the water was stagnant. The river was two feet below the culvert. There were many turtles out basking. The surrounding area was forested.

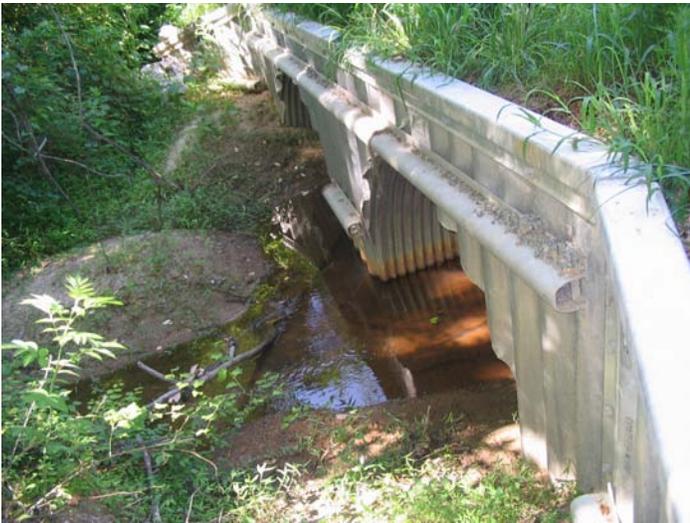
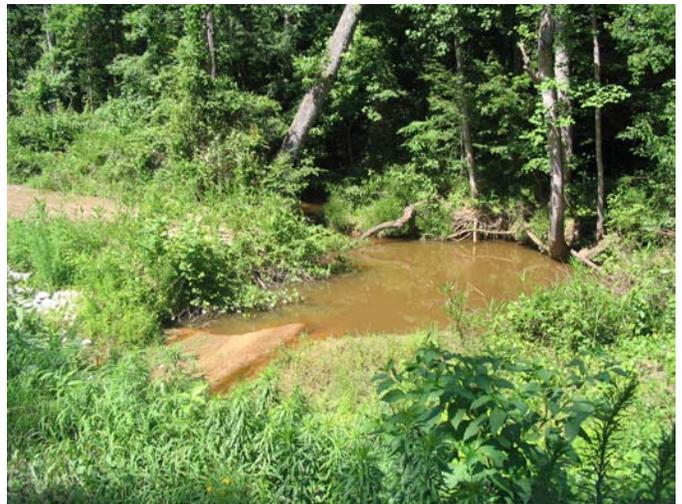
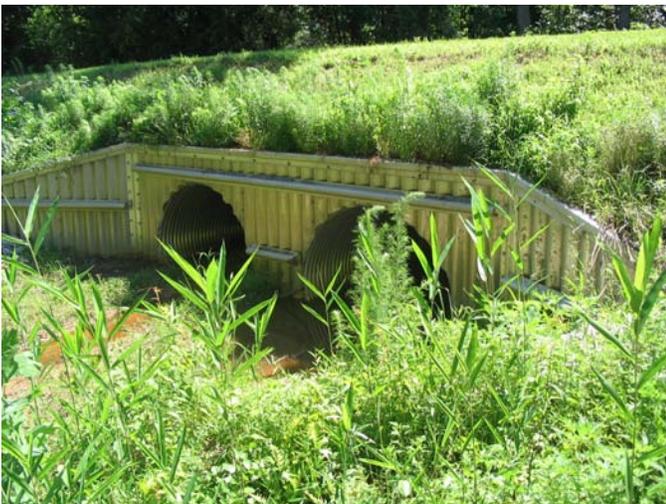
There are two aluminum pipe culverts located on Hares Branch, a tributary of the Meherrin River. This site is located just outside of Murfreesboro, near Chowan University. There is only a slow trickle in the stream, which is approximately a half foot deep. The stream is forested on either side.

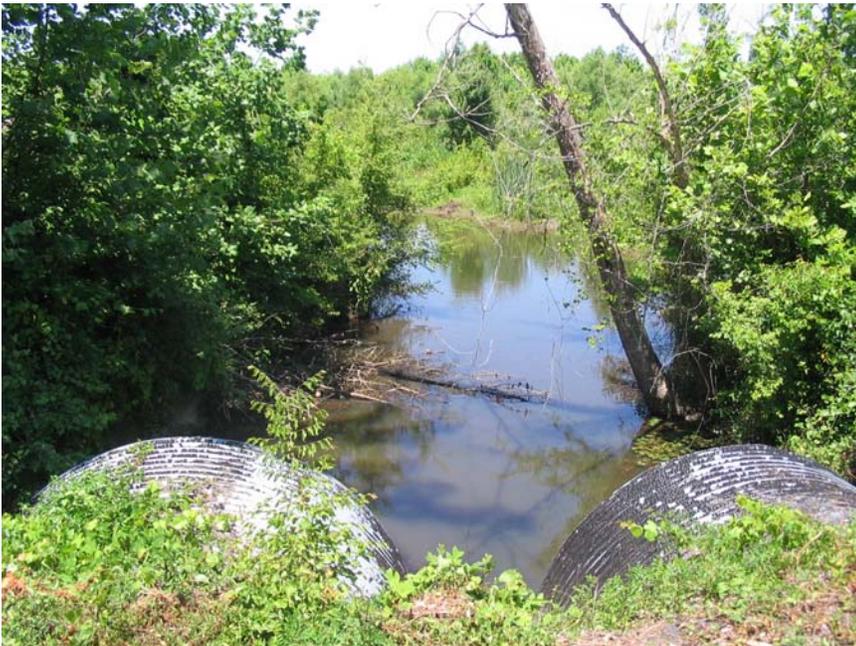
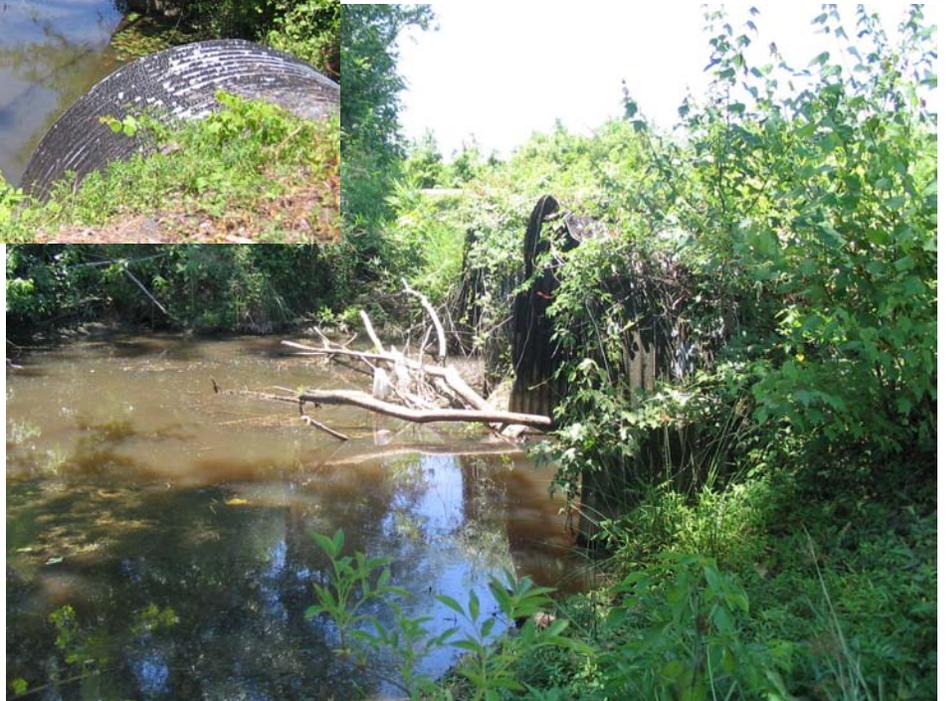
Site ID: 40

Along either side of the stream is forested, although there was a significant amount of agriculture along Ward Road. This site has two black pipe culverts, approximately six feet in diameter.

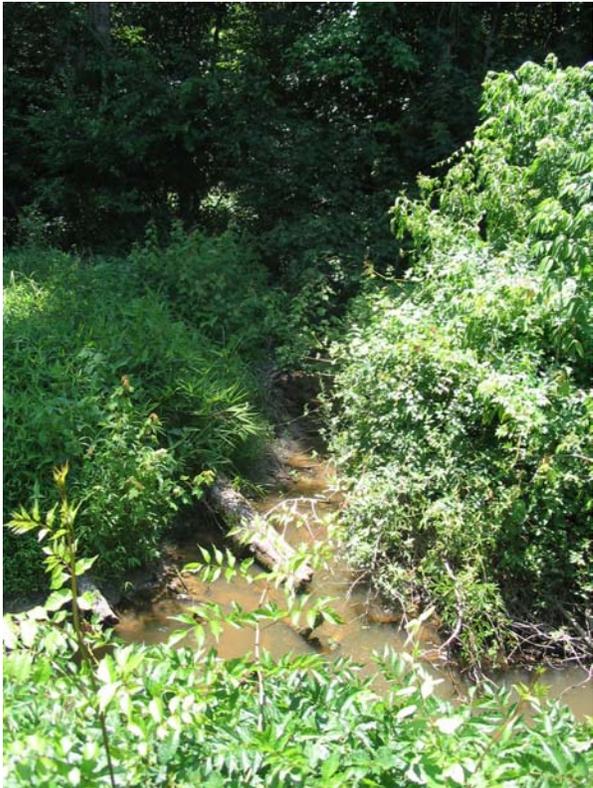
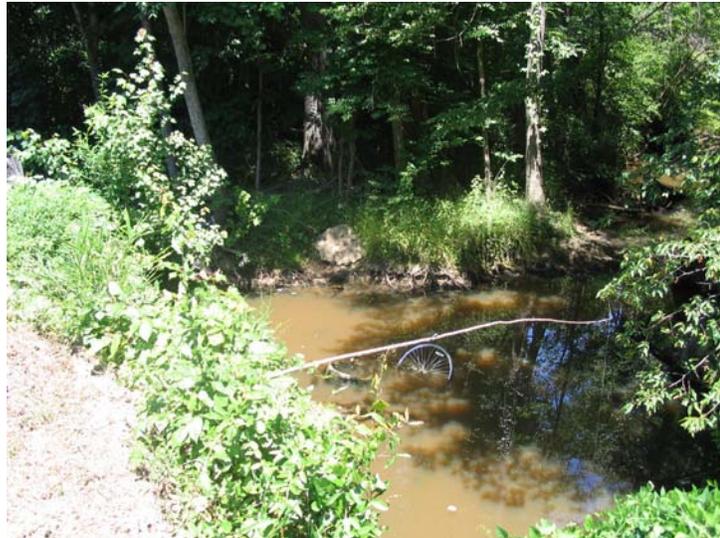
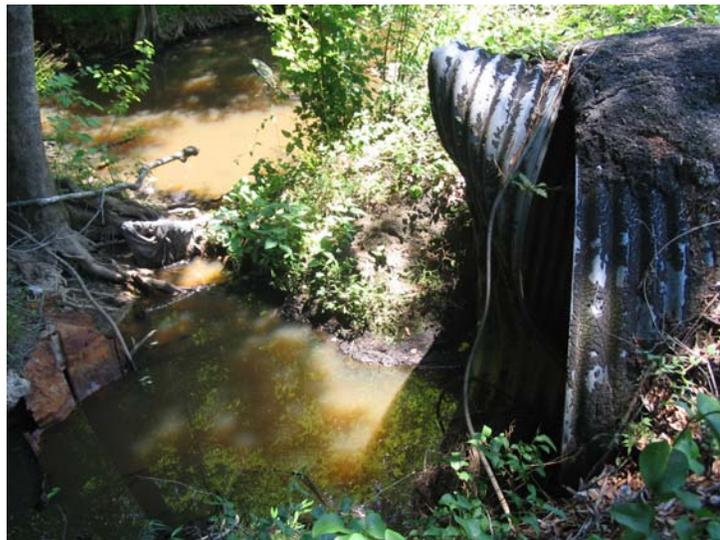
Site ID: 41
Type: Pipe Culvert
Location: Goodwin Road
Water Body:
Date Sampled: 6/21/2007

Site forty one was three black pipe culverts. One of the pipe culverts is in disrepair. It looks as if a tree has fallen on it, perhaps in the last hurricane. This would severely obstruct anadromous fish migration. The other two culverts are in good condition. The upstream habitat has a very low, minimal flow. There is a bicycle in the downstream habitat.
