SAV Mapping Cycle 2 Albemarle-Pamlico Region 2012-2016

Dean Carpenter
Albemarle-Pamlico National Estuary Partnership

SAV Monitoring Workshop
26 February 2016

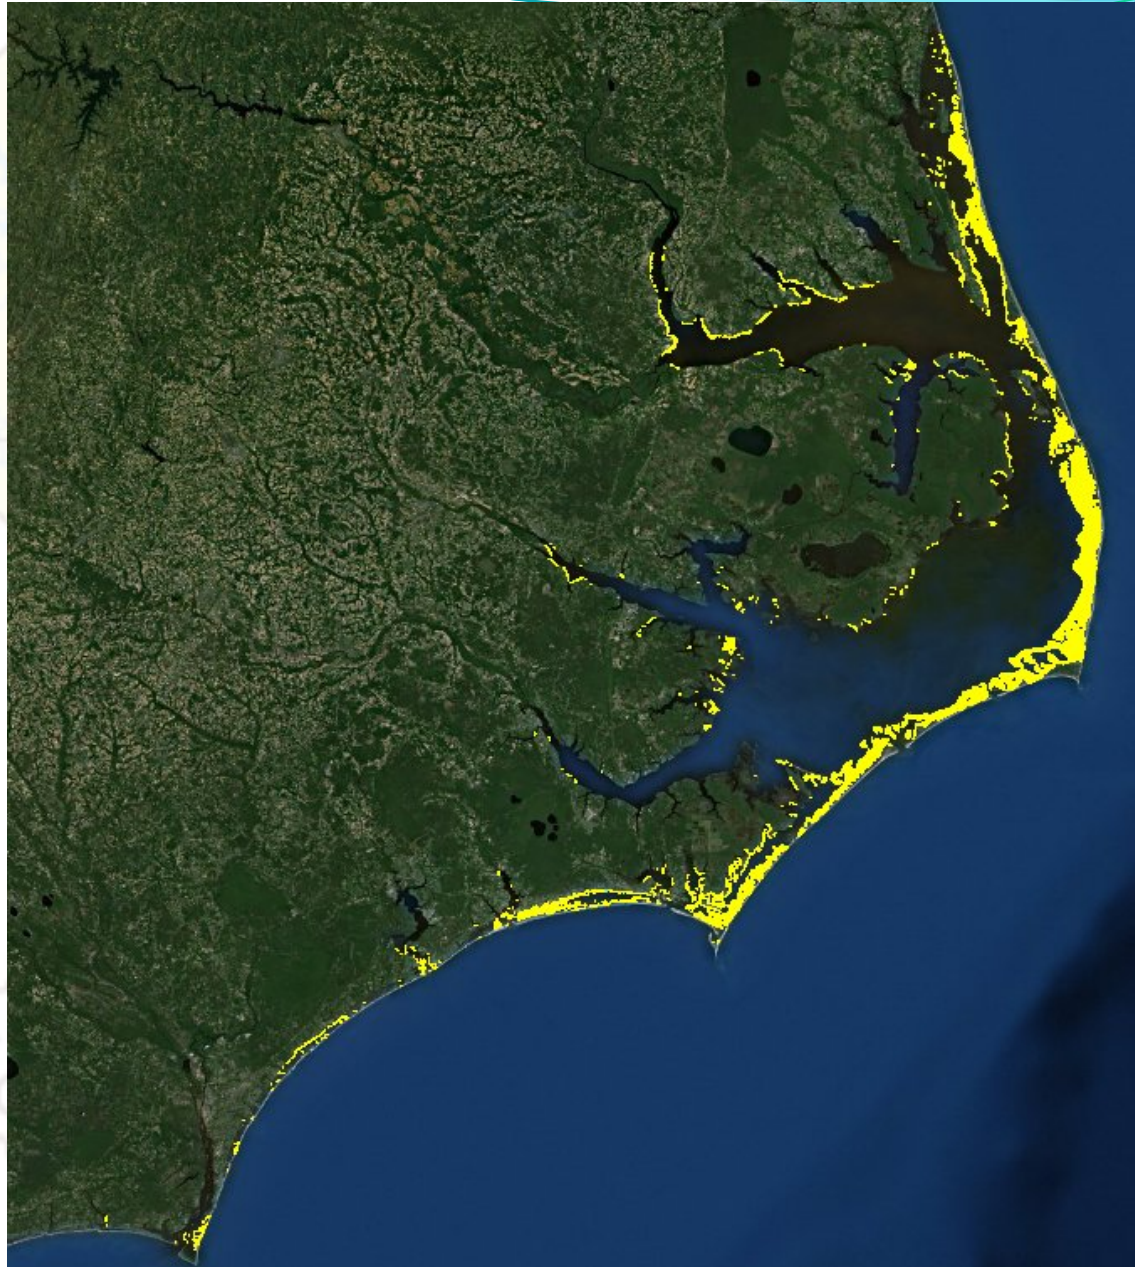
SAV in NC and Back Bay, VA 2006-2008

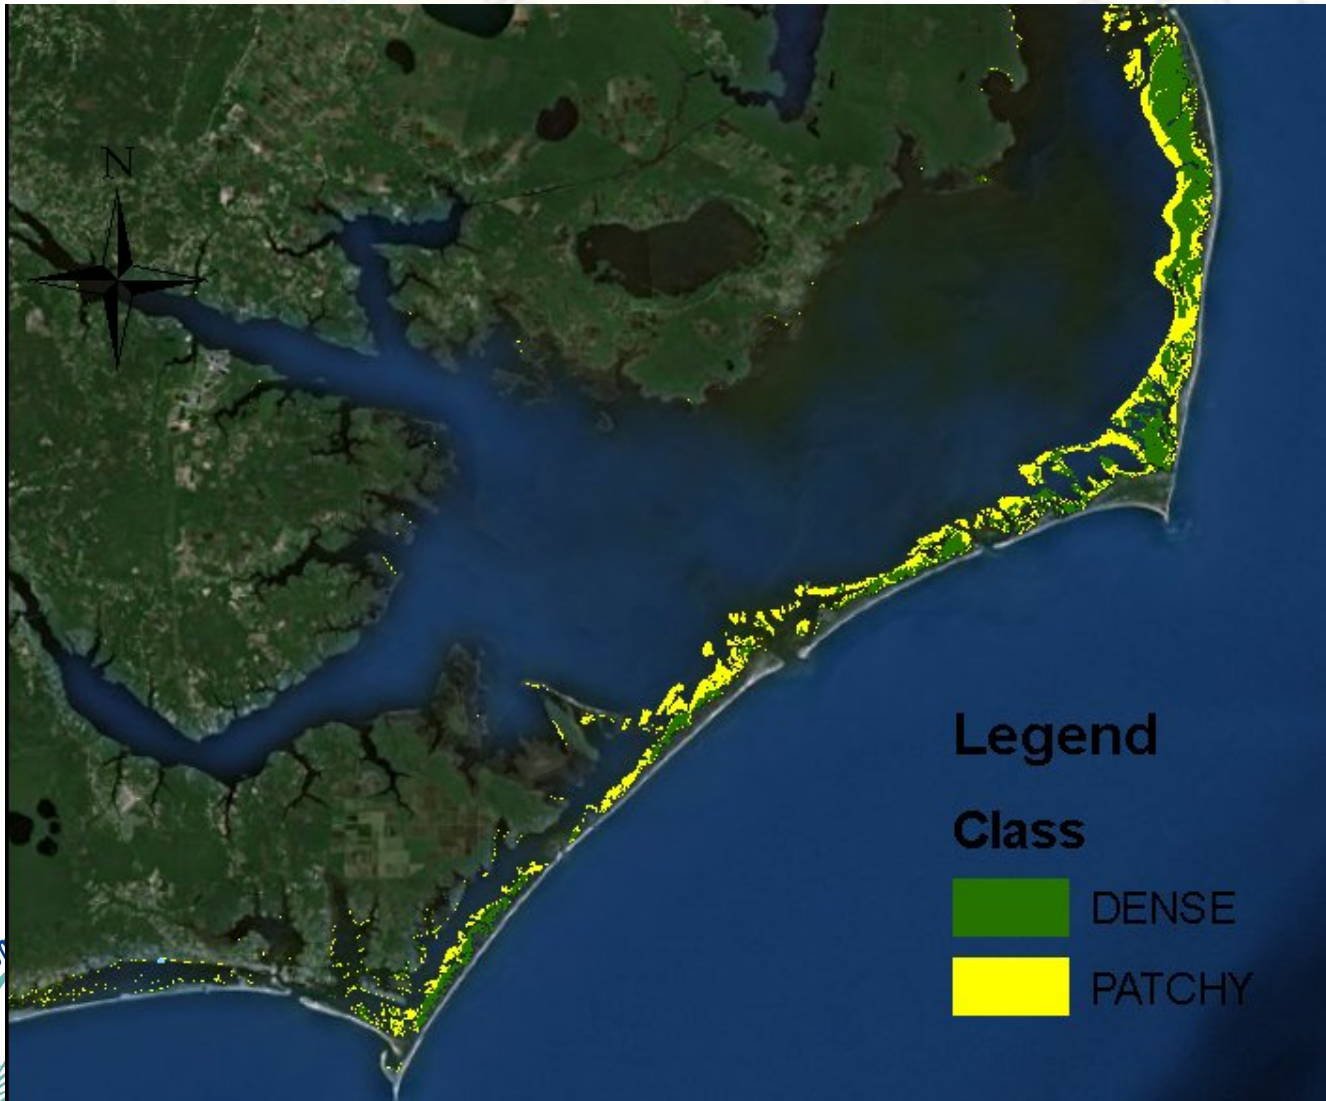
Oregon Inlet to Cape Lookout

- 86,103 acres
-71% of State
Total

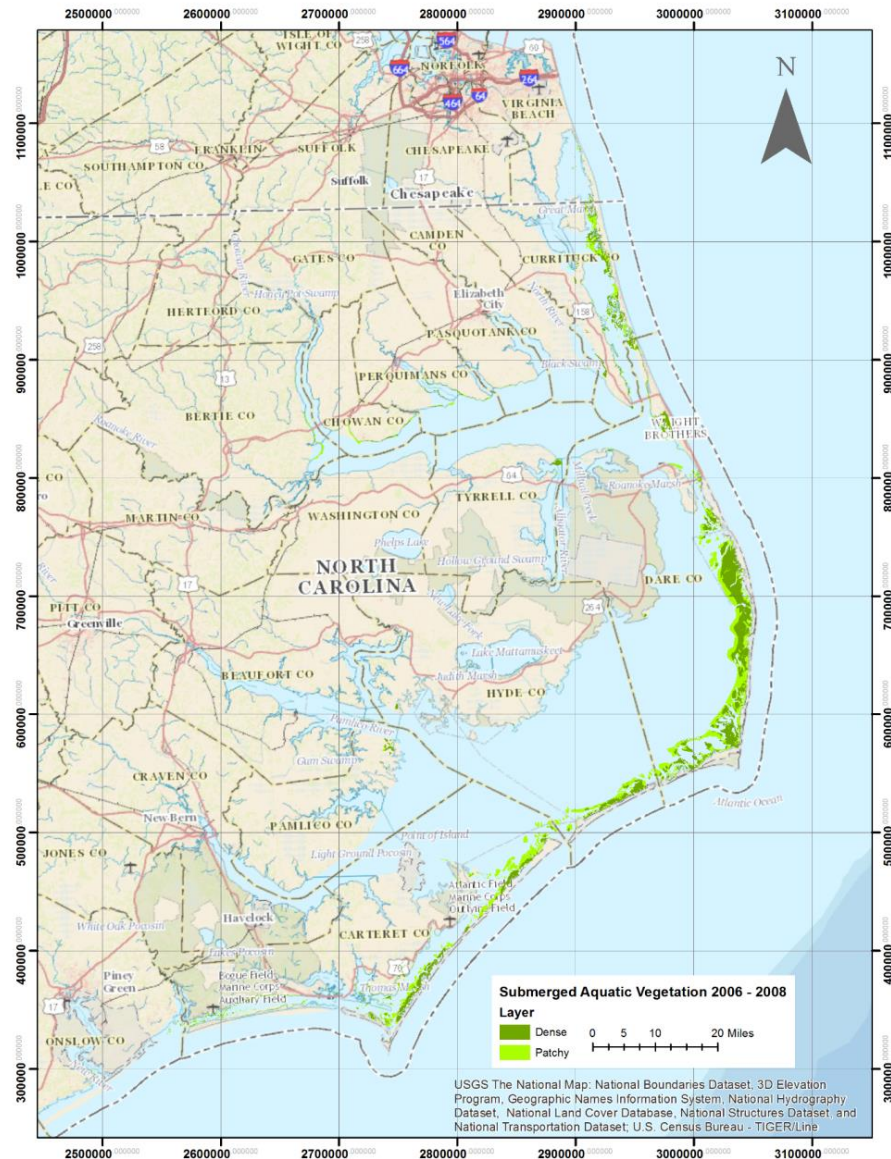
2006 - 2008 SAV TOTALS

SAV CLASS	ACREAGE
Aquaculture	24.2
Dense	72,108.8
Patchy	68,066.8
GRAND TOTAL	140,199.8

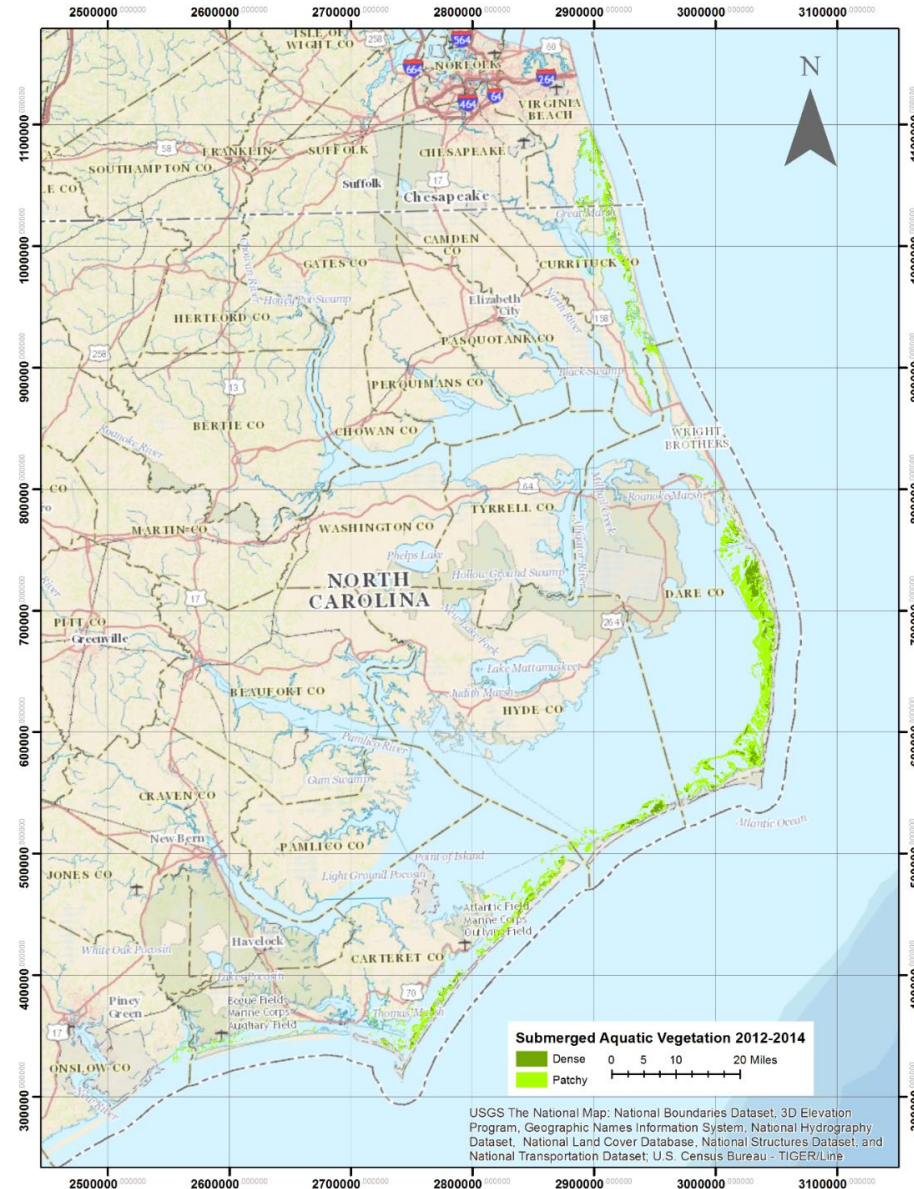
2012 - 2014 SAV TOTALS

SAV CLASS	ACREAGE
Dense	21,756.3
Patchy	101,477.7
GRAND TOTAL	123,234.0
