# Currituck Sound Ecosystem Restoration Study

## SAV Partners' Spring 2011 Meeting

USACE – Wilmington  
Doug Piatkowski

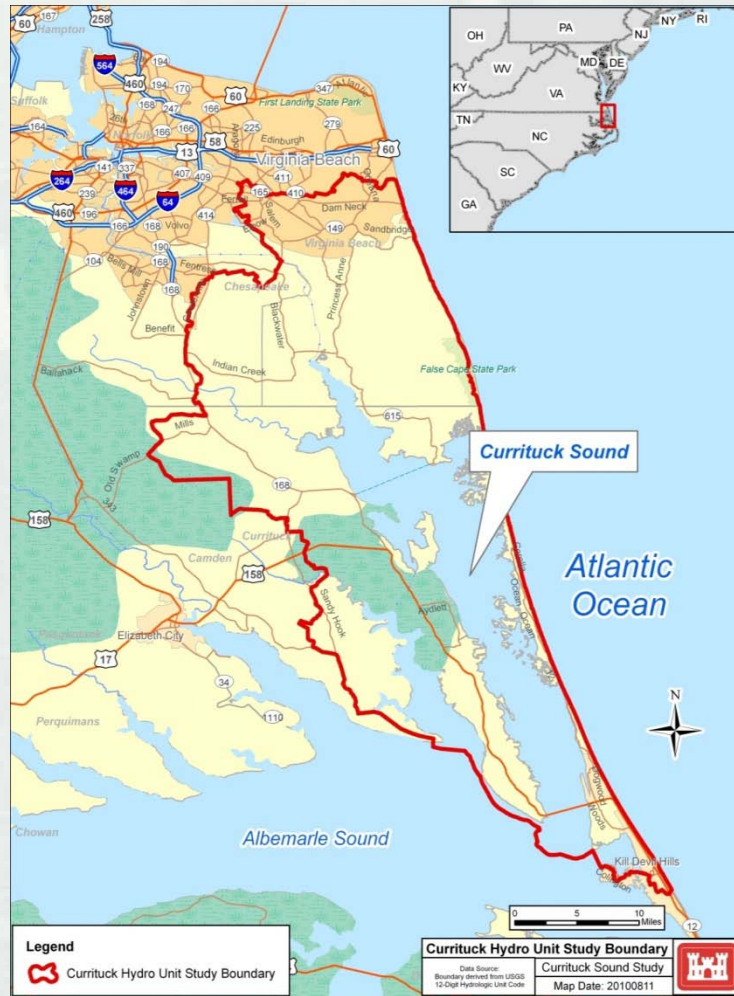
## Currituck Sound Study Area

- NE segment of Albemarle-Pamlico Sound
- Includes Currituck Sound, NC and Back Bay, VA and their surrounding watersheds
- Separated from the Atlantic by Outer Banks
- Sound is approximately 36 miles long, 3-8 mi wide and 153 mi<sup>2</sup> (~98,000 acres)
- Located predominately in Currituck and Dare Counties, NC and Virginia Beach County, VA
- Currituck Sound joins Back Bay in Virginia Beach, Virginia to the North and joins Albemarle Sound on the South
- Connected to the Atlantic Ocean through Albemarle Sound and Oregon Inlet

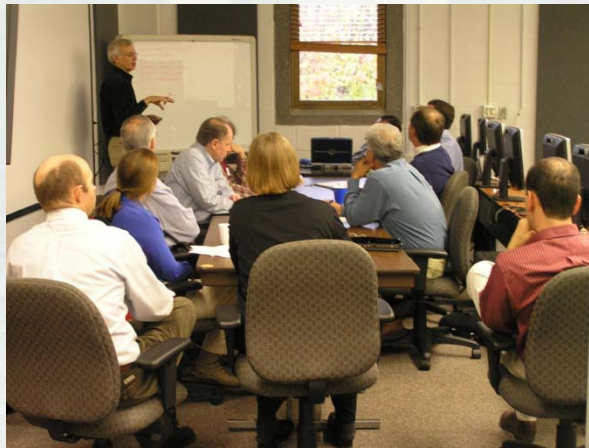
## Data Collection

- Collaborative multi-agency data collection initiative
- Developed a hydrologic/hydrodynamic and water quality monitoring and modeling group
- Data collection facilitated development of coupled hydrodynamic and water quality models of Currituck Sound and vicinity
  - ADCIRC, CH3D, CE-QUAL-ICM

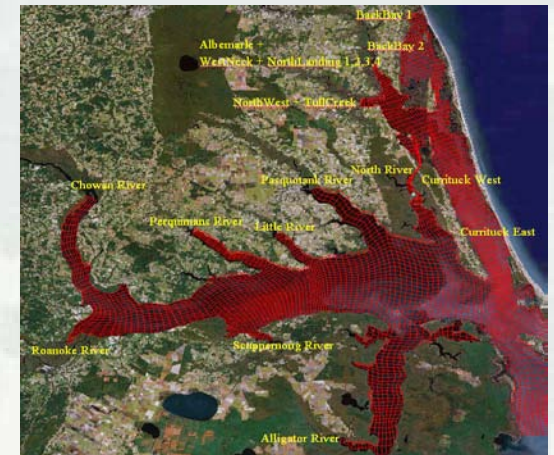
- **Wind driven Tide**

- Wind direction, speed, and duration, are key factors in the tidal influence of Currituck Sound
- Higher water levels result from a South wind and low water levels from North wind

- **Limited Flushing**

- Simulated tracer concentrations in Currituck Sound were not influenced by Oregon inlet
- Limited impact of the tributary inflows

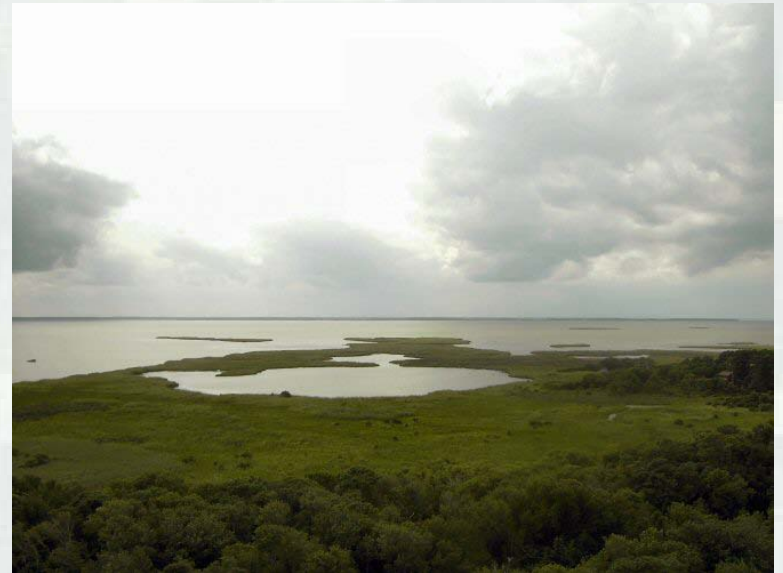
- Monitoring showed current nutrient loadings to the system are not as high as previously perceived and WQ is not as degraded as historically observed
  - Nitrogen and phosphorous values - within an acceptable range
  - Algal levels - normal
  - DO levels - low at times at certain locations but were not indicative of a major problem
  - light penetration - reduced by the presence of solids and algae in addition to color in the water column

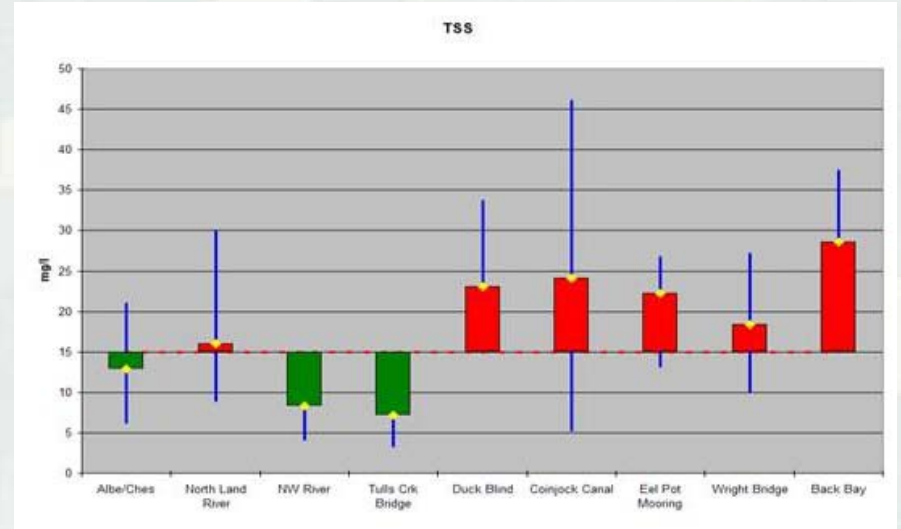
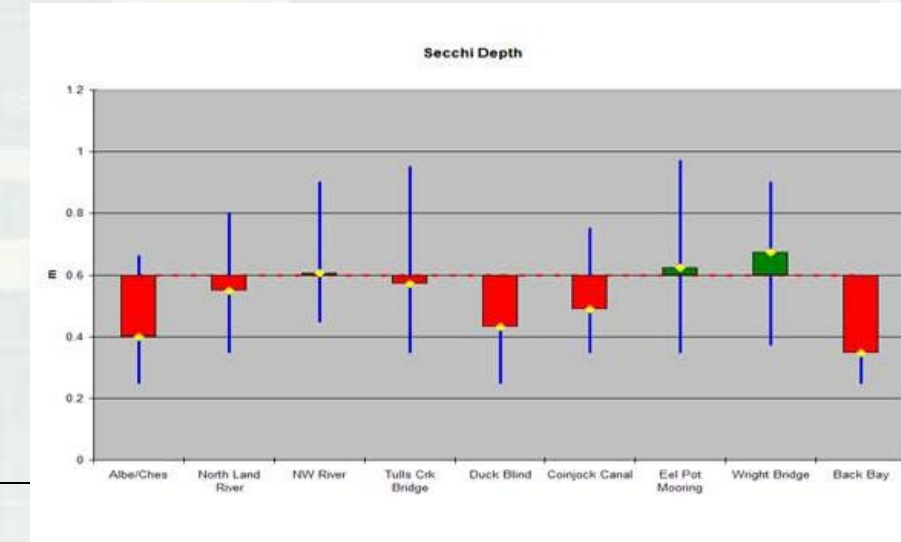
- SS concentrations in the open water - higher than SS in the tributaries
- Source of the SS from within the Sound - result of sediment re-suspension caused by high energy wind-wave events
- Re-suspension associated with loss of SAV

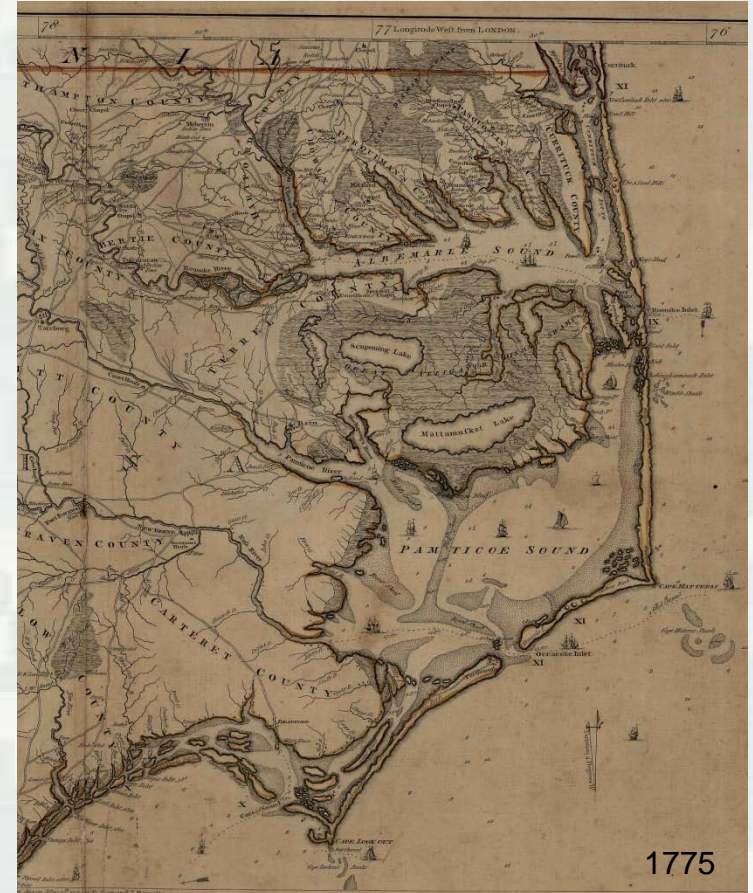
- Salt water system connected to the Atlantic Ocean by series of inlets
- Five known historic inlets from early 1600's to early 1800's
- Last inlet closed mid-1800's (Caffey's)
- Hydrology also affected by other anthropogenic (i.e. navigation channels) and natural events (storms)

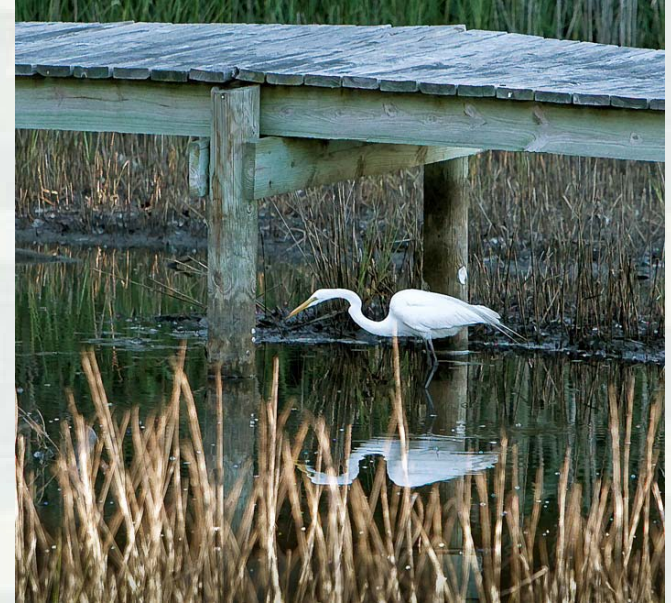
- Historically most heronries in coastal swamps
- Logging has degraded or eliminated areas for nesting
- It is believed historically - multiple wading bird nesting sites throughout Currituck Sound
- Monkey Island currently only remaining wading bird nesting habitat in study area
- Monkey island -
  - 1952 - 8.4 ac,
  - 2005 - 5.1 ac
  - 2010 - 4.4 ac

Note: For constructed wading bird nesting islands, a size range of 5-25 ac is recommended

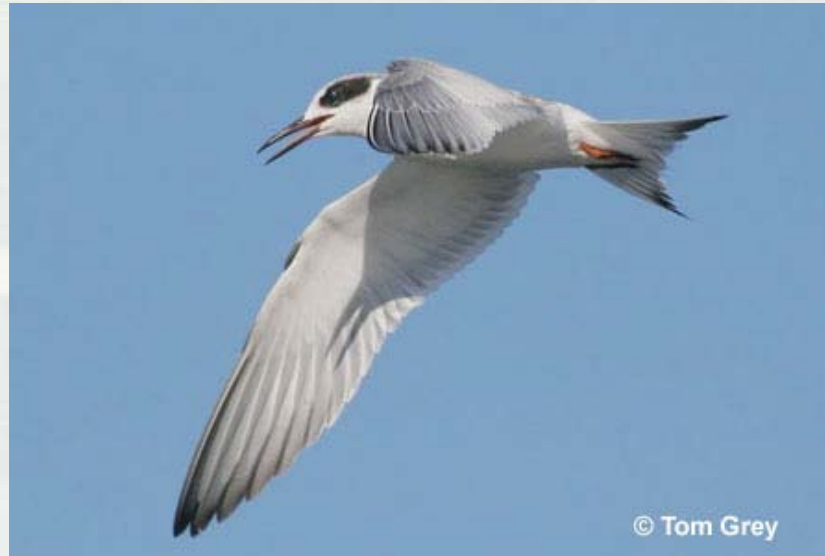
Development, beach driving, and associated disturbance factors on Currituck Banks have eliminated the piping plover and American oystercatcher from the study area and significant declines in least tern numbers are also evident

- In 1992 – 4 least tern colonies existed with 3-6 nests at each site; 2004 – 2 nests; and in 2010 – 1 nest.

Terns generally prefer bare or nearly bare substrates

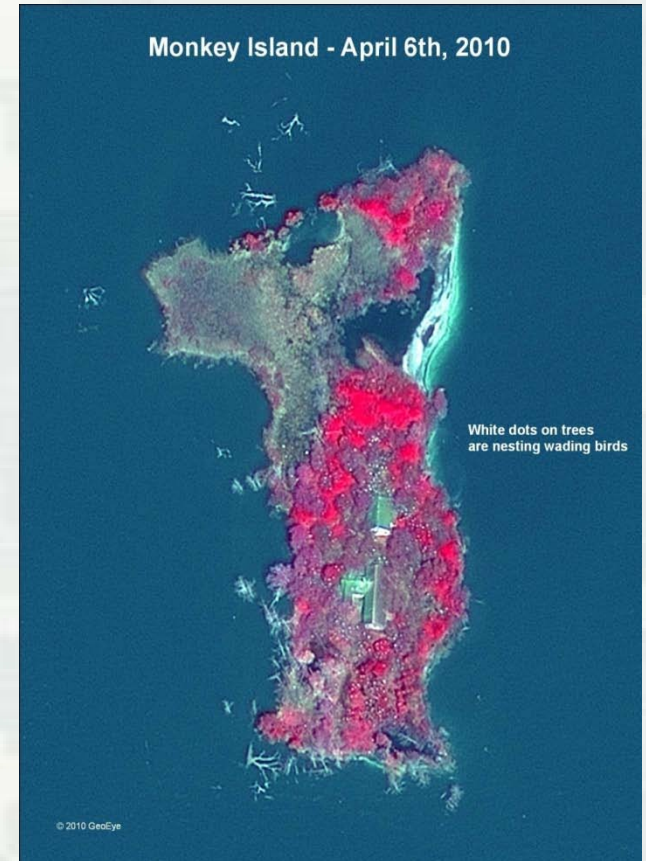
- Monkey Island supports herons, egrets, and ibis
- Often holds the largest little blue heron colony in the state
- Continued erosion of Monkey Island is currently decreasing the amount of available nesting habitat
- Nest crowding is apparent and is increasing.
- Increased accumulation bird feces could kill vegetation through soil acidification reducing appropriate nesting trees
- Monkey Island supports tidal wetlands and shelters about 3 acres of SAV from wind and wave attack

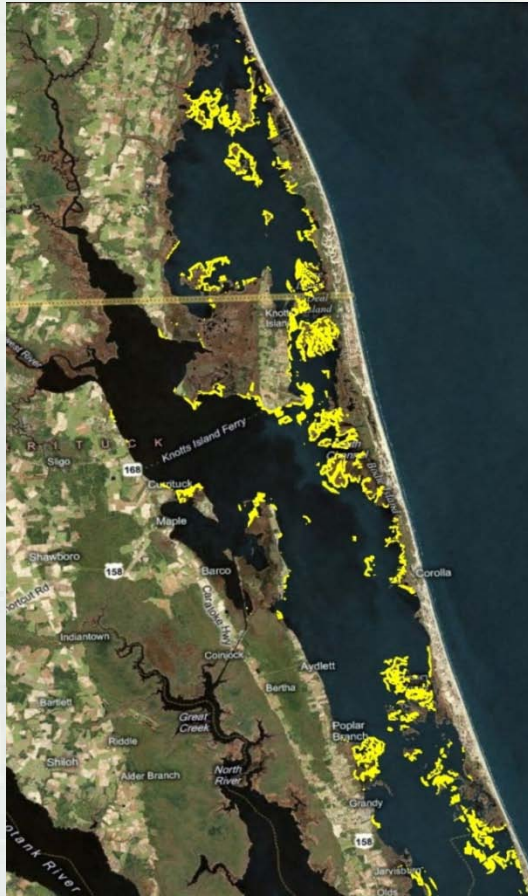
Marsh Focus Areas

**SDSS was used to identify areas which no longer contain these habitats & present high opportunity for restoration**

GIS-based method for scaling, weighting, and combining multiple, spatially explicit variables for the purpose of identifying distinct areas within a larger landscape that present good opportunities for restoration of a particular resource

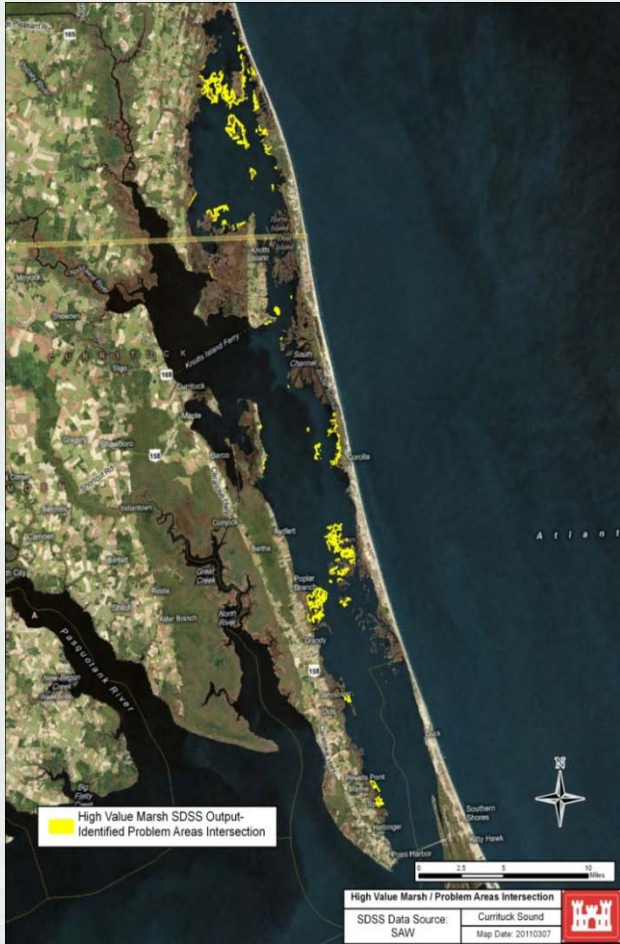
Marsh Focus Areas

Locations:

- most degraded
- posing an opportunity
- need for restoration by the stakeholders

Overlaid on the map of areas identified as “high opportunity” for restoration by the SDSS

From the regions of overlap, general restoration opportunity areas were identified
